AIRTIGHTNESS OF BUILDINGS — TOWARDS HIGHER PERFORMANCE

Interim Report D5 — Site Assessments and Feedback Material

Dr David Johnston, Centre for the Built Environment, Leeds Metropolitan University

Reference Number: CI 61/6/16 (BD2429)

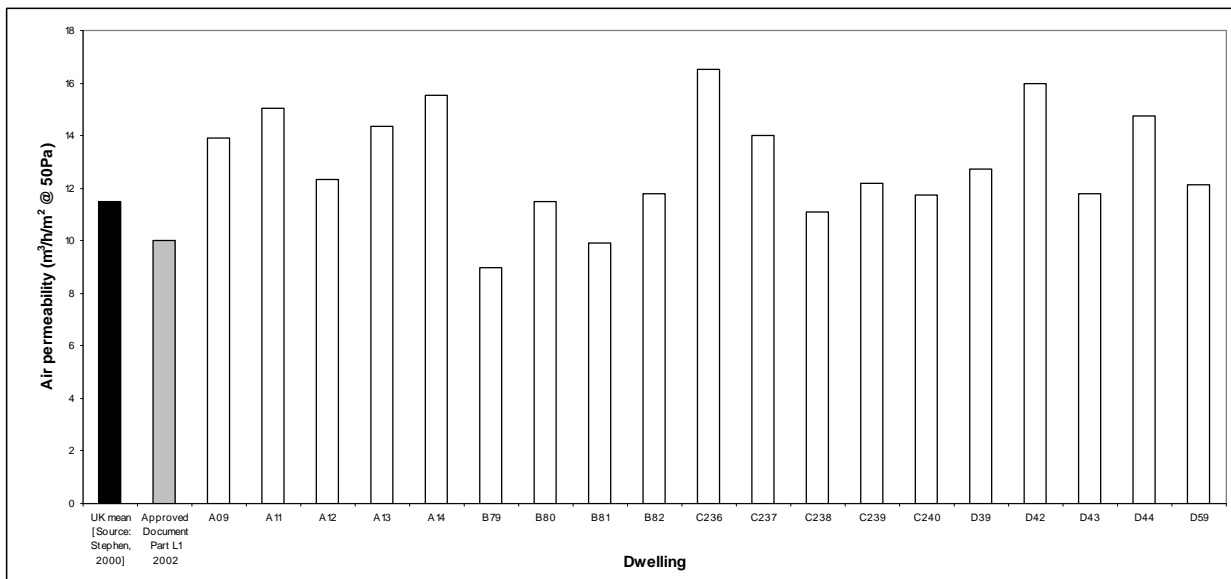
Figure 1 Mean air permeability of the tested dwellings.

- 19 Figure 1 illustrates the air permeability of the 16 tested dwellings compared with the UK mean¹ and the recommended maximum level set in the 2002 edition of the Building Regulations Approved Document Part L1 of 10 m³/(h.m²) @ 50Pa (ODPM, 2001). The data show that a relatively narrow range of airtightness was measured for the 16 tested dwellings. The air permeability ranged from 9 to 16 m³/(h.m²) @ 50Pa with a mean of 12.8 m³/(h.m²) and standard deviation of 1.9 m³/(h.m²). Only three of the 16 dwellings (dwelling B79, B80 and B81) had an air permeability that was lower than or equal to the UK mean of 11.5 m³/(h.m²). The mean of all 16 results (12.8 m³/(h.m²) @ 50Pa) suggests that these dwellings are less airtight than the average for the UK stock as a whole (11.5 m³/(h.m²) @ 50Pa). However, given the number of dwellings tested and the range of values measured, there is not a statistically significant difference between the sample and the UK mean.

- 20 Perhaps of most importance is that only two of the tested dwellings (dwellings B79 and B81) had air leakage values that were lower than the maximum specified level of 10 m³/(h.m²) @ 50Pa set in the 2002 edition of the Approved Document Part L1 (ODPM, 2001). Therefore, the results suggest that only two of the 16 dwellings would satisfy the air leakage criterion set out in Approved Document Part L1. However, given the small sample size and the range of values measured, there is not a statistically significant difference. All five developers were using Robust Details (see DEFRA, 2001) as the basis of the application for regulatory approval. Despite this, the developers were unable to achieve the airtightness target in the majority of cases. This could be due to a lack of on-site quality control relating to the construction of Robust Details, poor communication, poor inherent construction design relating to airtightness, a lack understanding of how Robust Details work or possibly even that the Robust Details themselves may be difficult to achieve in practice, impractical or insufficiently tolerant of site variability — so called 'buildability'. We understand that the impact of Robust Details on whole dwelling air leakage was not subjected to empirical testing when the current catalogue was compiled. This report suggests that empirical testing would be needed as part of a process of developing a catalogue of details capable of reliably delivering an air leakage target.

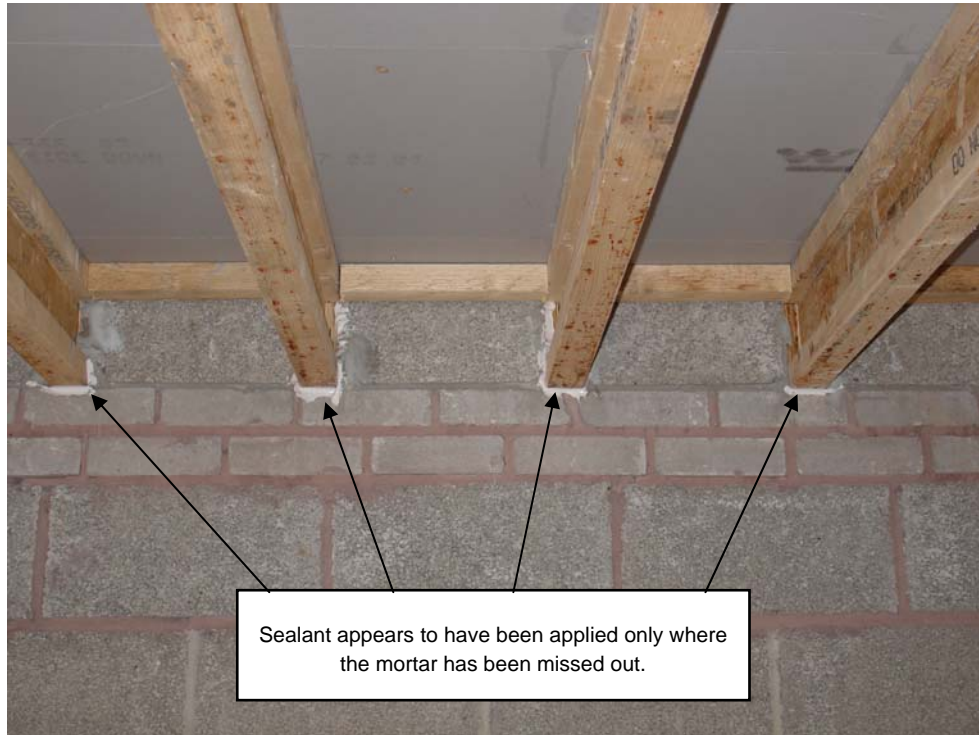
- 32 In several cases where built-in joists were used and when observed at the stage prior to final sealing, very large gaps were visible between the joist and blockwork, often with the joist resting at an angle. This would make it much more difficult to properly seal the gaps between block and joist.

Figure 2 Partial application of mastic sealant (developer B).

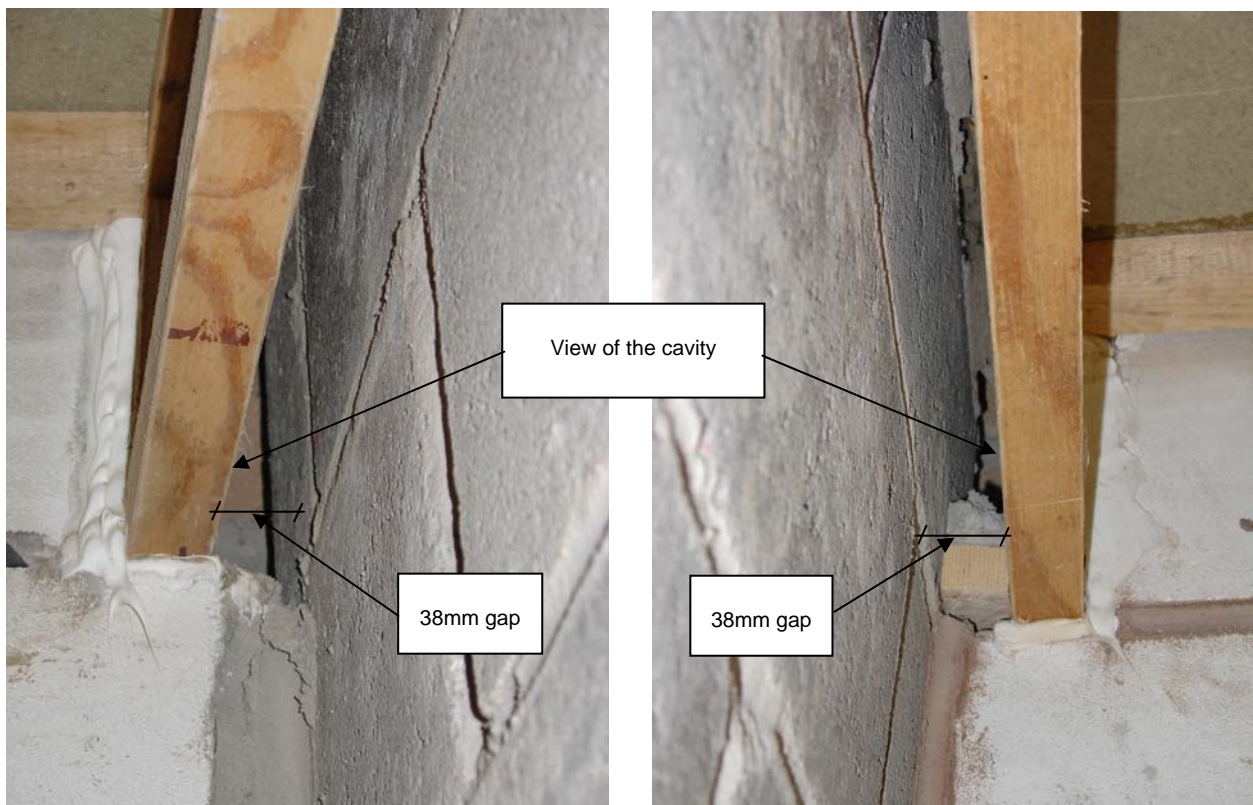
- 33 For developers A, B and C the timber I-beams that are used to support the intermediate floors are offset from the inner leaf of the external/party wall to allow services to be run from one floor to the next. In a number of dwellings this offset is so small that it is not possible to seal the area between the joist and the external/party wall using mortar and mastic sealant. The result is that in a number of the dwellings it is possible to see through the cavity to the external brick skin (see Figure 3). These gaps will enable air within the intermediate floor void to leak through to the external/party wall cavity and then to outside.

Figure 3 Gaps between the joist and the external/party wall (developer A).

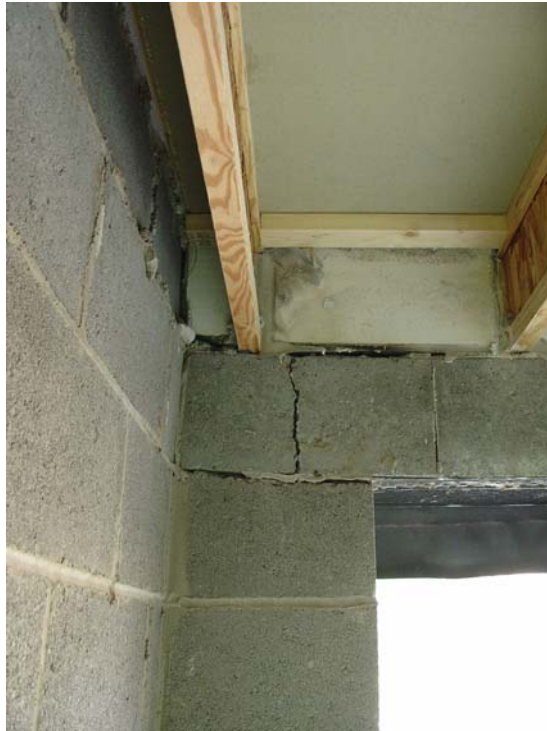
- 34 Site observations have identified a number of areas where cracks and gaps are visible on the internal blockwork leaf of the external/party wall (see Figure 4), and perpends have not been fully filled (see Figure 5). Any cracks or gaps in the blockwork inner leaf of the external wall could result in air leakage to the external/party wall cavity and then to outside.

Figure 4 Cracks in internal blockwork leaf of external wall.

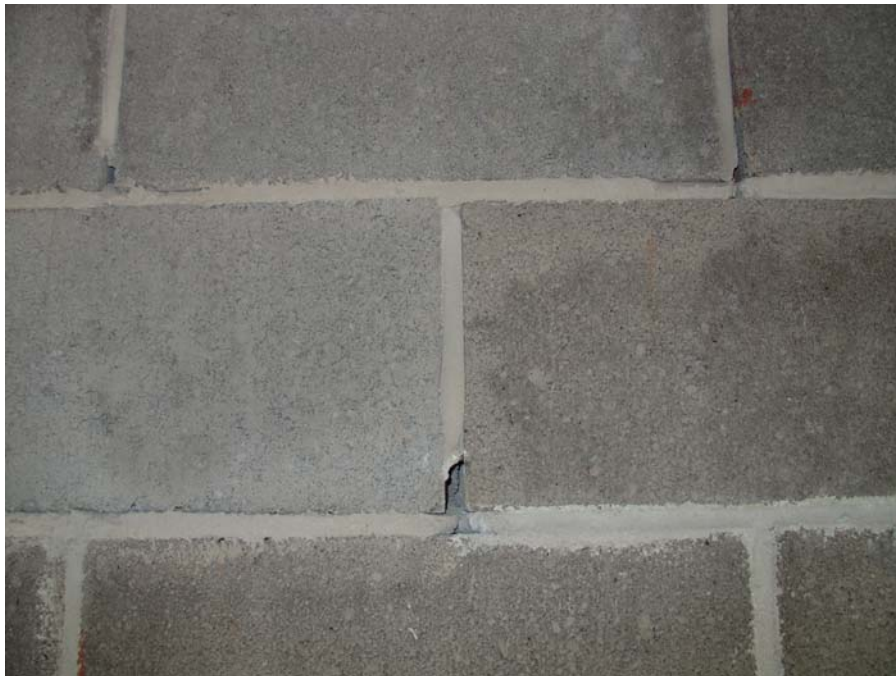
Figure 5 Perpends not fully filled in internal blockwork leaf of external wall.

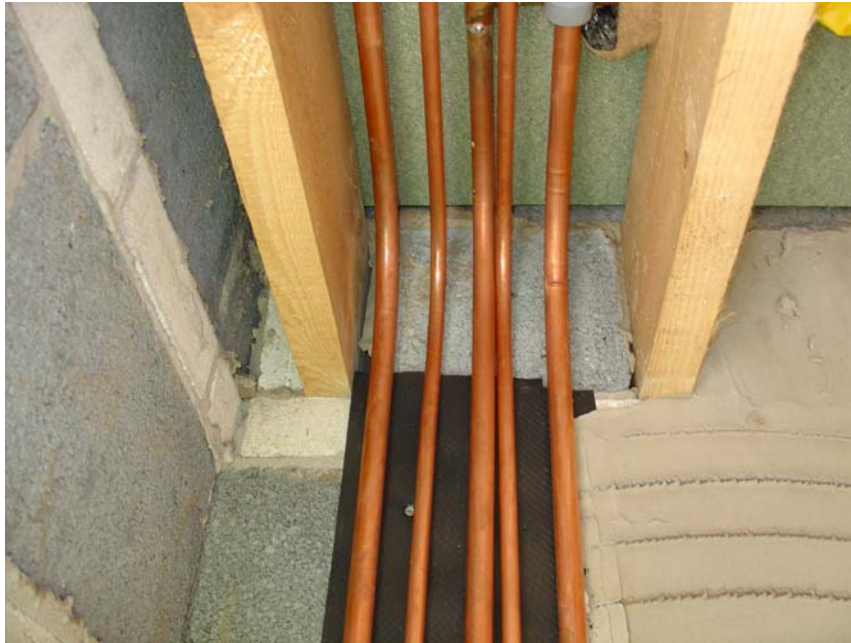
workmanship, prior to the application of the dry-lining. This coat also has the potential to improve the air permeability of the party wall by acting as an additional air barrier. Site observations indicate that the scratch coat has not been applied across the entire party wall (see Figure 6) in dwellings C239 and C240, and it is also being applied after the stairs and services have been installed (see Figures 6 and 7). The partial application and sequencing of the scratch coat means that it has not been possible to completely seal the blockwork party walls in these dwellings. Consequently, there is a risk that air may leak through badly pointed joints, shrinkage cracks, or gaps in the party wall to the wall cavity and then to outside, in locations where the scratch coat has not been applied.

Figure 6 Incomplete scratch coat applied to party walls around services.

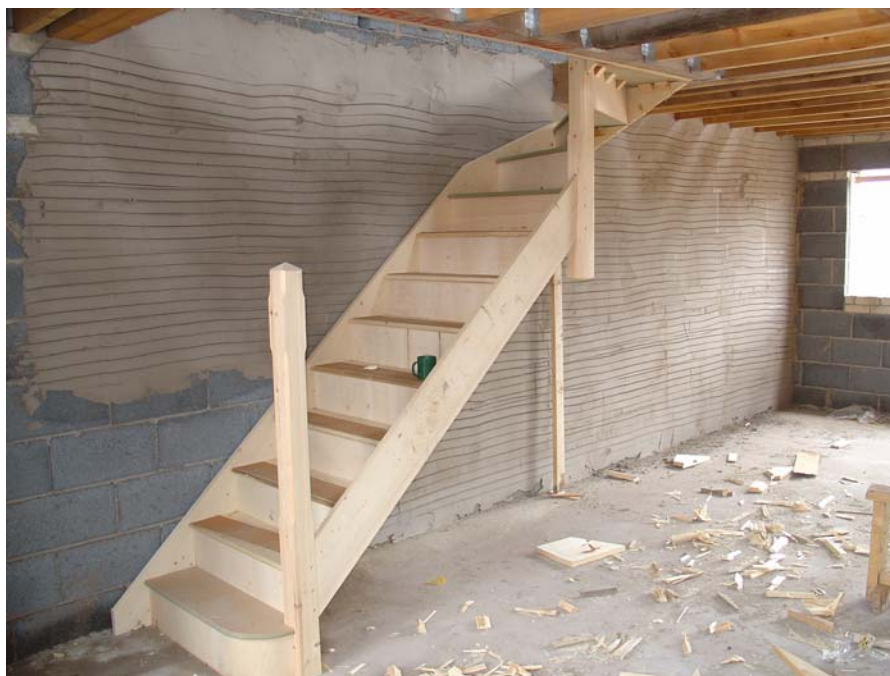
Figure 7 Incomplete scratch coat applied to party walls around stairs.

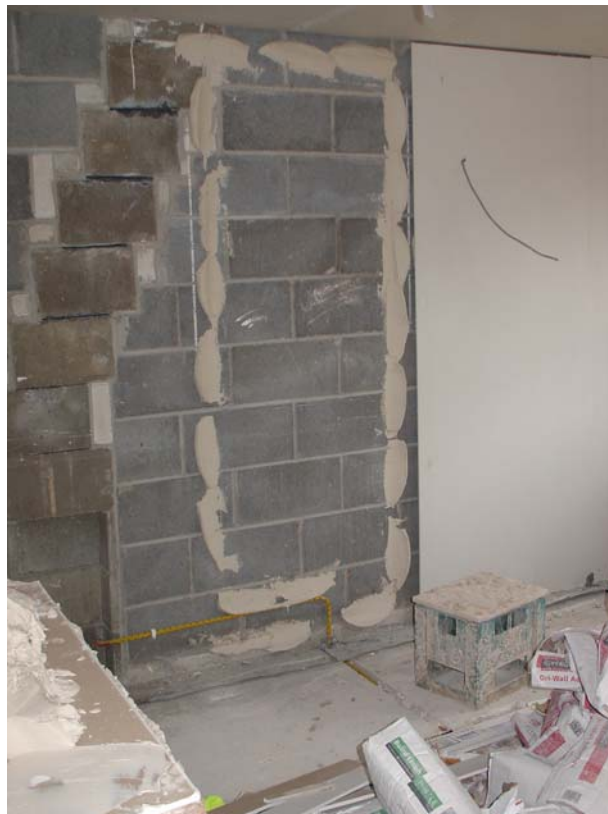
- 36 One of the main air leakage paths within UK dwellings is plasterboard dry-lining (see Stephen, 1998 and 2000). Problems arise with plasterboard dry-lining when air can freely move into the gap between the plasterboard and the masonry wall, especially where the plasterboard is fixed to the wall using adhesive dabs. The air gap between the plasterboard sheet and the masonry wall then acts as a plenum, effectively interconnecting all of the leakage paths within the dwelling. To limit air leakage through plasterboard dry-lining, the report on Robust Construction Details (see DEFRA, 2001) recommends that continuous ribbons of adhesive are used to seal the dry-lining at the perimeter of external walls, openings, and services on external walls. This is illustrated in Figure 8. In our opinion, the process of applying plaster ribbons in such a way as to seal all potential leakage sites is technically difficult to carry out. Observations from site confirm this (see Figures 9 to 11). Figures 10 and 11 also illustrate that the overall thermal performance of these dwellings will be degraded, as the discontinuous ribbons of adhesive will enable air to bypass the internal insulation.

Figure 9 Discontinuous ribbons of adhesive used to seal plasterboard dry-lining.

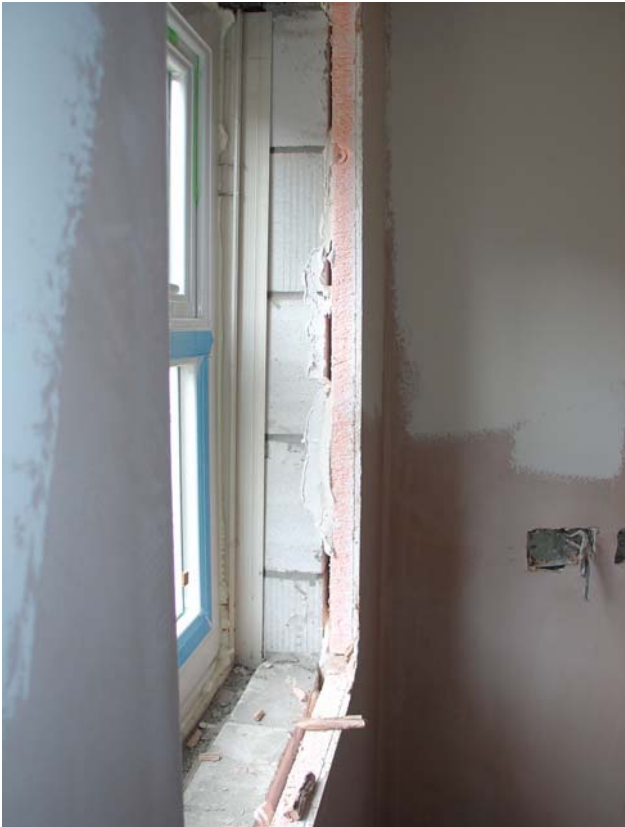
Figure 10 Discontinuous ribbons of adhesive around window opening.

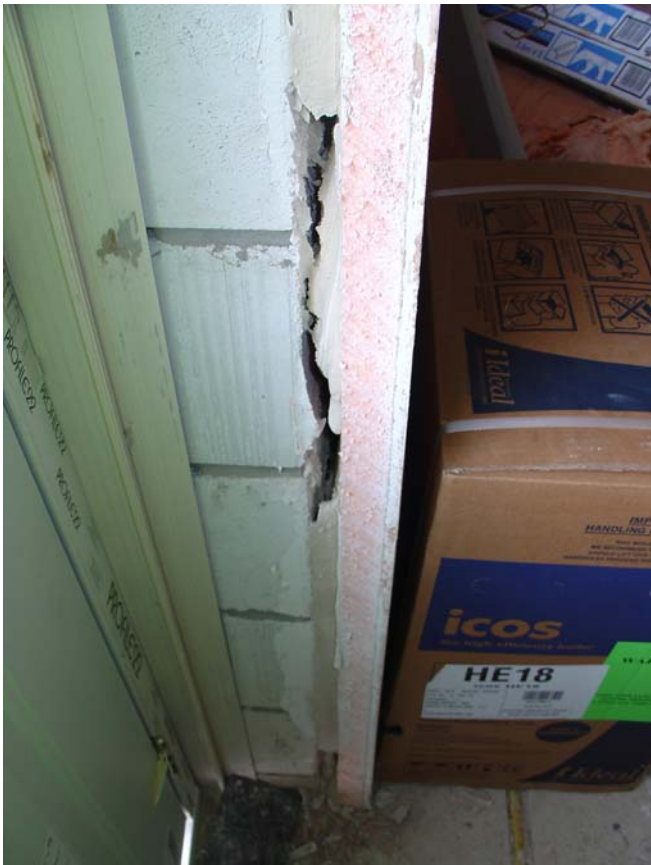
Figure 11 Discontinuous ribbons of adhesive around door opening.

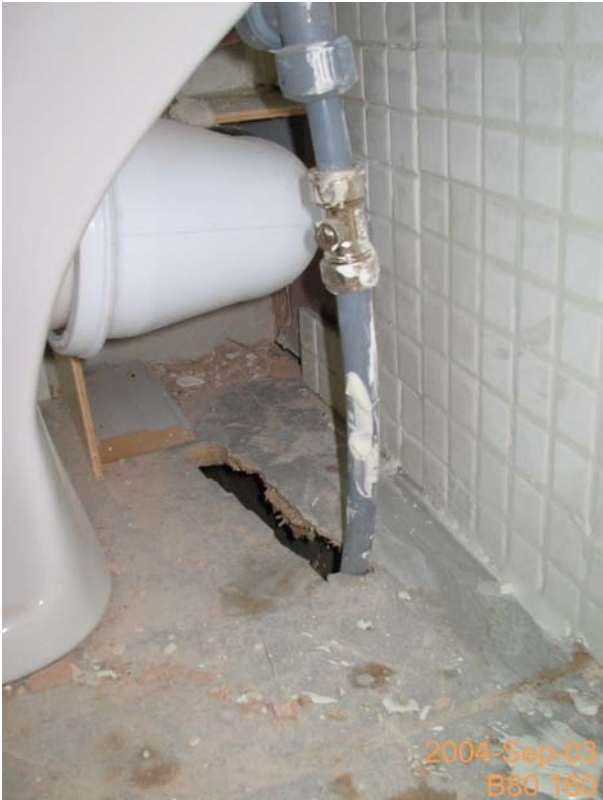
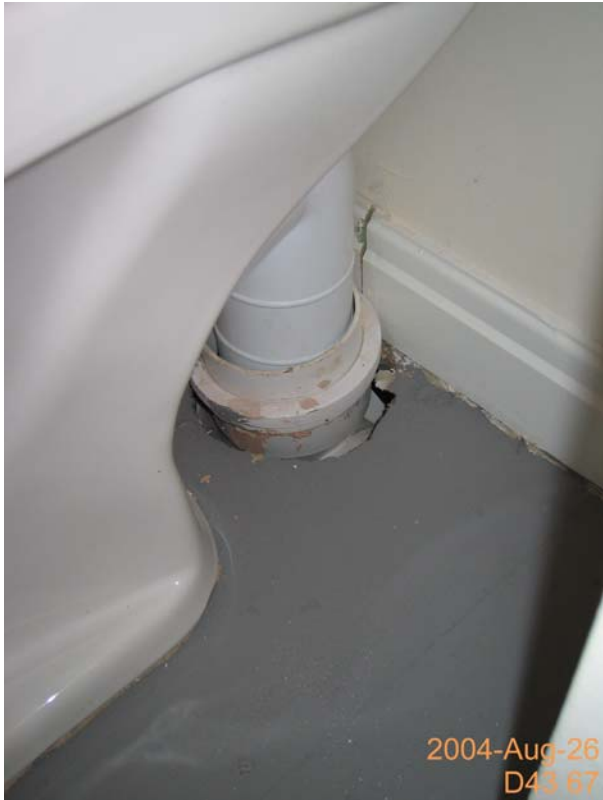
- 37 Service penetrations are known to be a significant route for air leakage (see Stephen 1998 and 2000). The report on Robust Construction Details (DEFRA, 2001) states that particular care on site should be paid to service penetrations and all service penetrations should be sealed with expanding foam or other suitable sealant, whether in the wall, ground floor, intermediate floor or ceiling (see Figure 12). Where large voids exist, mineral wool or some other backing material should be used to support the sealant. Observations from site illustrate that little attempt has been made to seal the majority of service penetrations through walls, ground floors, intermediate floors and ceilings, and where attempts at sealing have been made, the penetrations are generally inadequately sealed and inappropriate sealants have been used to seal gaps around the service penetrations. These points are illustrated in Figures 13 to 17.

Figure 13 Unsealed service penetrations around WC.

- c) Sealing all service penetrations, including those concealed beneath baths and showers, using an appropriate sealant.

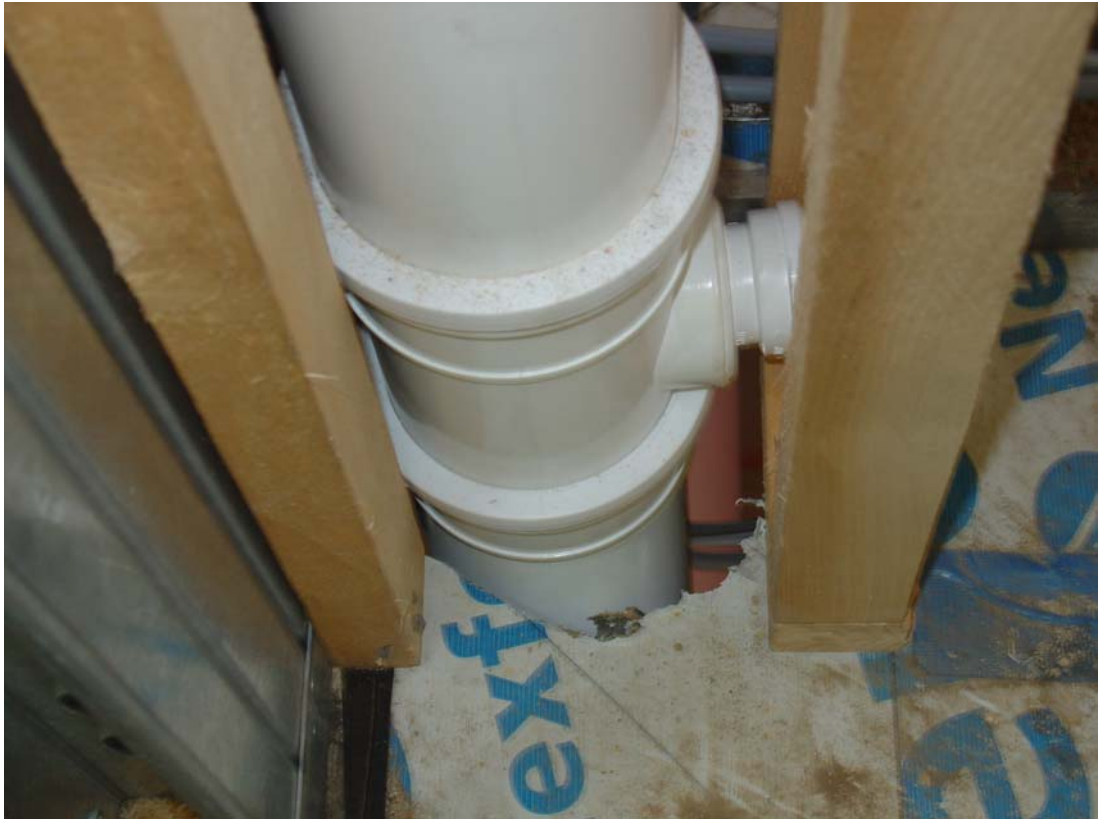
Figure 14 Unsealed soil stack penetrating through intermediate floor.

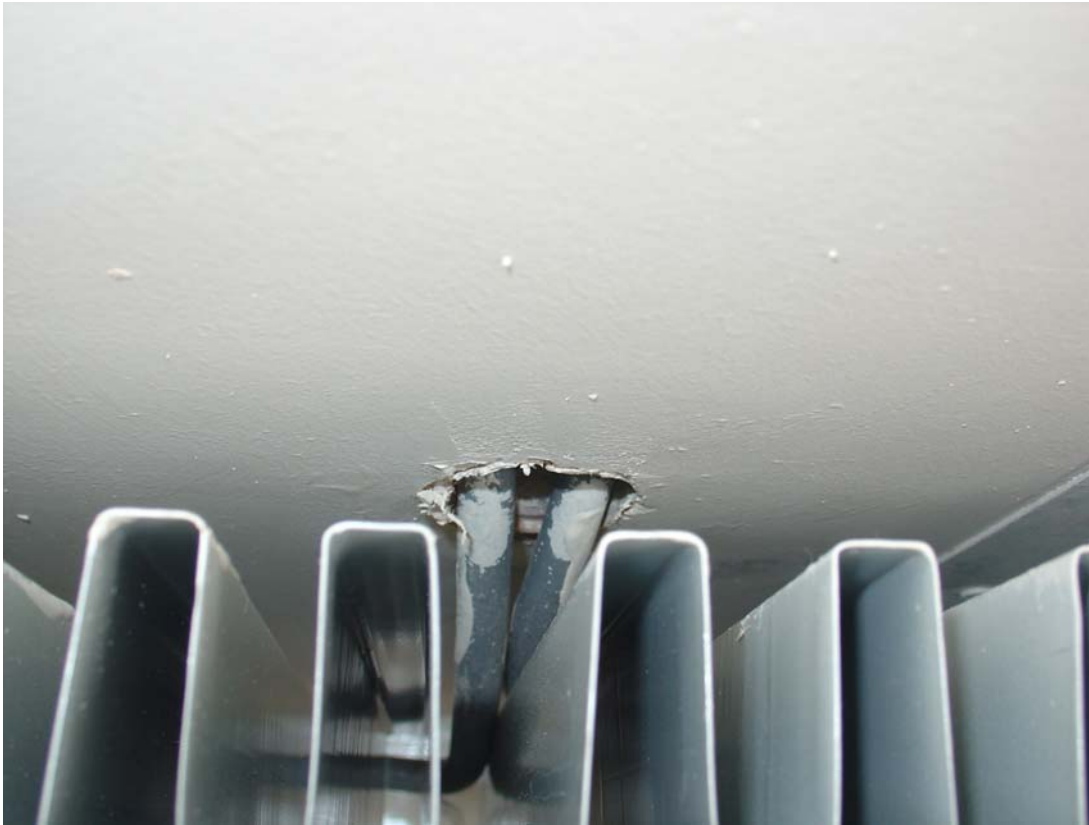
Figure 15 Unsealed pipework penetrations behind radiator.

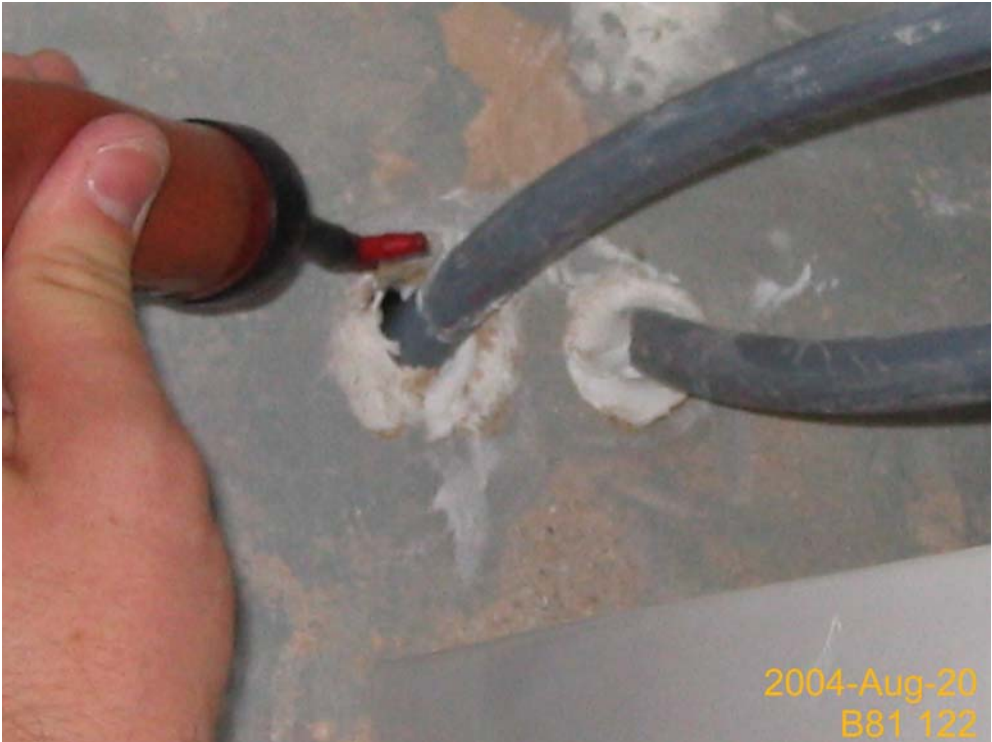
Figure 16 Unsuccessful attempt at sealing around water pipes.

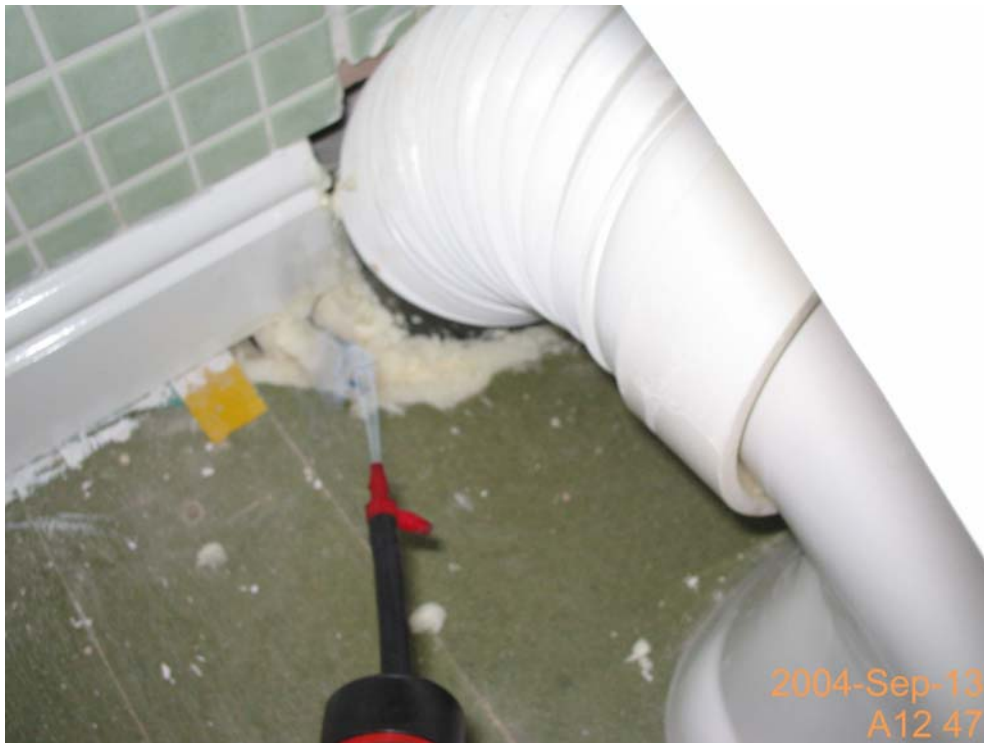
Figure 17 Inappropriate use of sealant to seal service penetrations.

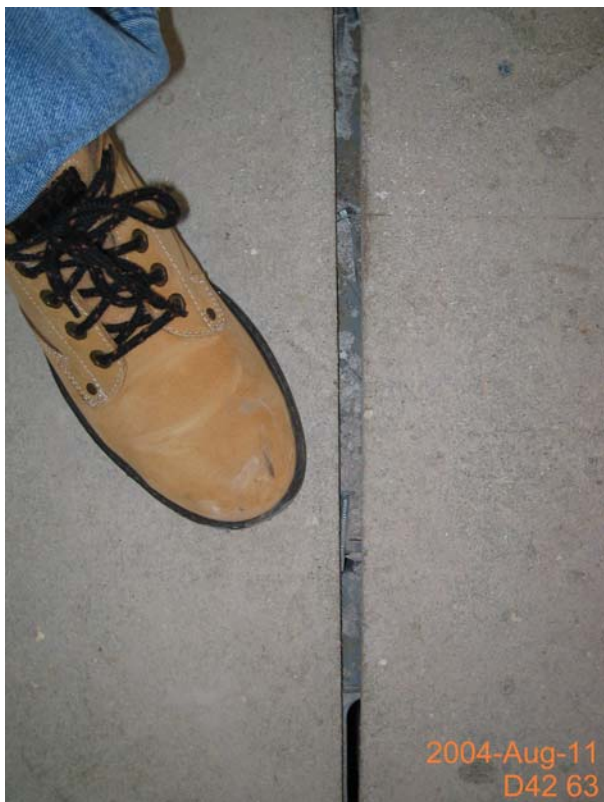
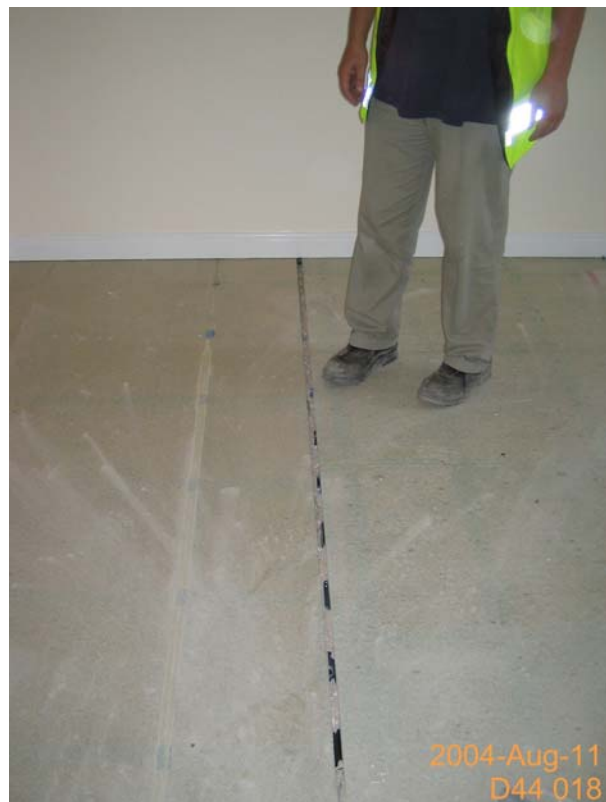
- 39 Holes in the flooring and gaps between the flooring panels were observed in the intermediate floors of a number of the dwellings (see Figures 18 to 22). In two dwellings (D42 and D44) the gaps in the flooring panels were up to 25 mm wide. Any holes or gaps in the floor will enable air to leak into the intermediate floor void where it may then leak through the external/party walls to outside.

Figure 18 Leaks at the junction between flooring panels.

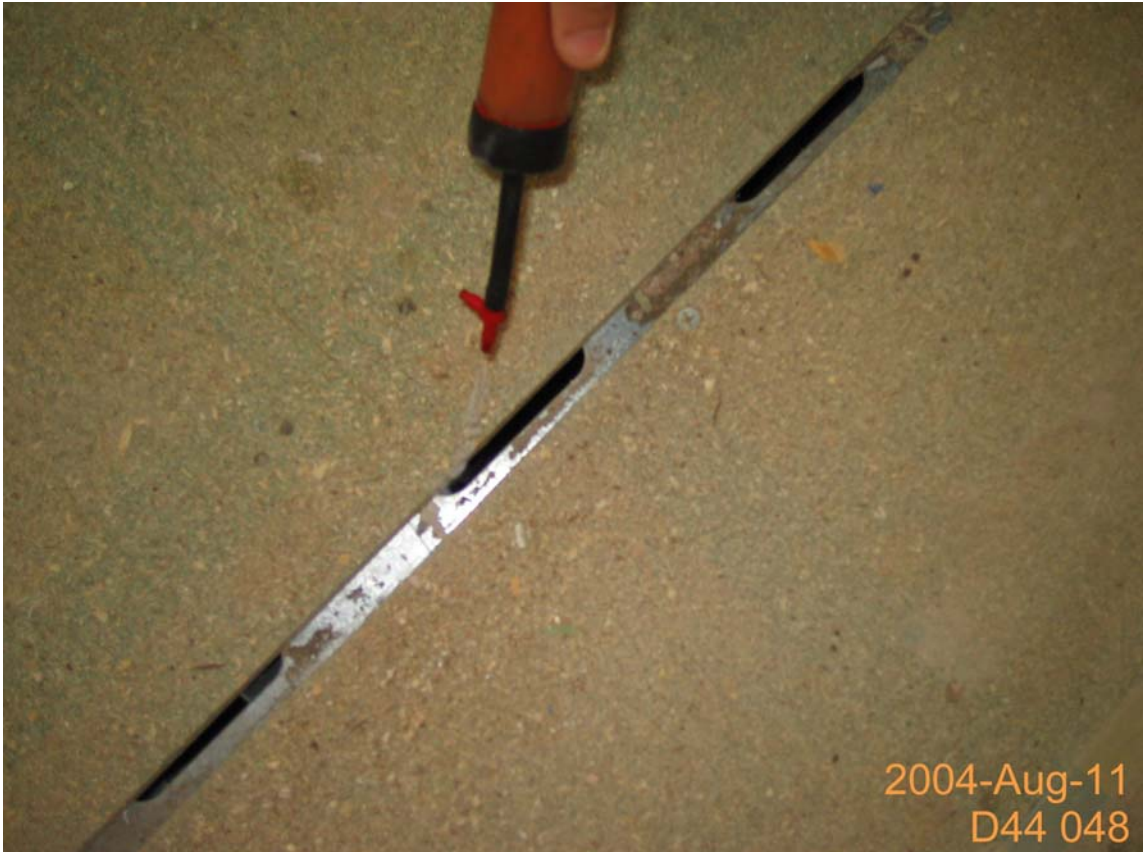
Figure 19 Leaks at the junction between flooring panels.

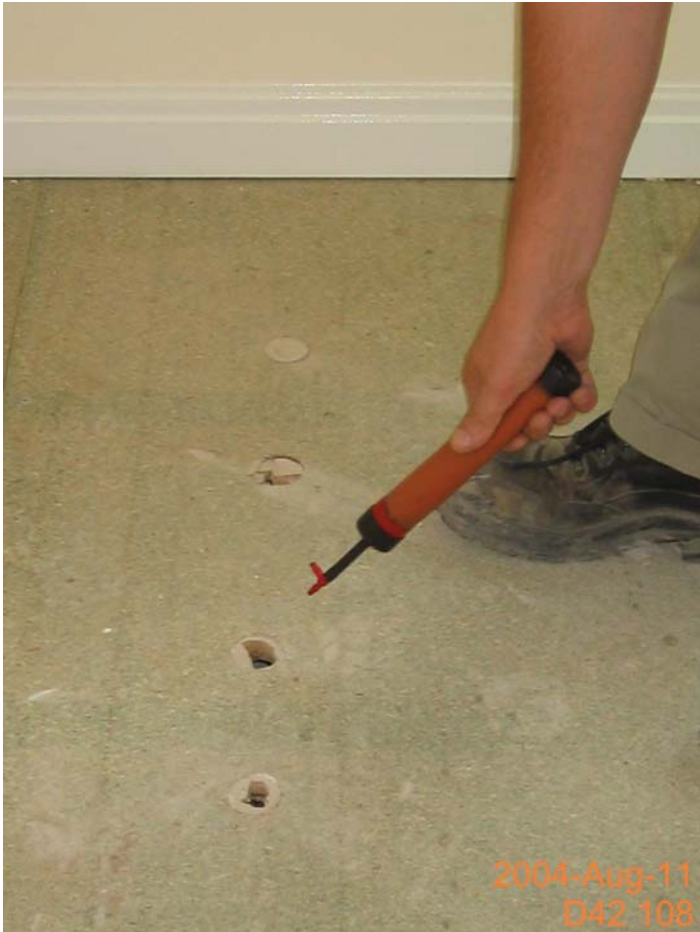
Figure 20 Holes in the flooring panels.

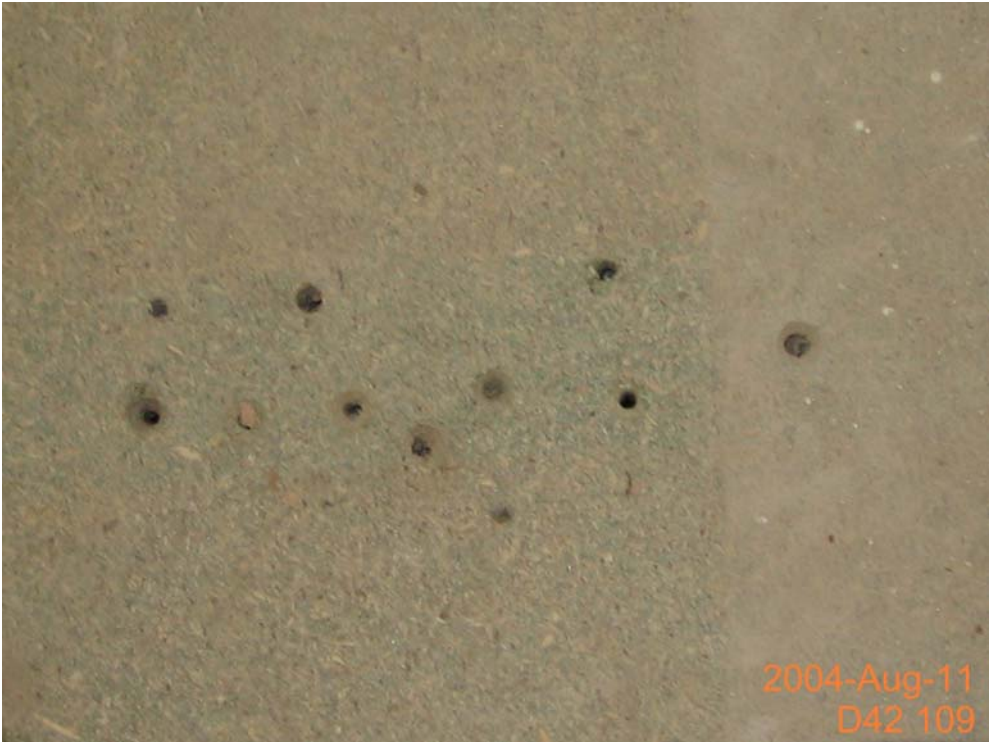
Figure 21 Screw holes in the flooring panels.

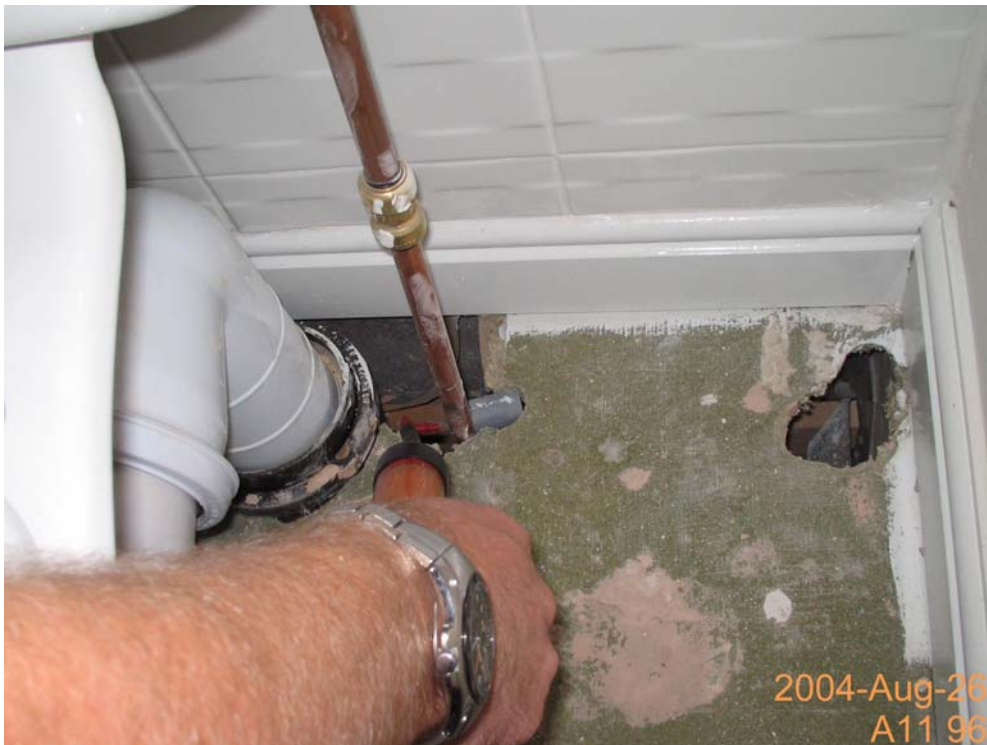
Figure 22 Holes in bathroom floor.

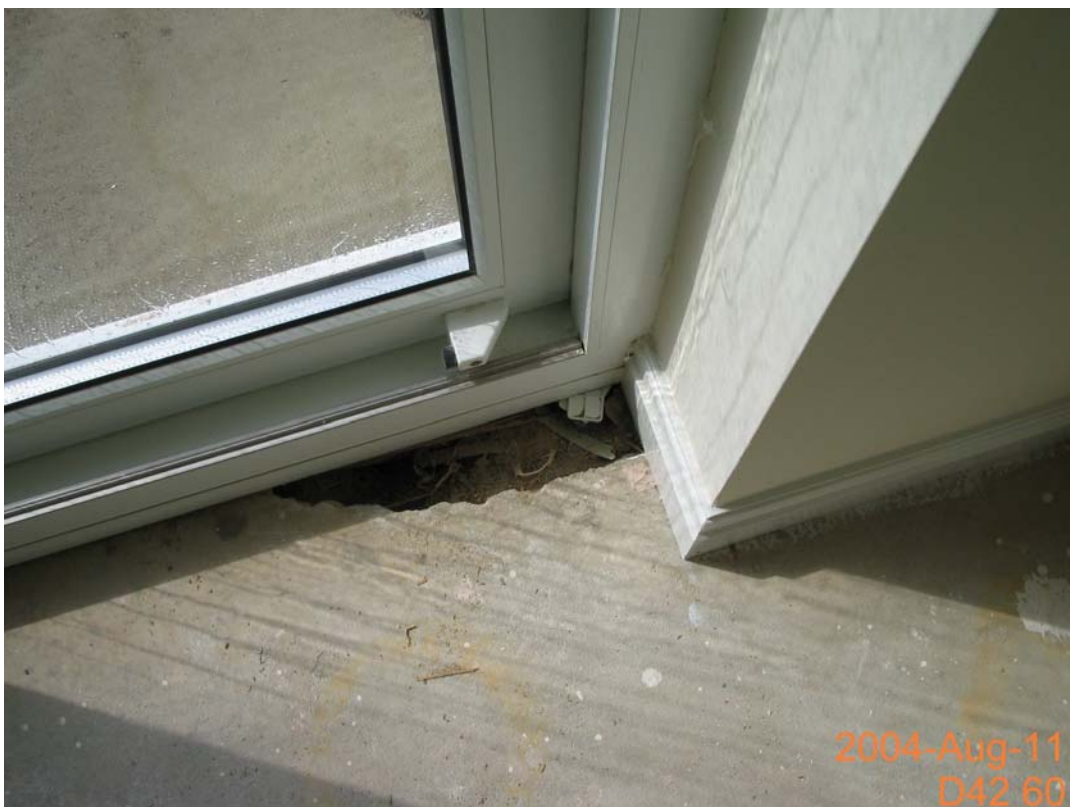
- 40 The ground floor slabs in a number of the dwellings were observed to be incomplete, particularly around the patio door area, resulting in holes in the ground floor slab (see Figures 23 and 24). Any holes in the ground floor slab will result in an air leakage path from the inside to the outside of the dwelling.

Figure 23 Hole in ground floor slab at patio door.

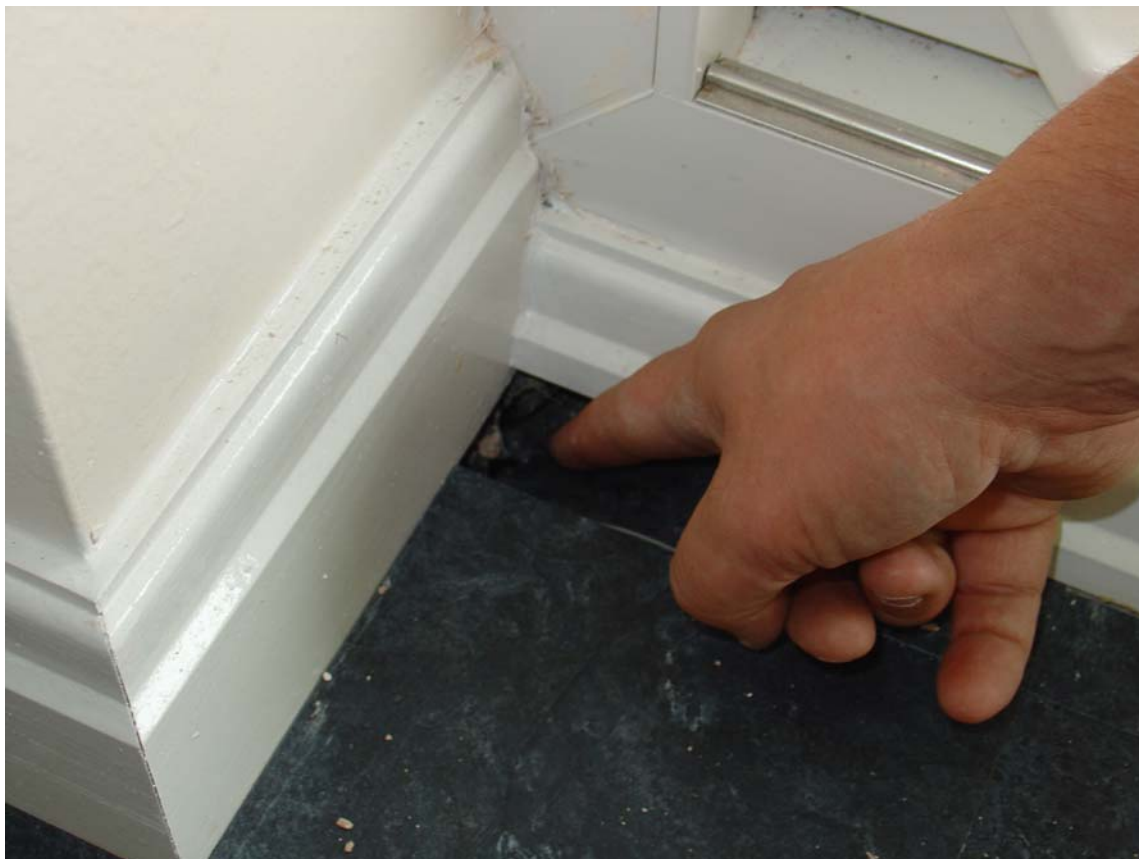
Figure 24 Hole in ground floor slab hidden by floor covering.

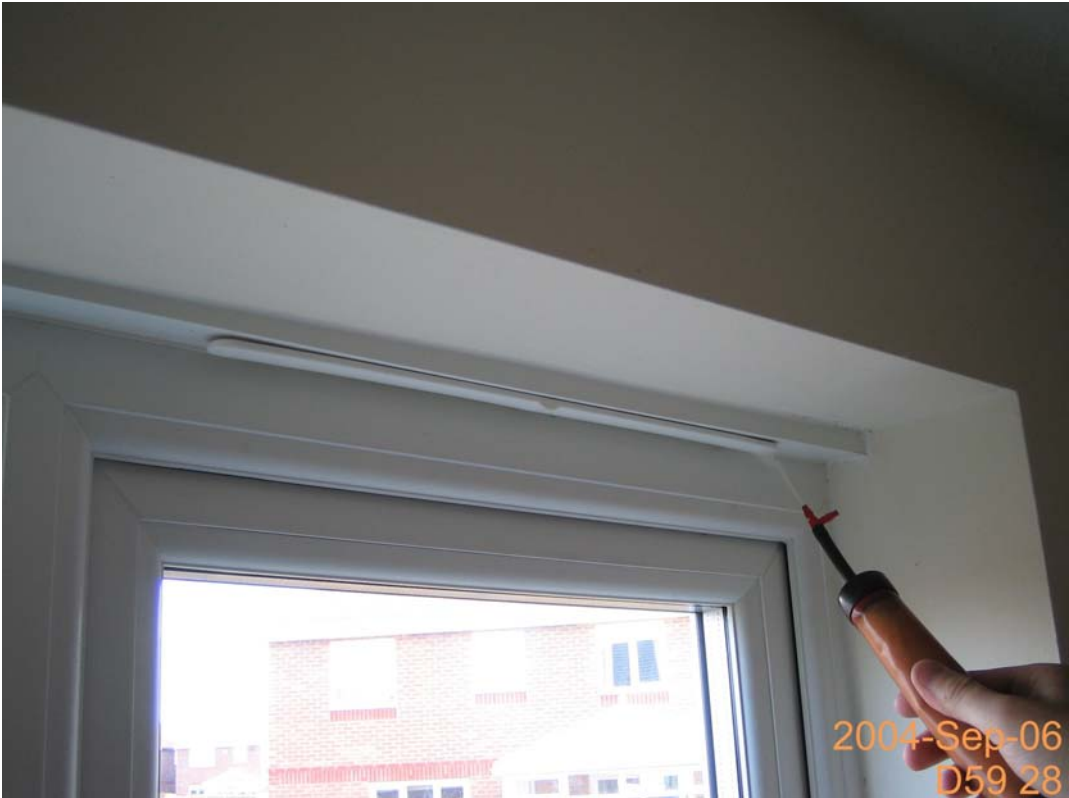
- 41 Windows and doors can be a significant source of air leakage (see Stephen, 1998 and 2000). Any poorly fitting or sealed windows, trickle vents or doors will result in an air leakage path directly from the inside to the outside of the dwelling. It was observed on a number of the dwellings that the trickle vents were either of a poor fit or would not close properly allowing passage of air either through the vent itself (when in the closed position) or through a gap between the vent and window.
- 42 In several cases the patio doors did not fit correctly such that the seals were uncompressed and in the worst cases there were observable gaps between the external door and the surrounding door frame. These points are illustrated in Figures 25 to 27.

Figure 25 Leakage through poorly fitting trickle vents.

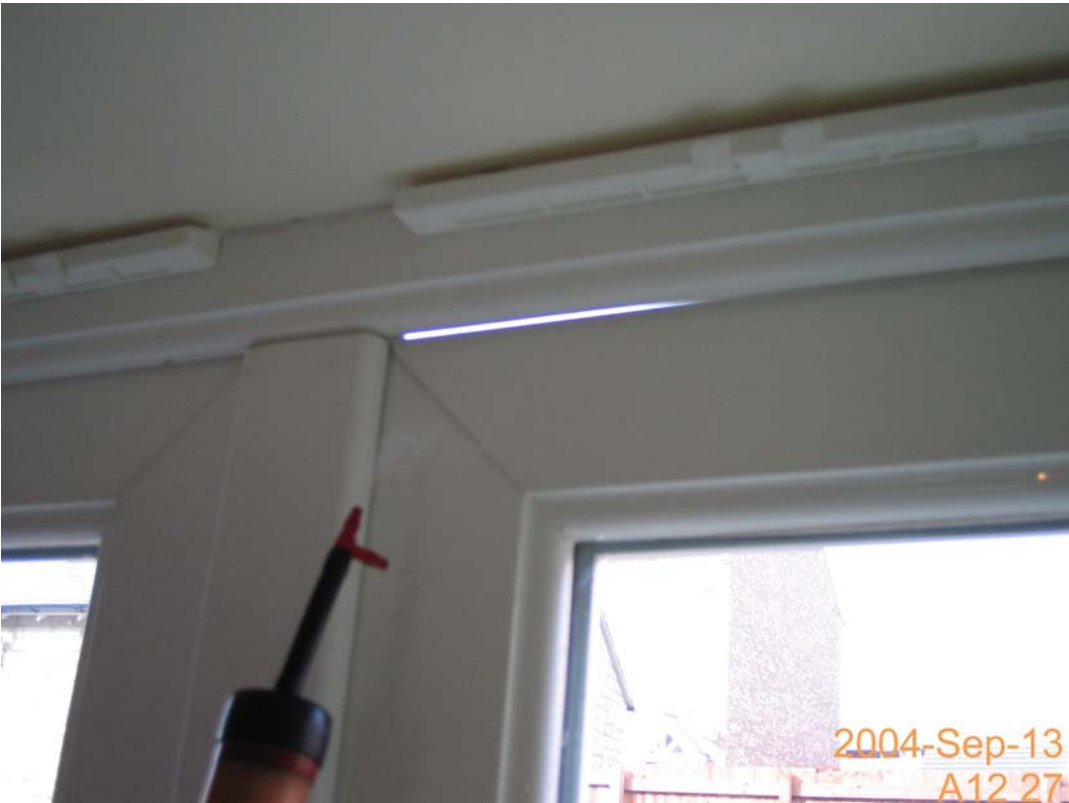
Figure 26 Poorly fitting patio door with visible gap.

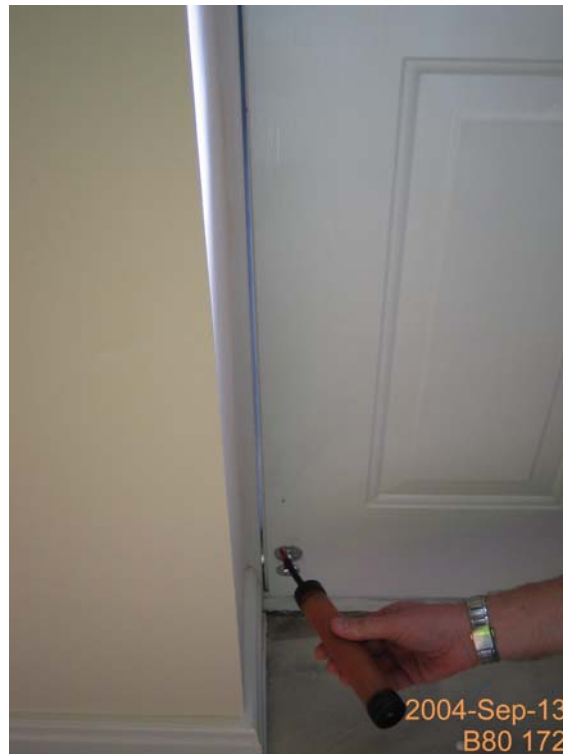
Figure 27 Observable gap between external door and frame.

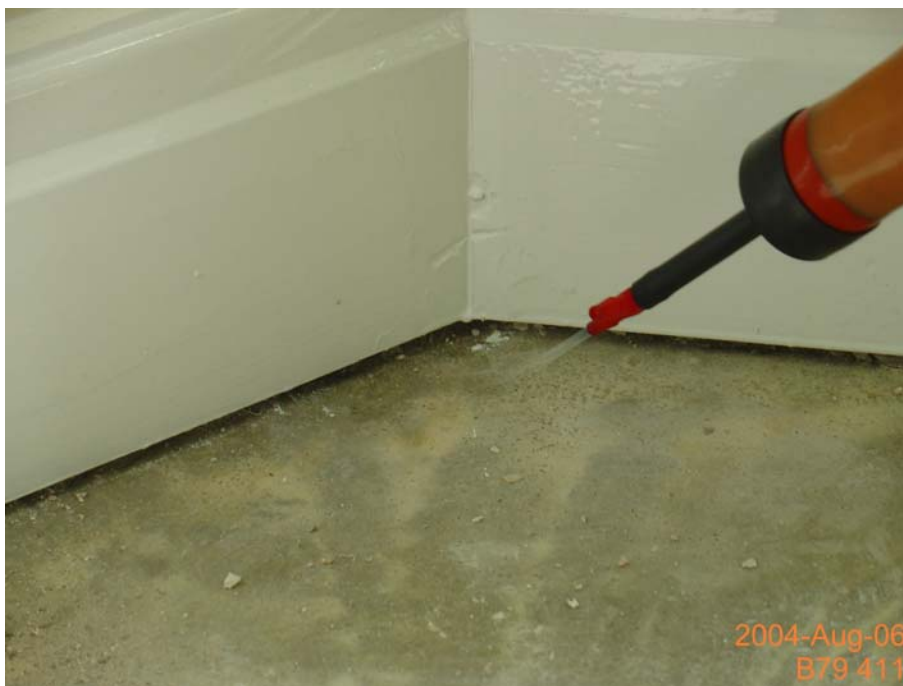
- 43 The report on Robust Construction Details (DEFRA, 2001) states that particular care on site should be paid to joints between structural components, for instance, walls to floors. Observations from site illustrate that a number of gaps exist between the ground floor and the skirting board and the intermediate floor and the skirting board (see Figures 28 to 30). Any gaps will result in an air leakage path. Indeed, in the case of one of the developers (developer D) the air leakage between the wall and intermediate floor was so bad that a flow pattern was observed in the dust on the floor where air had flowed into the building during the depressurisation test (see Figure 29).

Figure 28 Leak at gap between skirting board and ground floor.

- a) Sealing the junction between the skirting board and the floors with an appropriate sealant.
 - b) Sealing the kitchen floor, including areas concealed under kitchen units.

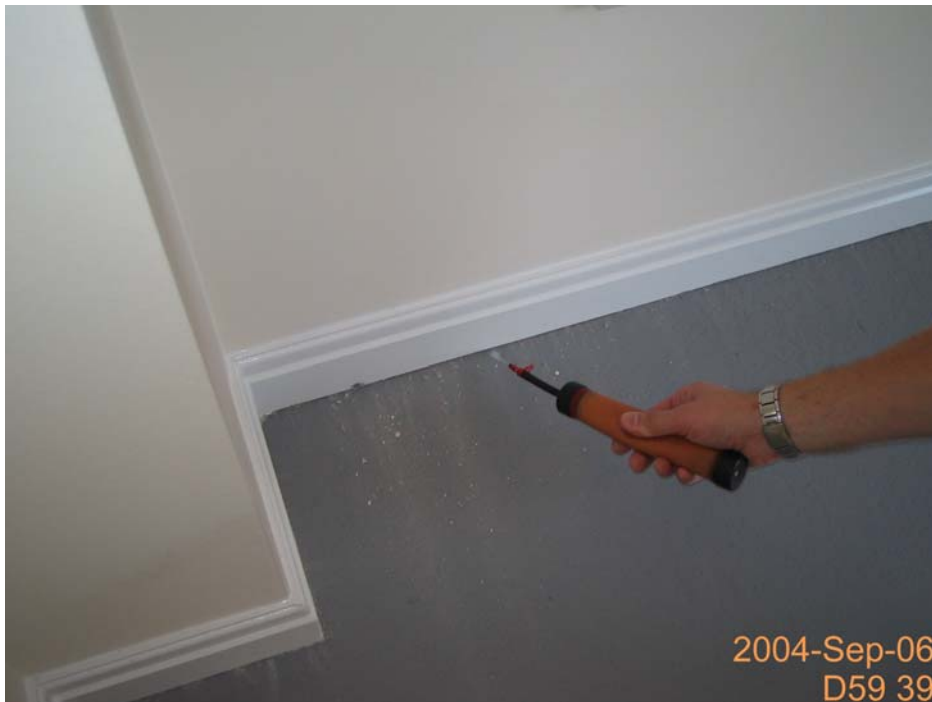
Figure 29 Leak at gap between skirting board and ground floor.
