AIRTIGHTNESS OF BUILDINGS — TOWARDS HIGHER PERFORMANCE

Interim Report D5 — Site Assessments and Feedback Material

Dr David Johnston, Centre for the Built Environment, Leeds Metropolitan University

Reference Number: CI 61/6/16 (BD2429)

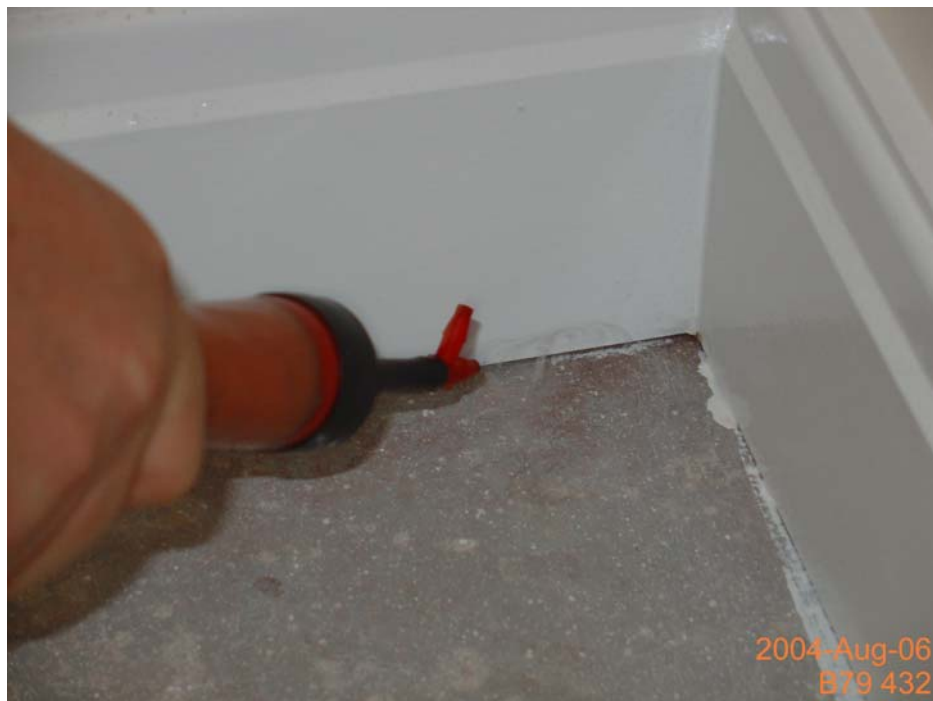
Figure 30 Gaps at the junction between the skirting board and the first floor.

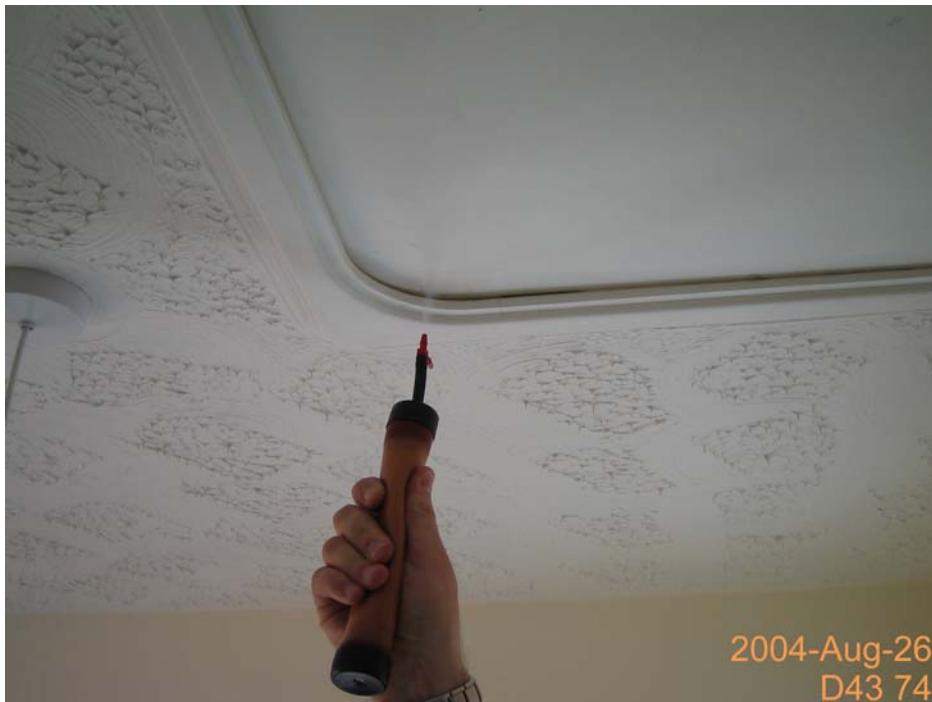
- 44 Loft hatches are known to contribute to air leakage. Site observations illustrate that the loft hatches specified by one of the developers (developer D) had been installed in such a way that the hatch was not hinged, it could only be secured on one side and it did not compress the seal fully when it was closed. This was confirmed during a pressurisation test on one of the dwellings where the loft hatch was observed to leak and lift during the test (see Figures 31 and 32). In addition, a number of loft hatches have not been adequately sealed to the ceiling, resulting in air leakage between the loft

Figure 31 Leak through poorly sealed loft hatch.

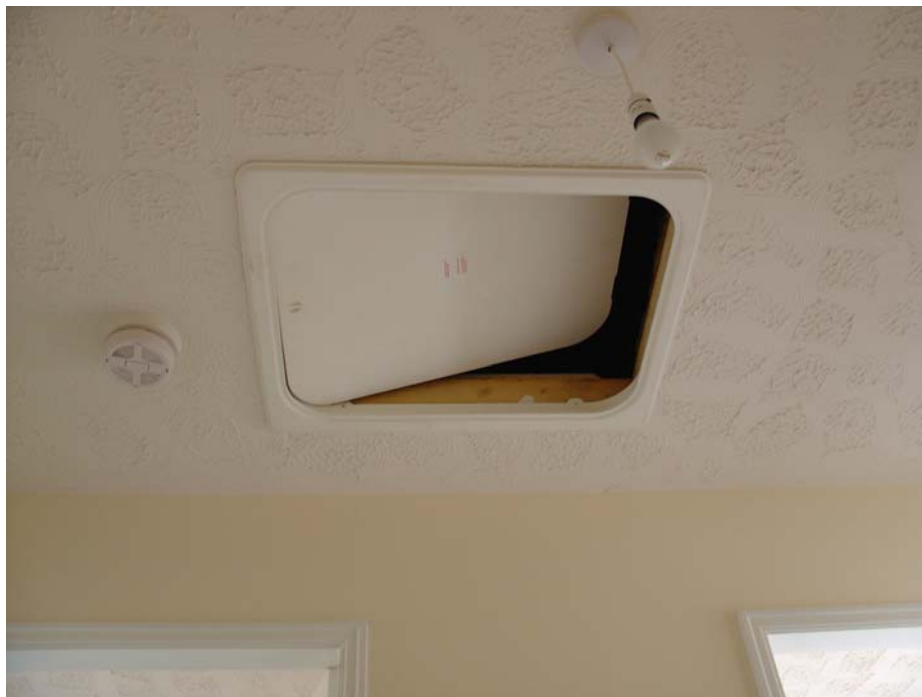
Figure 32 Loft hatch lifting during pressurisation test.

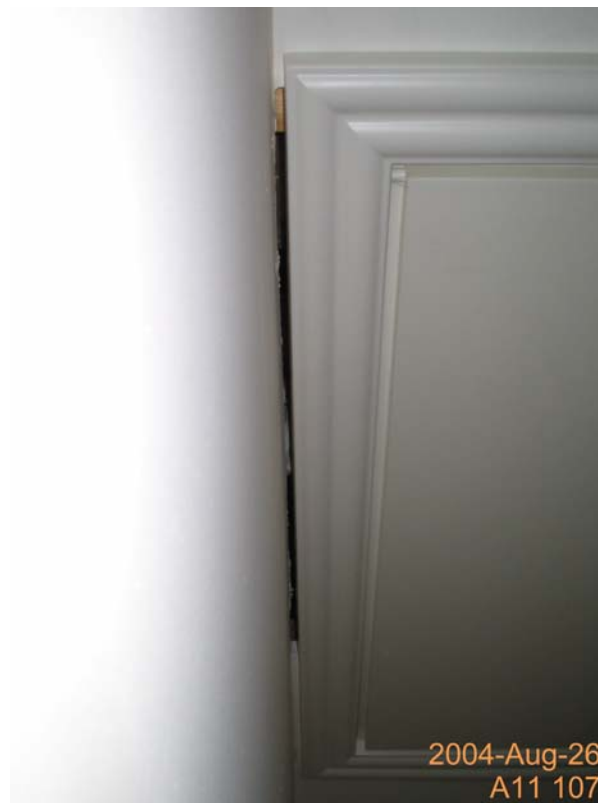
hatch frame and ceiling. In one case sealing was made more difficult by the proximity of the loft hatch frame to the wall (see Figure 33).

Figure 33 Loft hatch not adequately sealed to the ceiling.
