## **List of Appendices**

## Appendix 1: Pressurisation Test of Bryant Plot 116

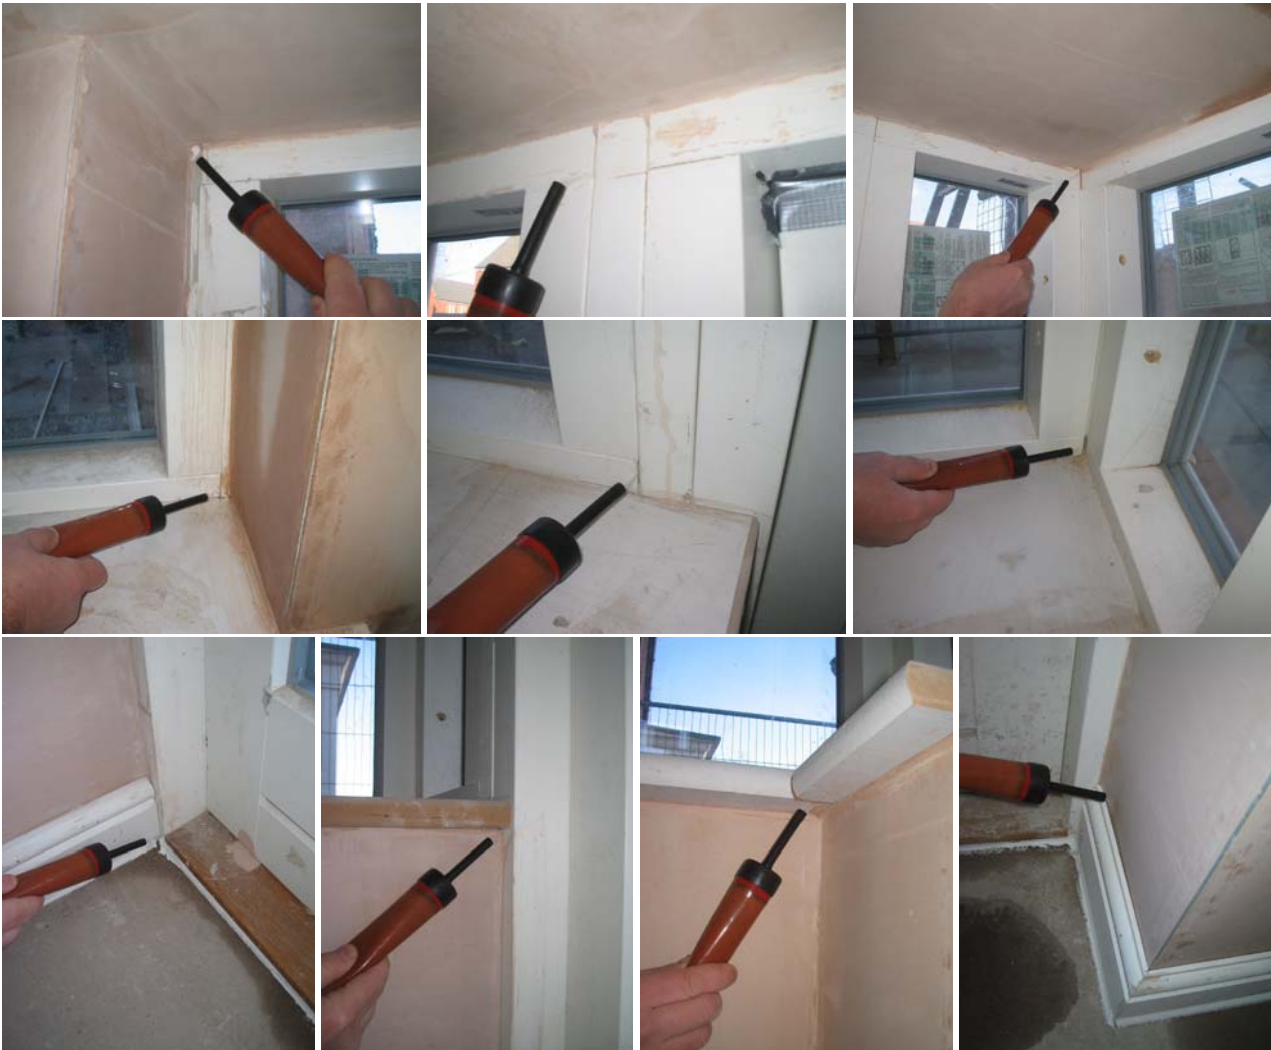
Figure 1.3 Air leakage around the bay window.

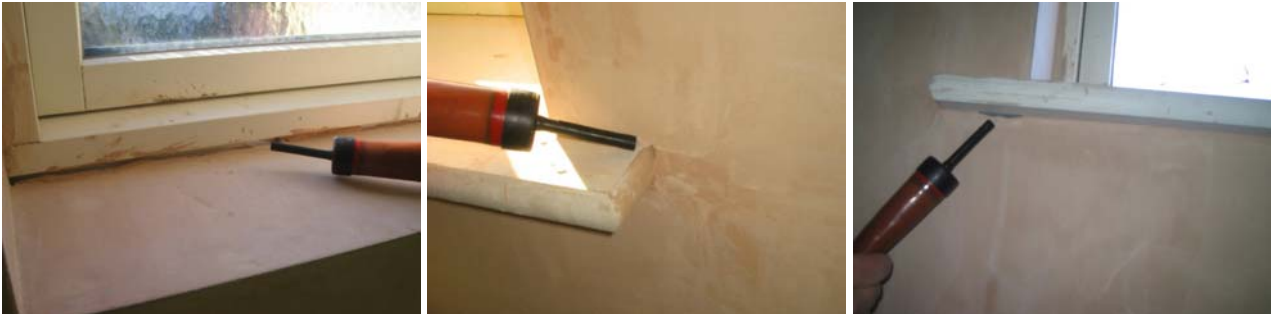
Figure 1.4 Bathroom, bedroom and kitchen sills.

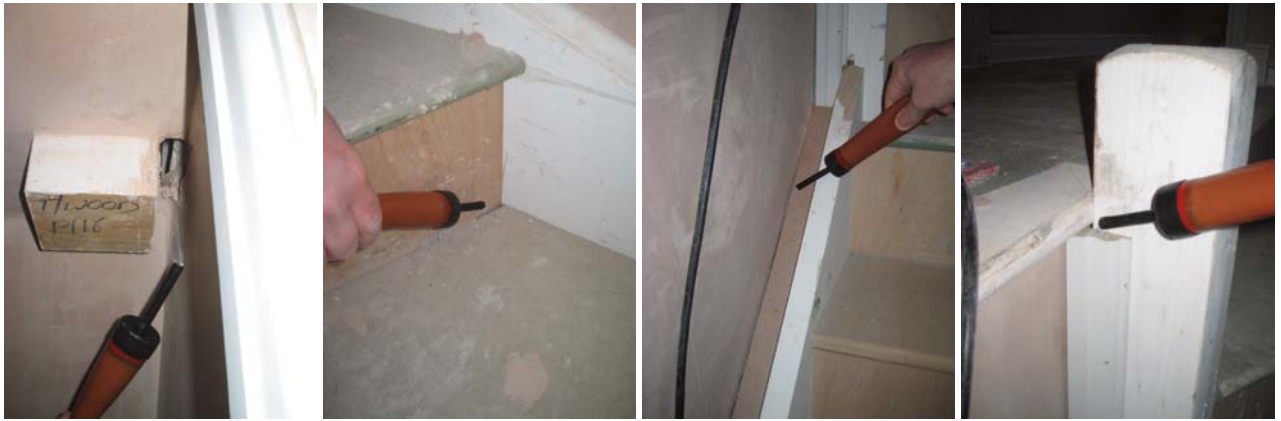
Figure 1.5 Air leakage around the staircase.

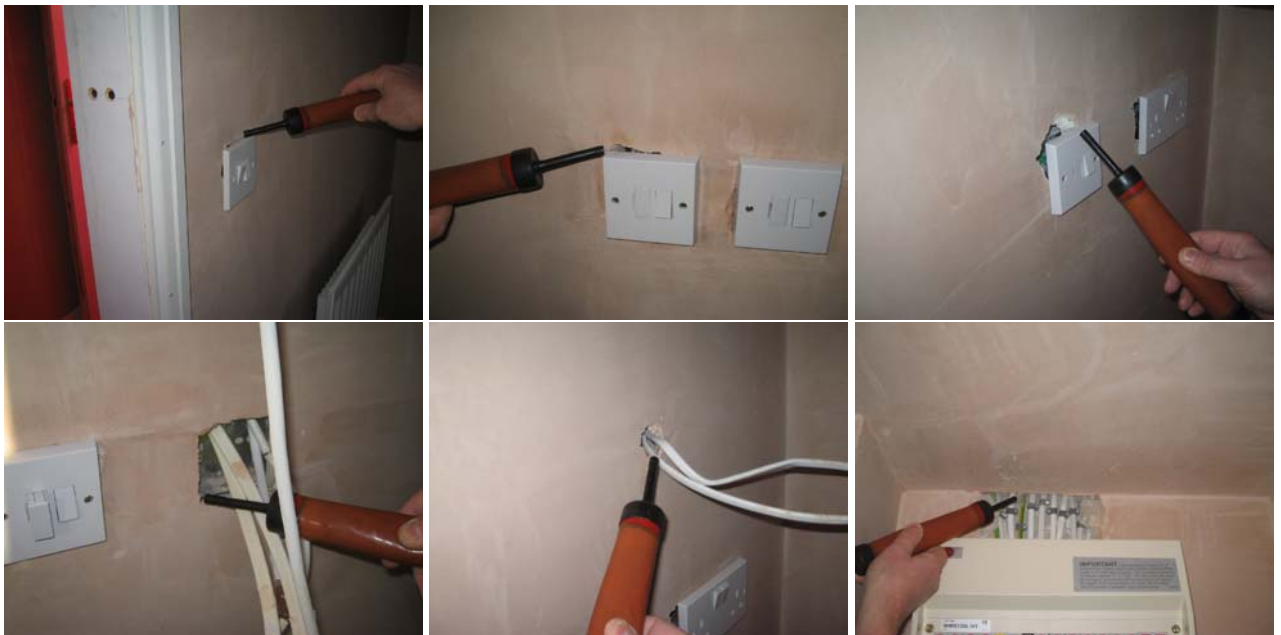
Figure 1.6 Ground floor electrical service penetrations.

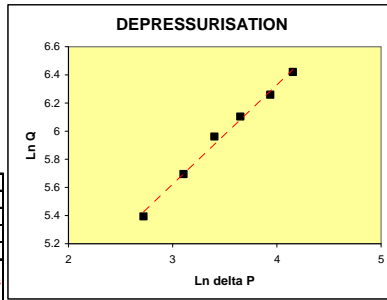
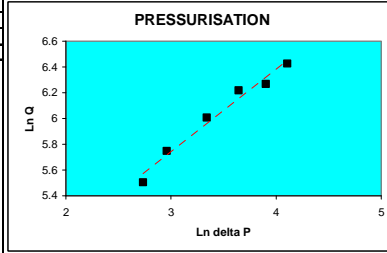
<b>RESULTS:</b>			
Mean Flow AT 50Pa =	552.61 m3/h		
ACH50 =	3.04 ach		
Air Permeability at 50 Pa =	2.75 m3/h		
Equivalent Leakage Area =	0.022 m2 at 10 Pa

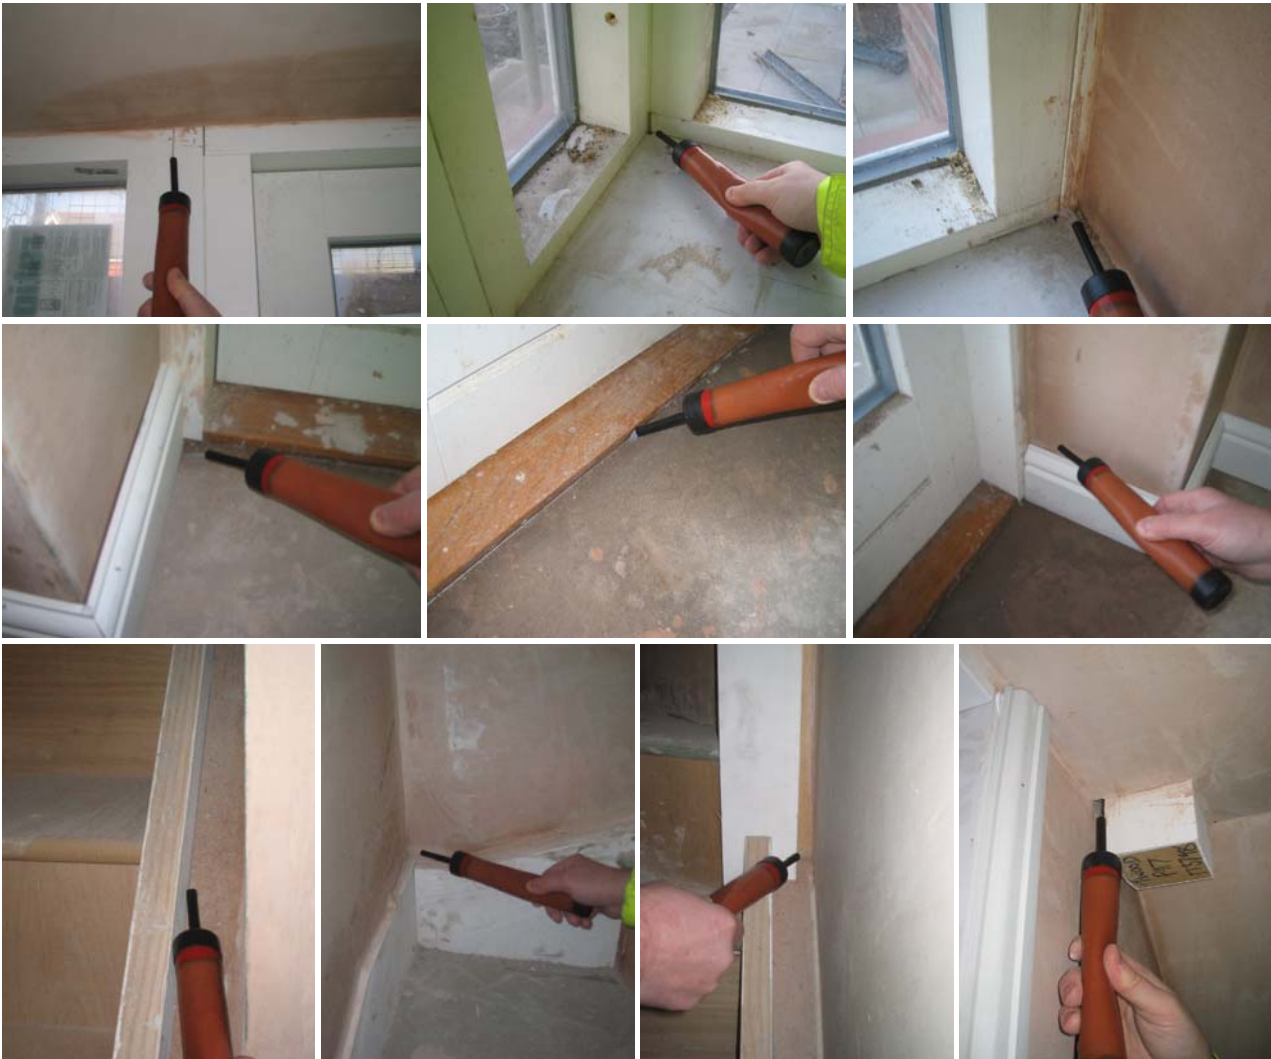
Figure 2.3 Air leakage around the staircase.

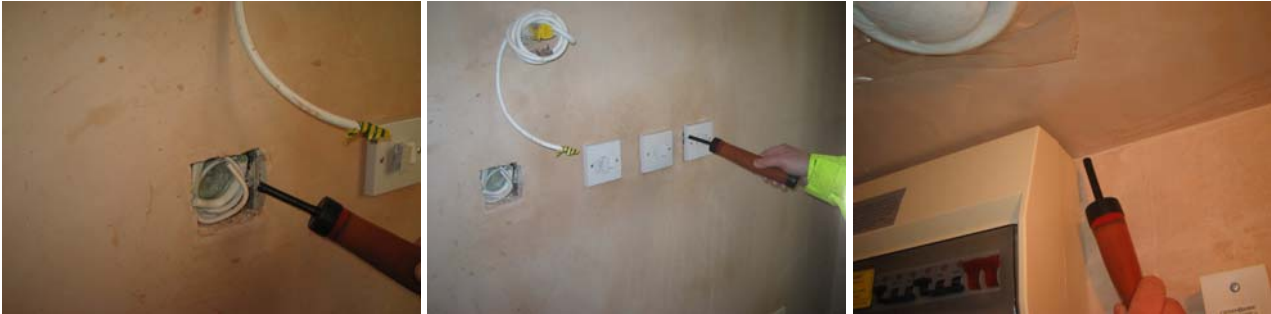
Figure 2.4 Ground floor electrical penetrations.

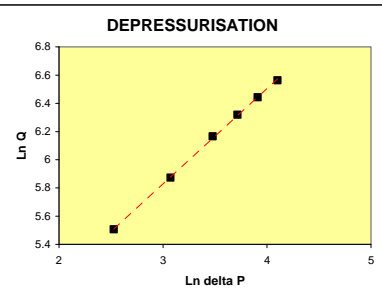
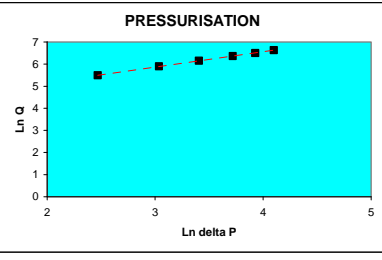
wind speed (m/s):	0		
baseline pressure diff (Pa) (+/-)	Pa		
house width:	4.61 m		
house depth:	7.738 m		
house height:	5 m		
floor area:	37.02 m2		
volume:	181.53 m3		
envelope area including floor:	200.69 m2		
Pressure Difference for ELA	10 Pa

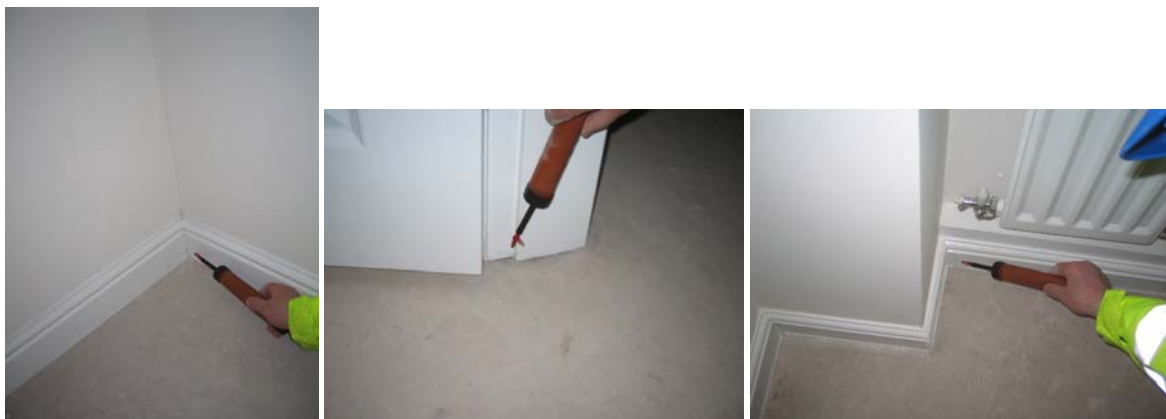
Figure 3.2 Leakage at the ground floor perimeter in the kitchen and utility room.

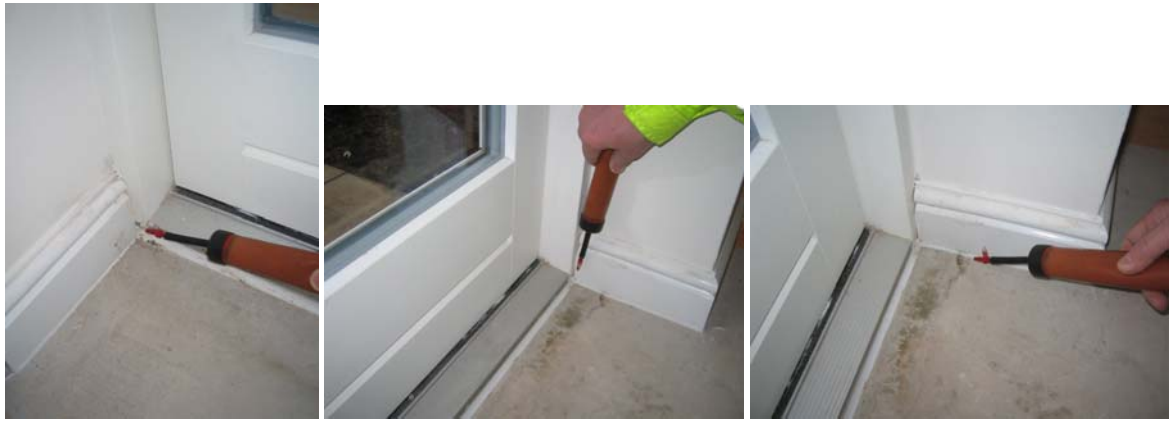
Figure 3.3 Air movement around the patio door threshold in the kitchen.

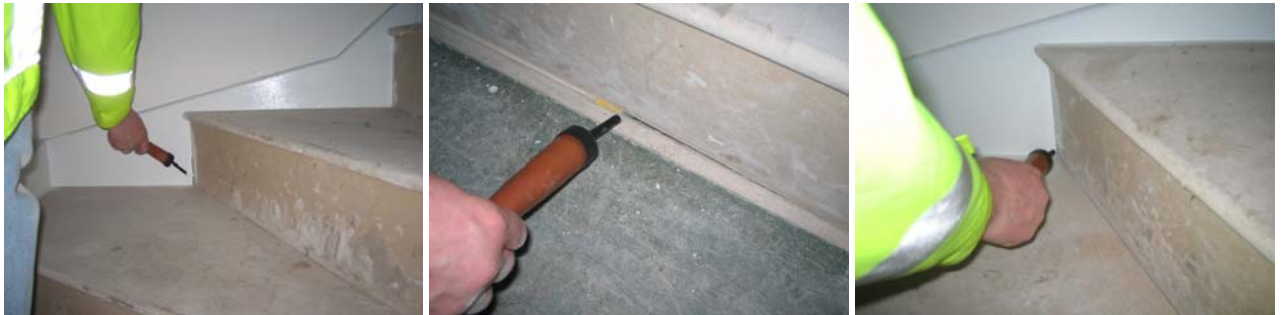
Figure 3.4 Air leakage detected around steps and risers of both staircases.

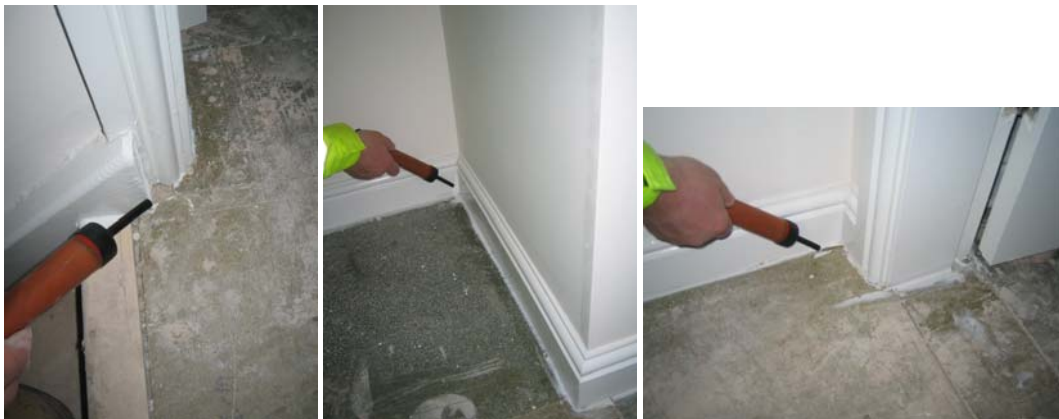
Figure 3.5 Air leakage at the first floor room perimeters in the landing and master bedroom.

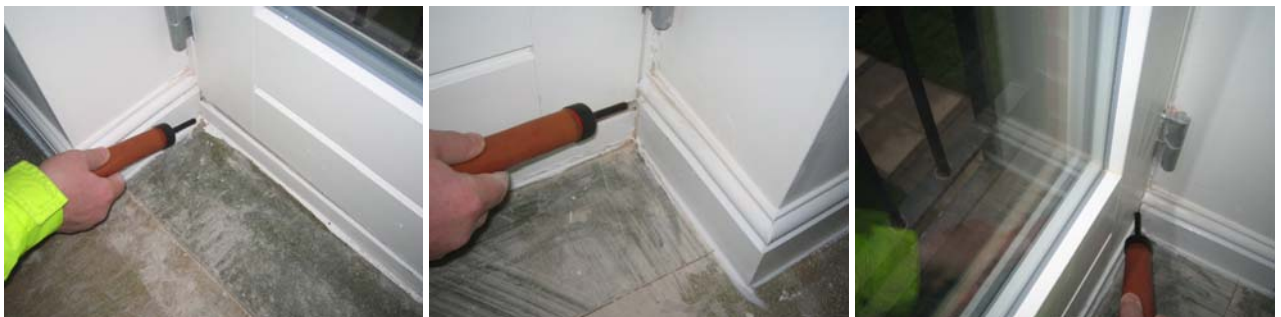
Figure 3.6 Leakage detected around the first floor patio doors in the master bedroom.

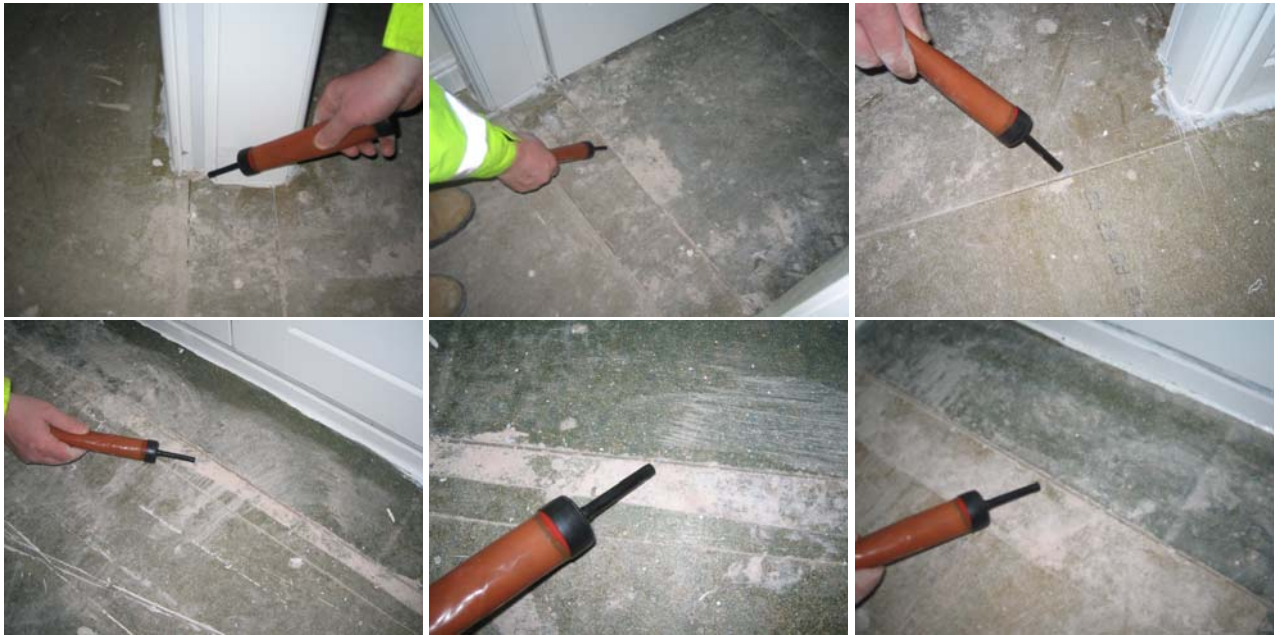
Figure 3.7 Air movement into the intermediate floor voids on the first floor landing and en-suite, on the second floor landing, and close to the patio doors in the lounge and master bedroom.

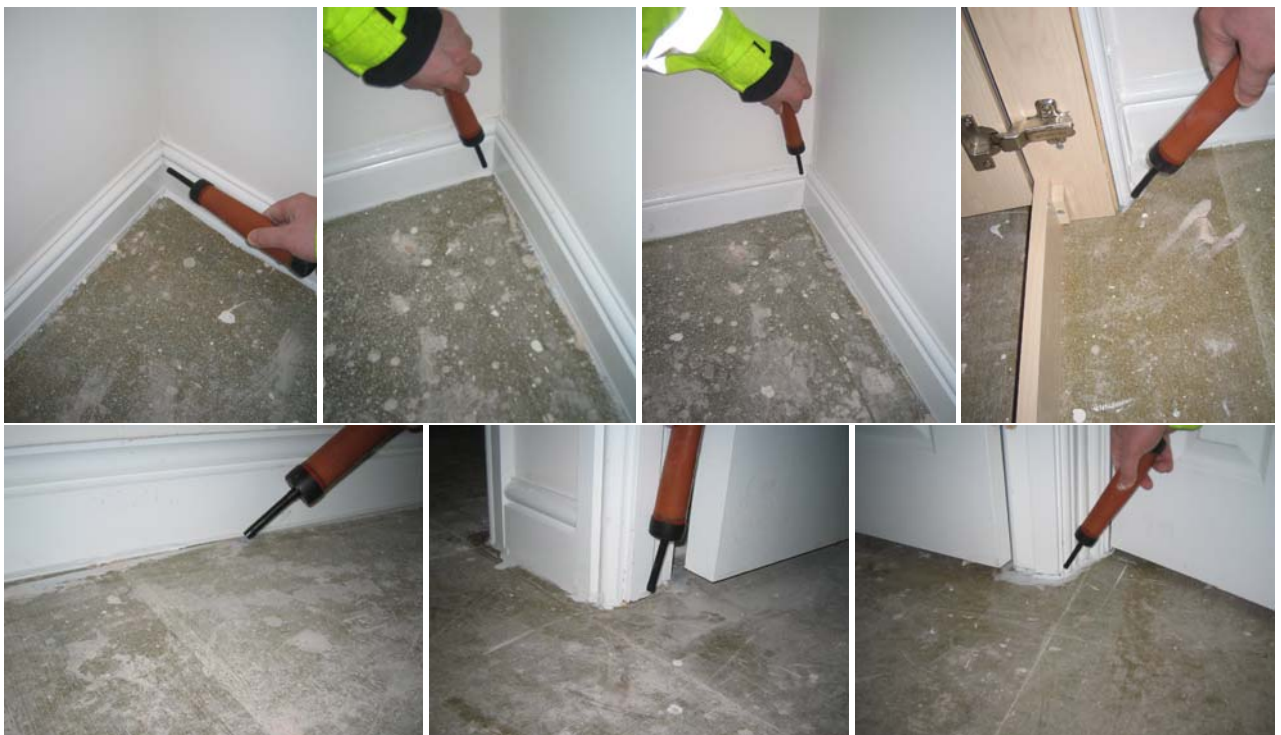
Figure 3.8 Air leakage around the wall/floor junctions on the second floor.

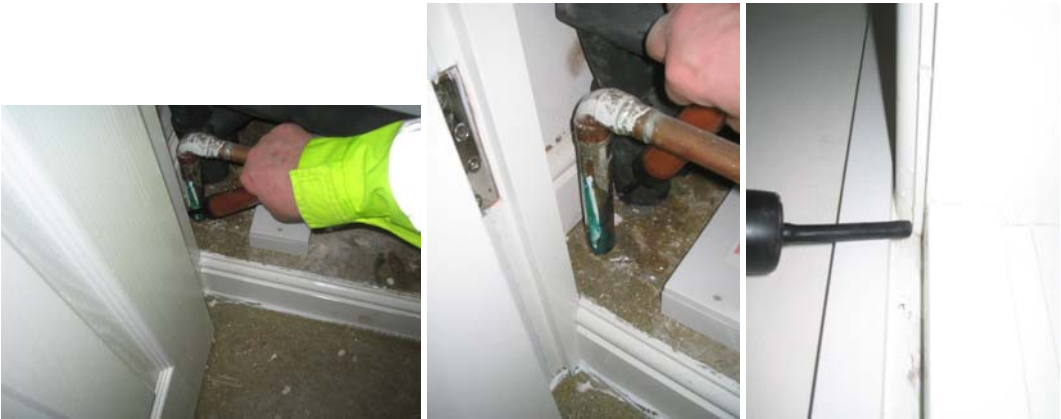
Figure 3.9 Air leakage in the cylinder cupboard.

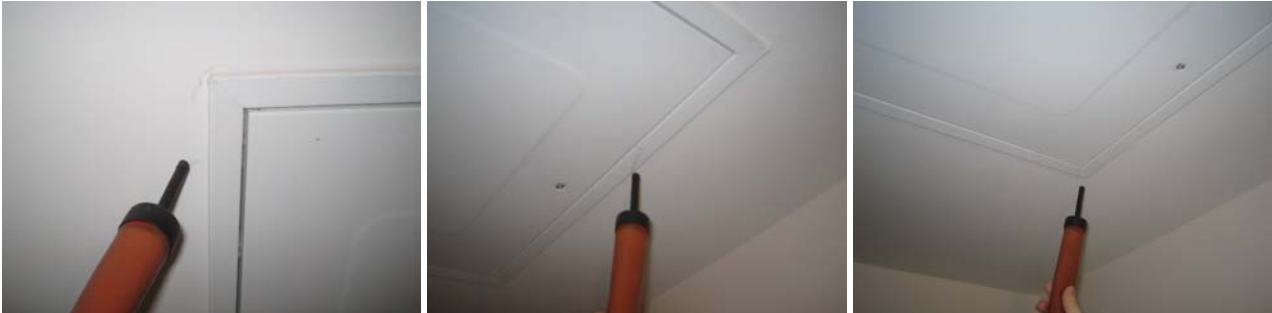
Figure 3.10 Direct air leakage around the loft hatch.

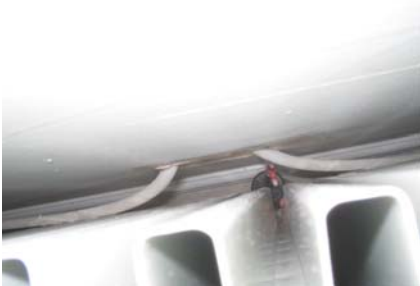
Figure 3.11 Air movement around the radiator pipework.

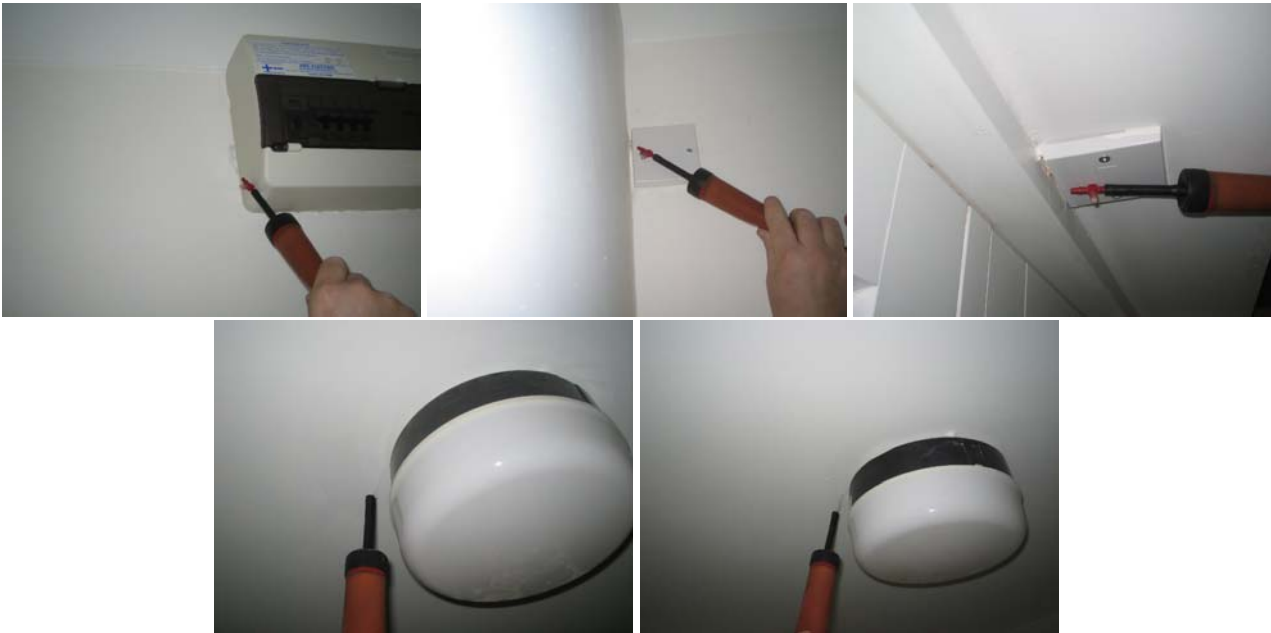
Figure 3.12 Air leakage around electrical penetrations around the consumer unit, electrical fixings in the kitchen and the bathroom/en-suite/WC light fixings

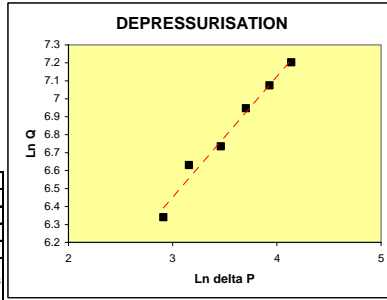
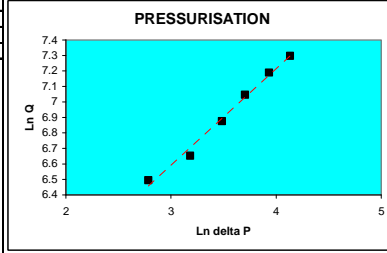
floor area:			
volume:	356 m3		
envelope area including floor:	305 m2		
Pressure Difference for ELA	10 Pa

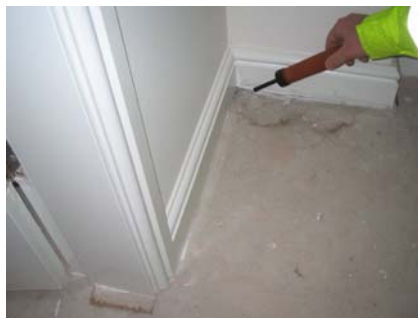
Figure 4.2 Ground floor perimeter in the utility room.

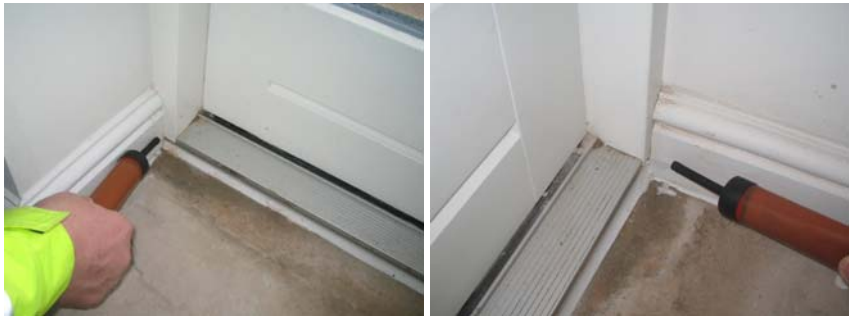
Figure 4.3 Leakage through gaps around the patio door threshold in the kitchen.

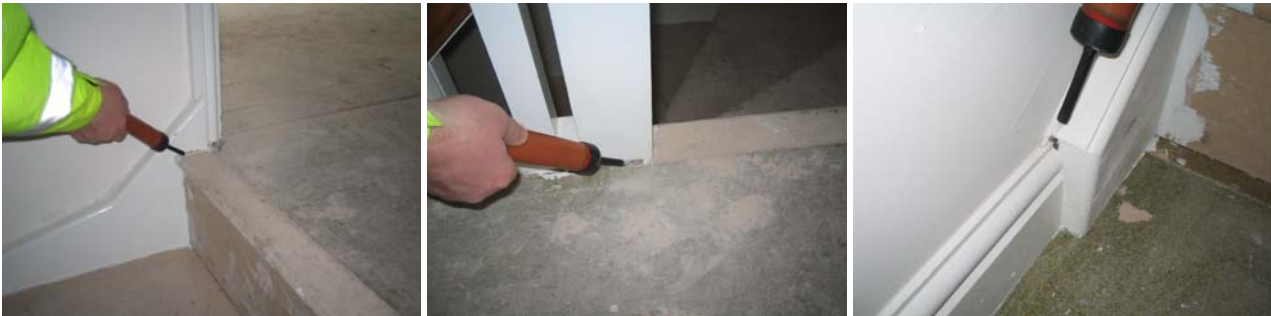
Figure 4.4 Gaps around the staircases.

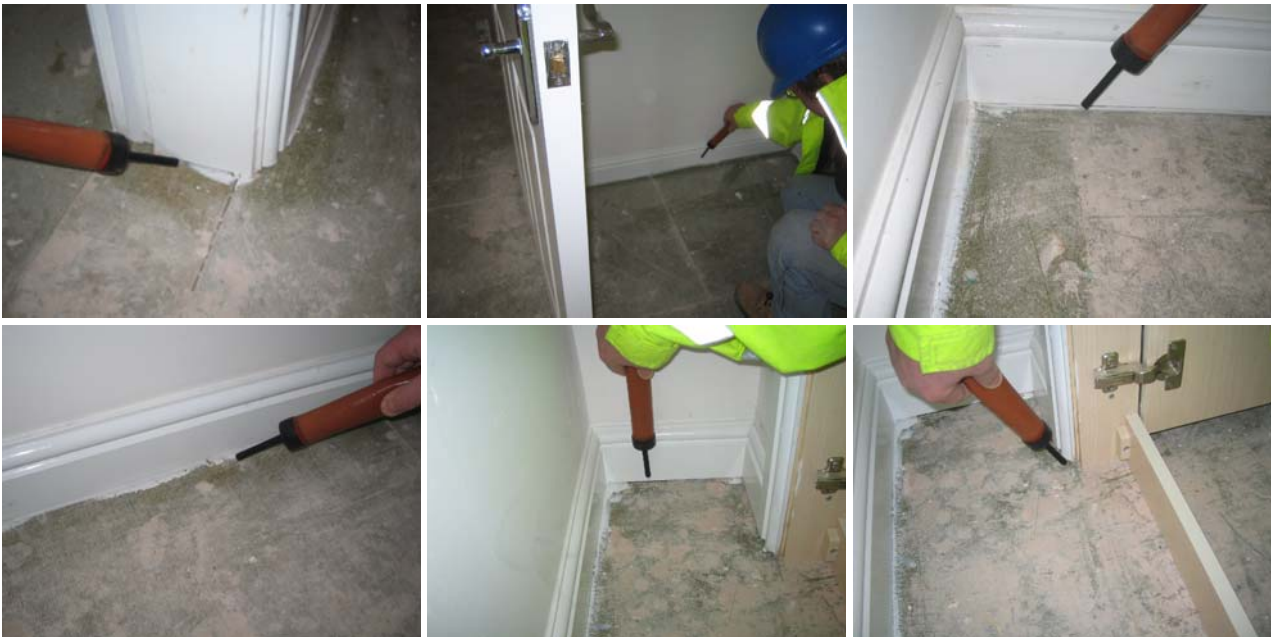
Figure 4.5 Missing or failed sealing at the wall/floor junctions in the landing, lounge, master bedroom and built-in wardrobe on the first floor.

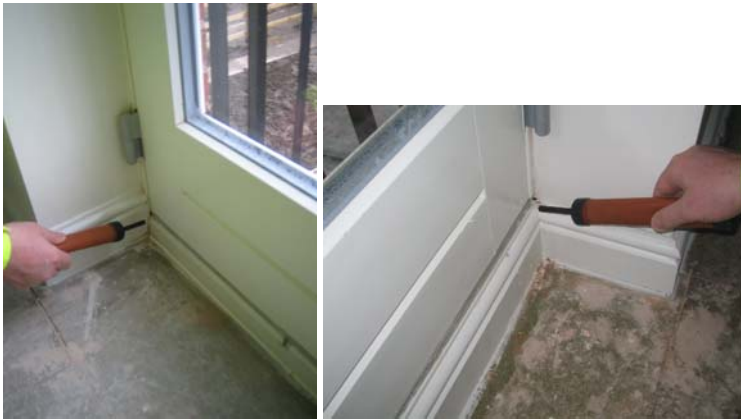
Figure 4.6 Leakage around the patio doors on both the first and second floors.

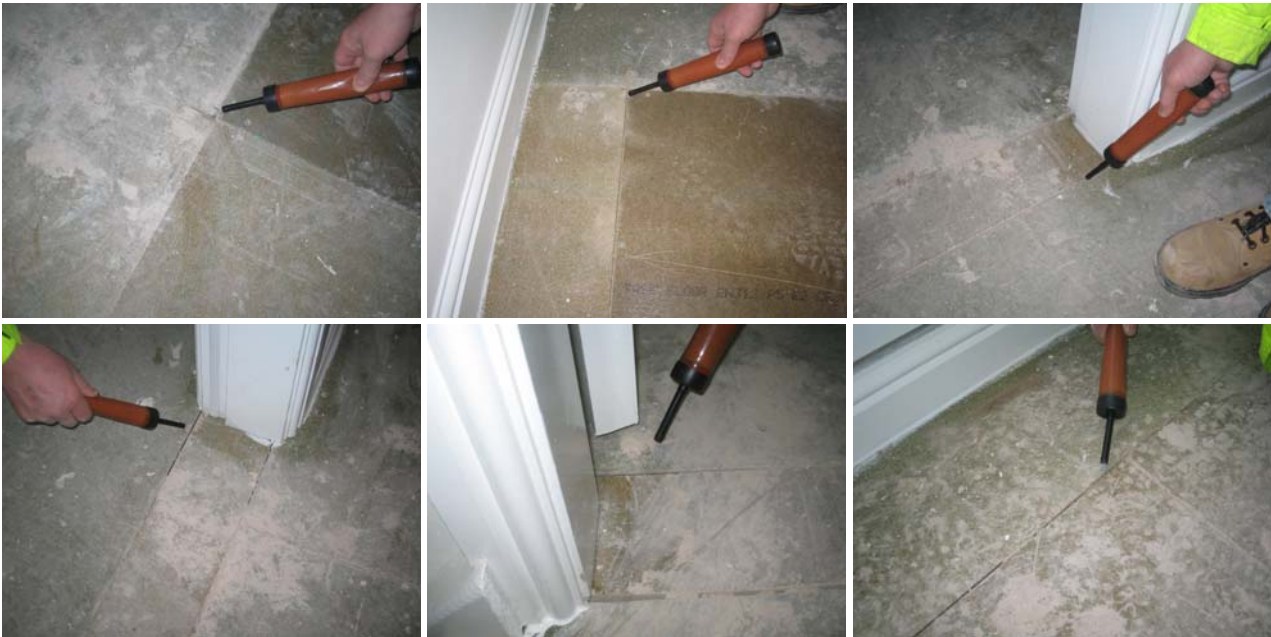
Figure 4.7 As in R110 leakage was observed into both intermediate floor voids through gaps between flooring panels, again this appeared most severe just in front of the patio doors.

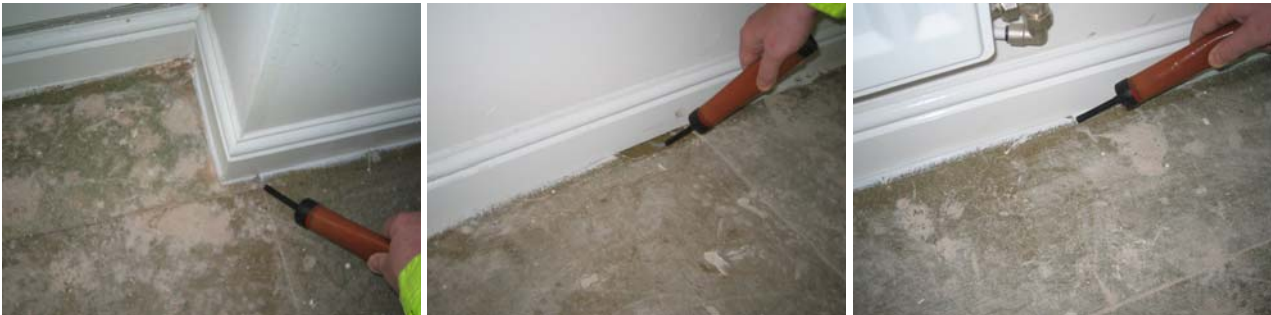
Figure 4.8 Air leakage at internal, separating and external wall/floor junctions on the second floor where gaps existed in the sealant.

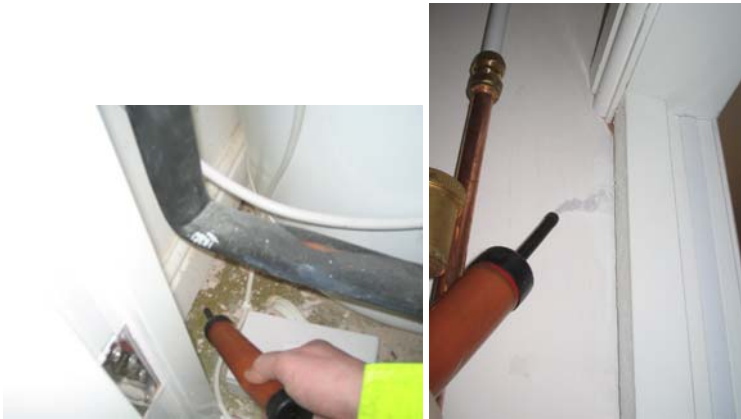
Figure 4.9 Cylinder cupboard air leakage.

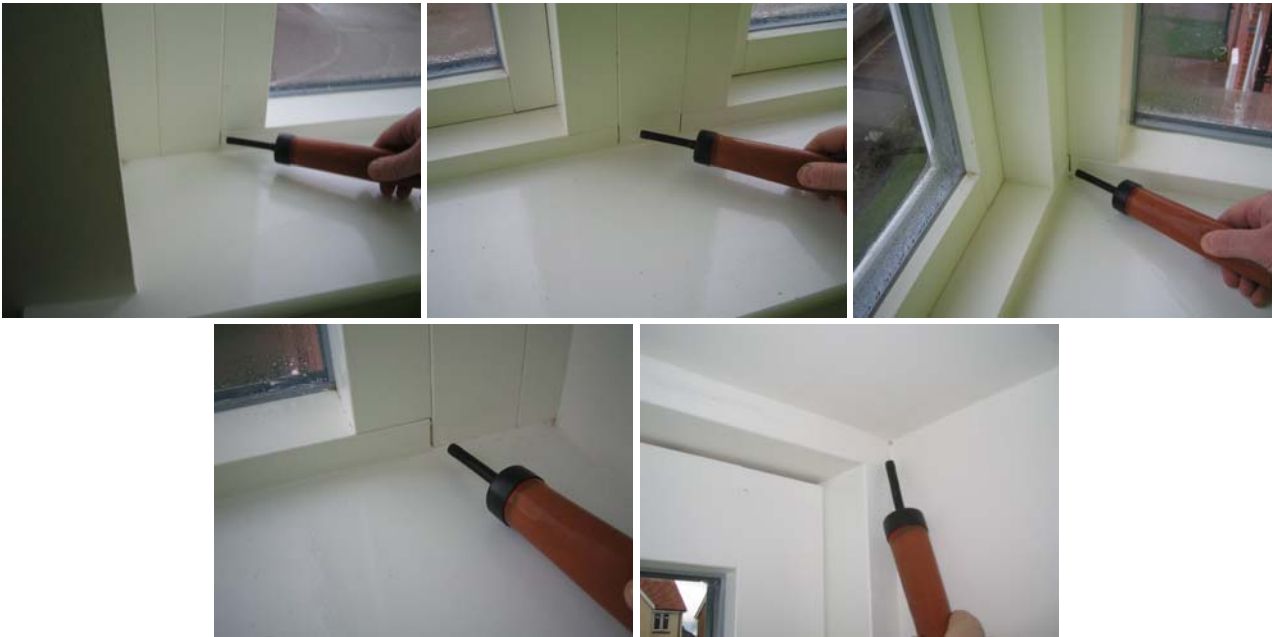
Figure 4.10 Leakage detected between elements of the first floor bay window and around the frame of the patio door in the kitchen.

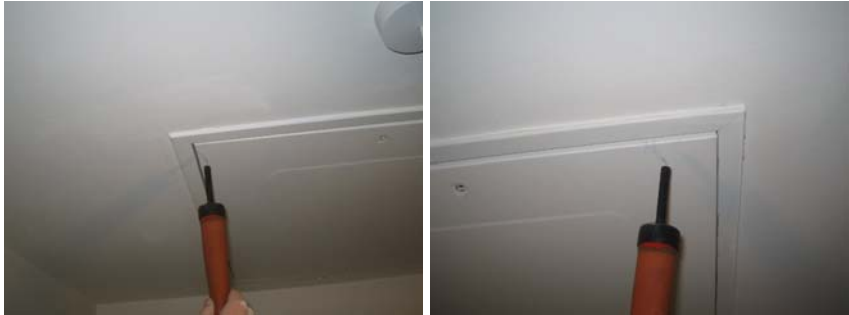
Figure 4.11 Air movement through the loft hatch.

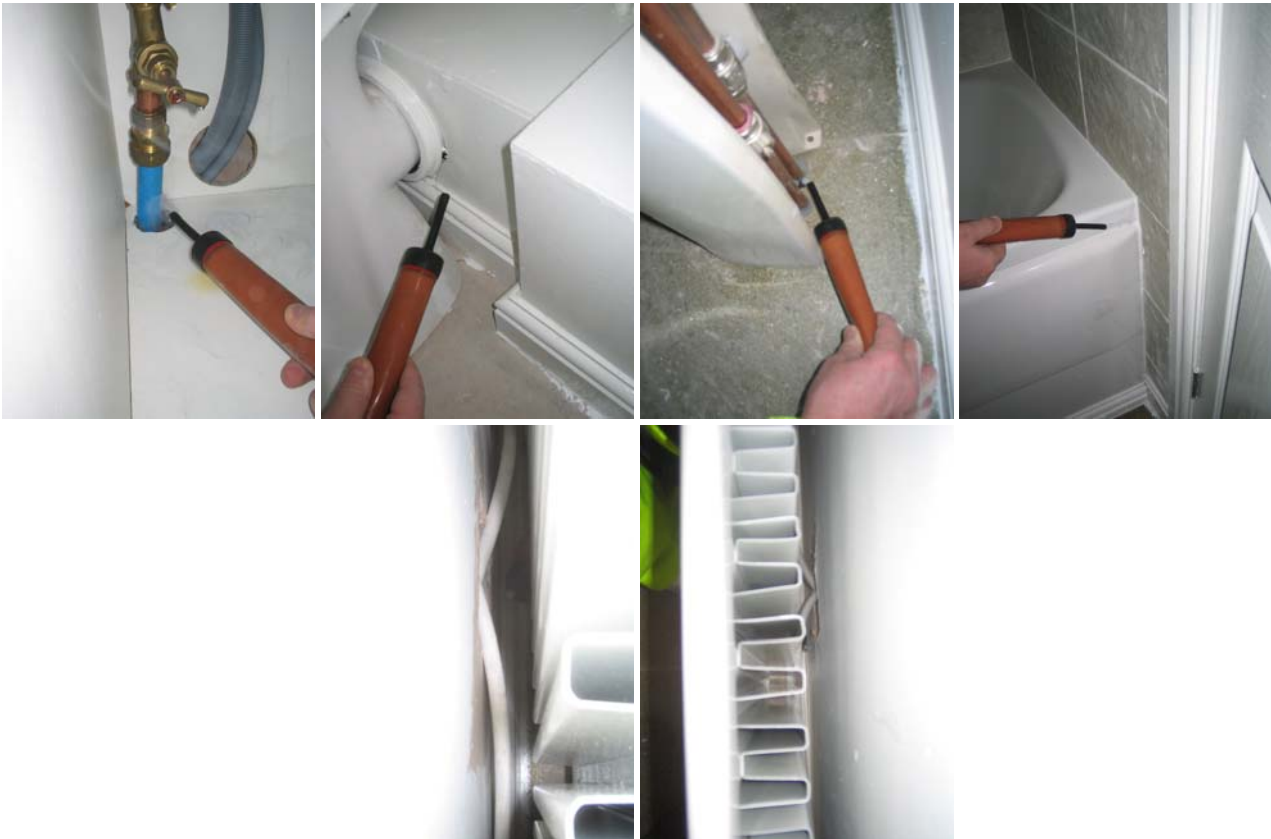
Figure 4.12 Air movement observed around plumbing elements in the kitchen, downstairs WC, en-suite and bathroom, and behind radiators on the 1<sup>st</sup> and 2<sup>nd</sup> floors.

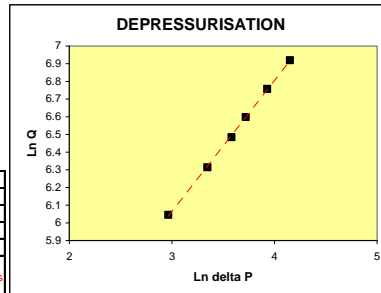
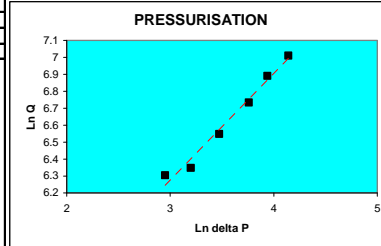
RESULTS:	
Mean Flow AT 50Pa =	896.08 m <sup>3</sup> /h
ACH50 =	2.46 ach
Air Permeability at 50 Pa =	2.84 m <sup>3</sup> /h
Equivalent Leakage Area =	0.034 m <sup>2</sup> at 10 Pa

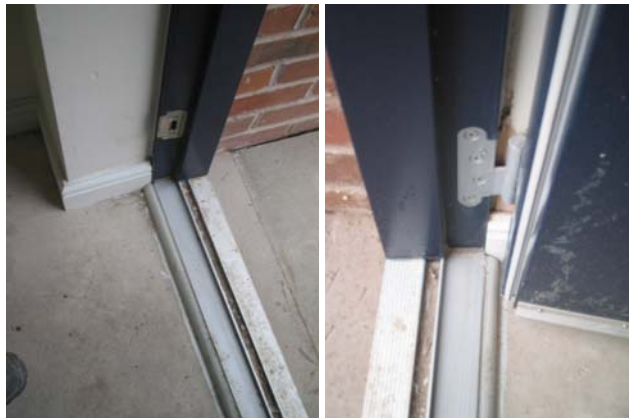
Figure 5.3 Gaps around the front entrance which were inaccessible during the test.

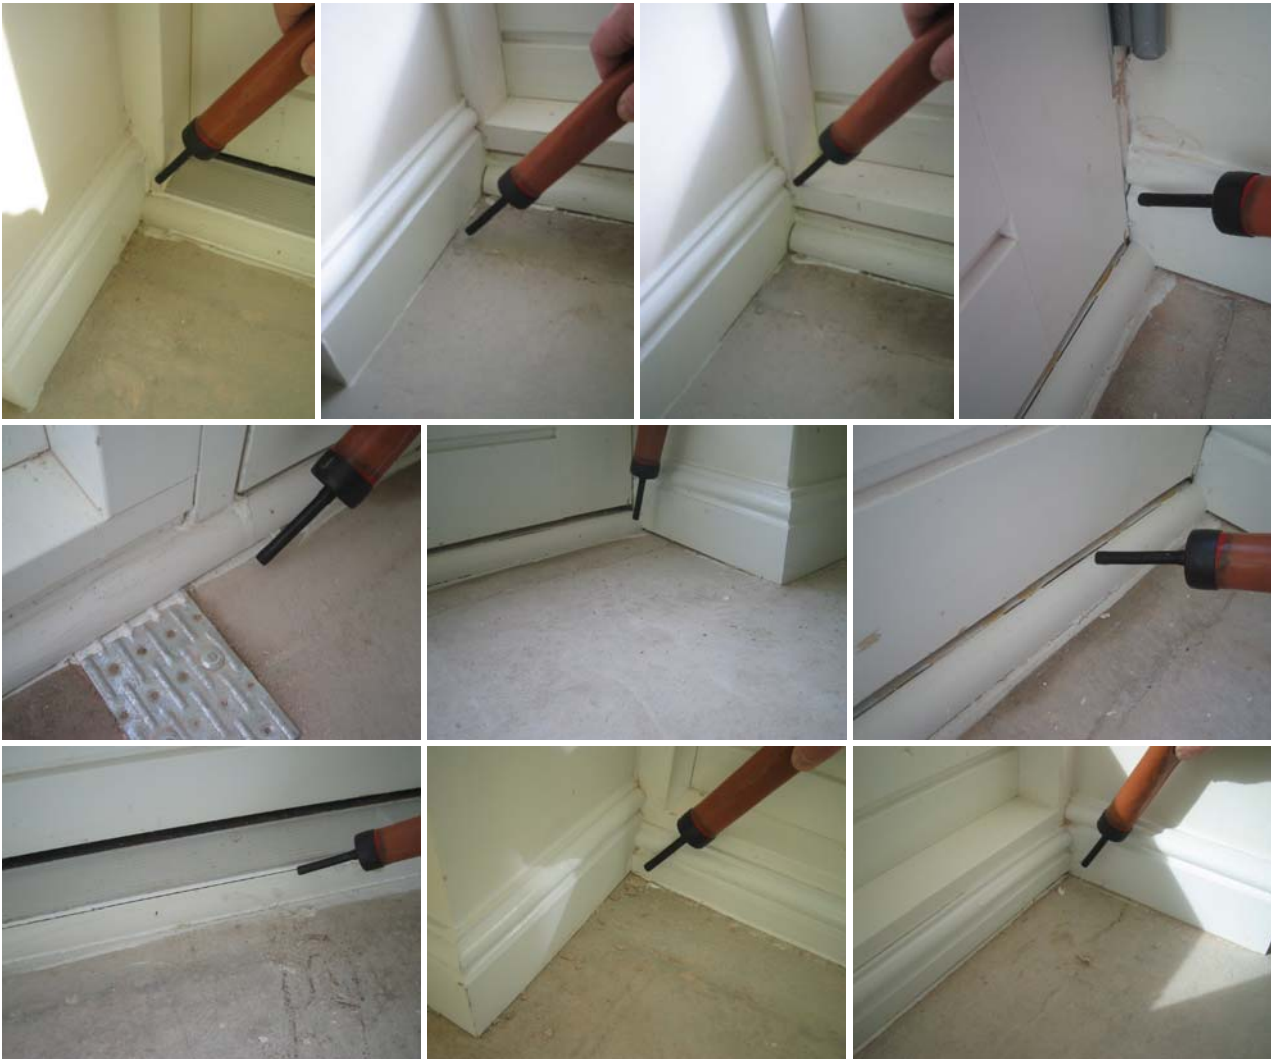
Figure 5.5 Air leakage at the rear door and patio door thresholds, and around the base of the gallery window in the kitchen

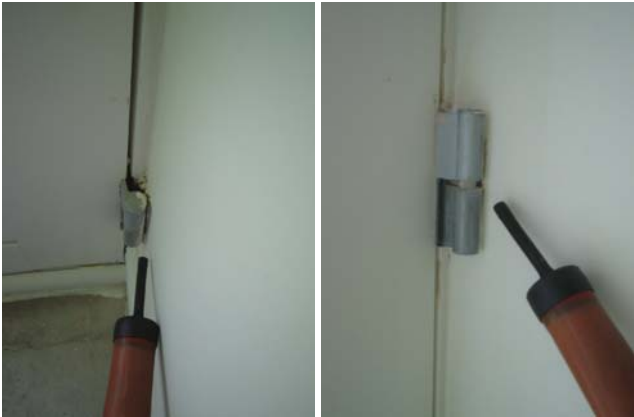
Figure 5.6 Air leakage around external door hinges in the kitchen.

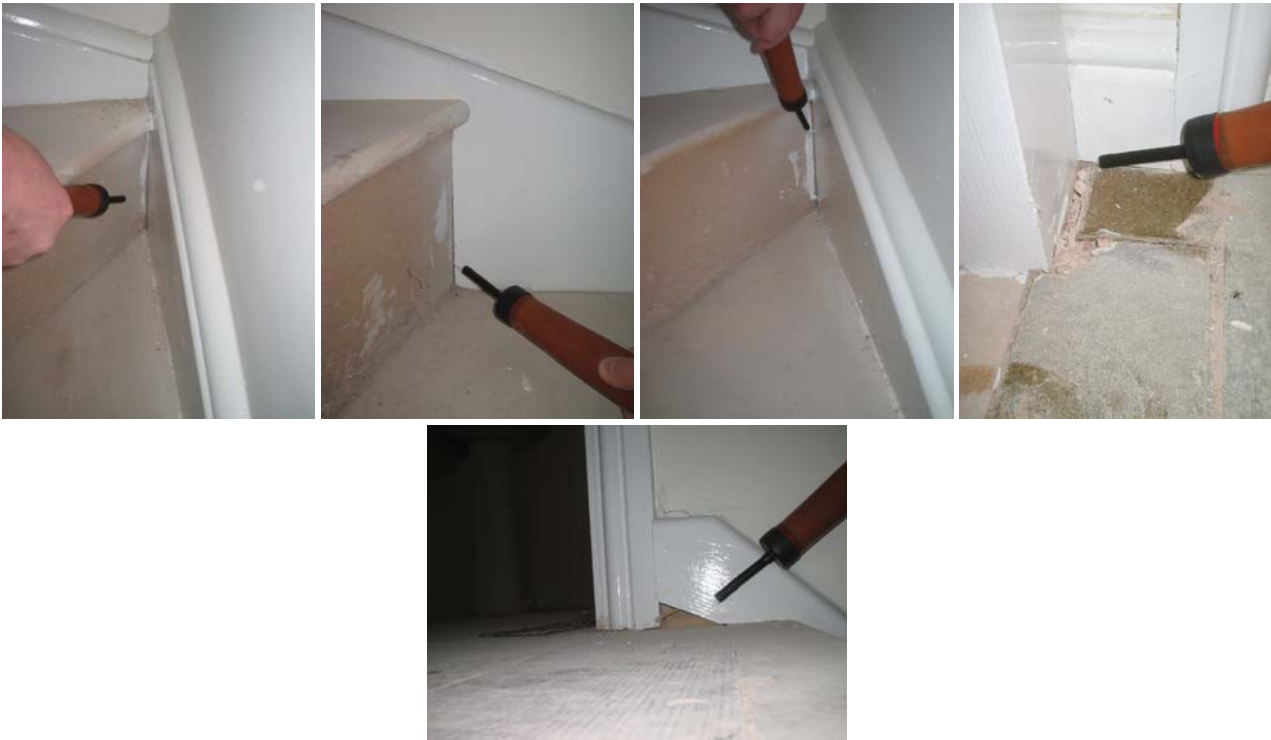
Figure 5.7 Air movement around both sets of stairs.

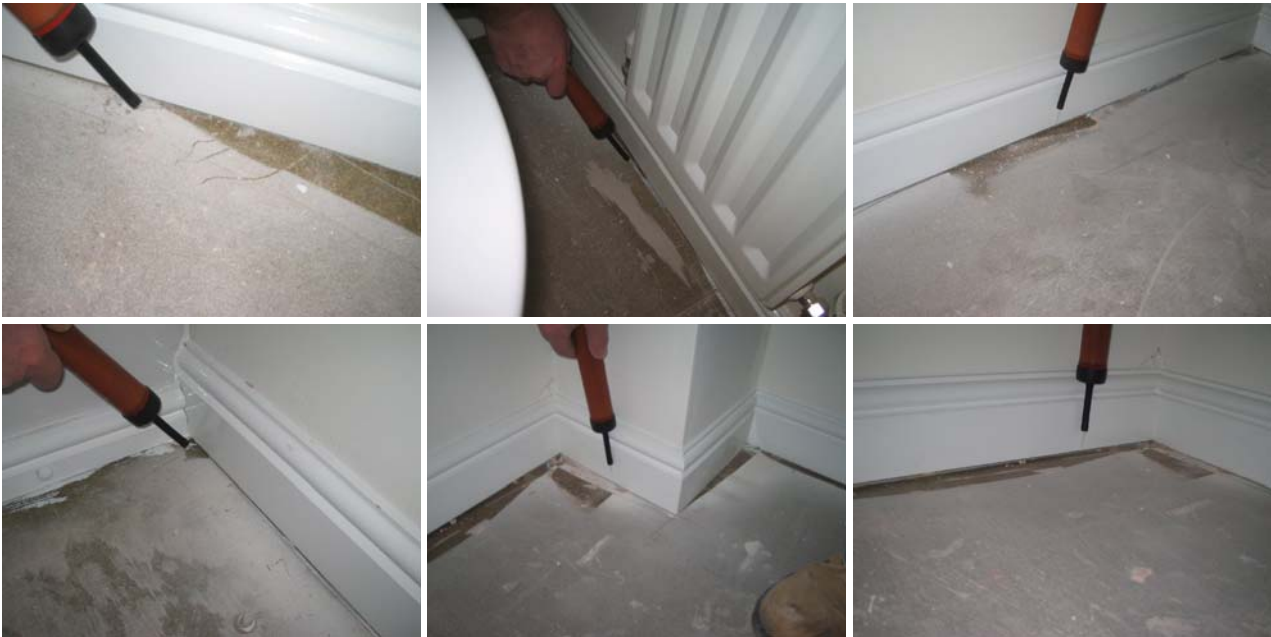
Figure 5.8 Leakage was observed at almost all points around the first floor perimeter, on internal, separating and external walls.

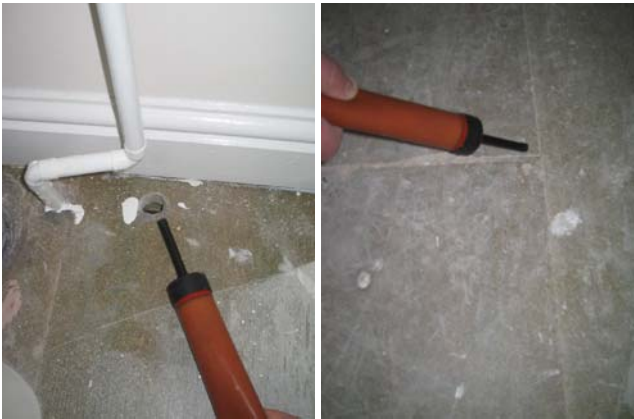
Figure 5.9 Air leakage into the first intermediate floor void through an unsealed hole in the bathroom and gaps between flooring panels in the front bedroom.

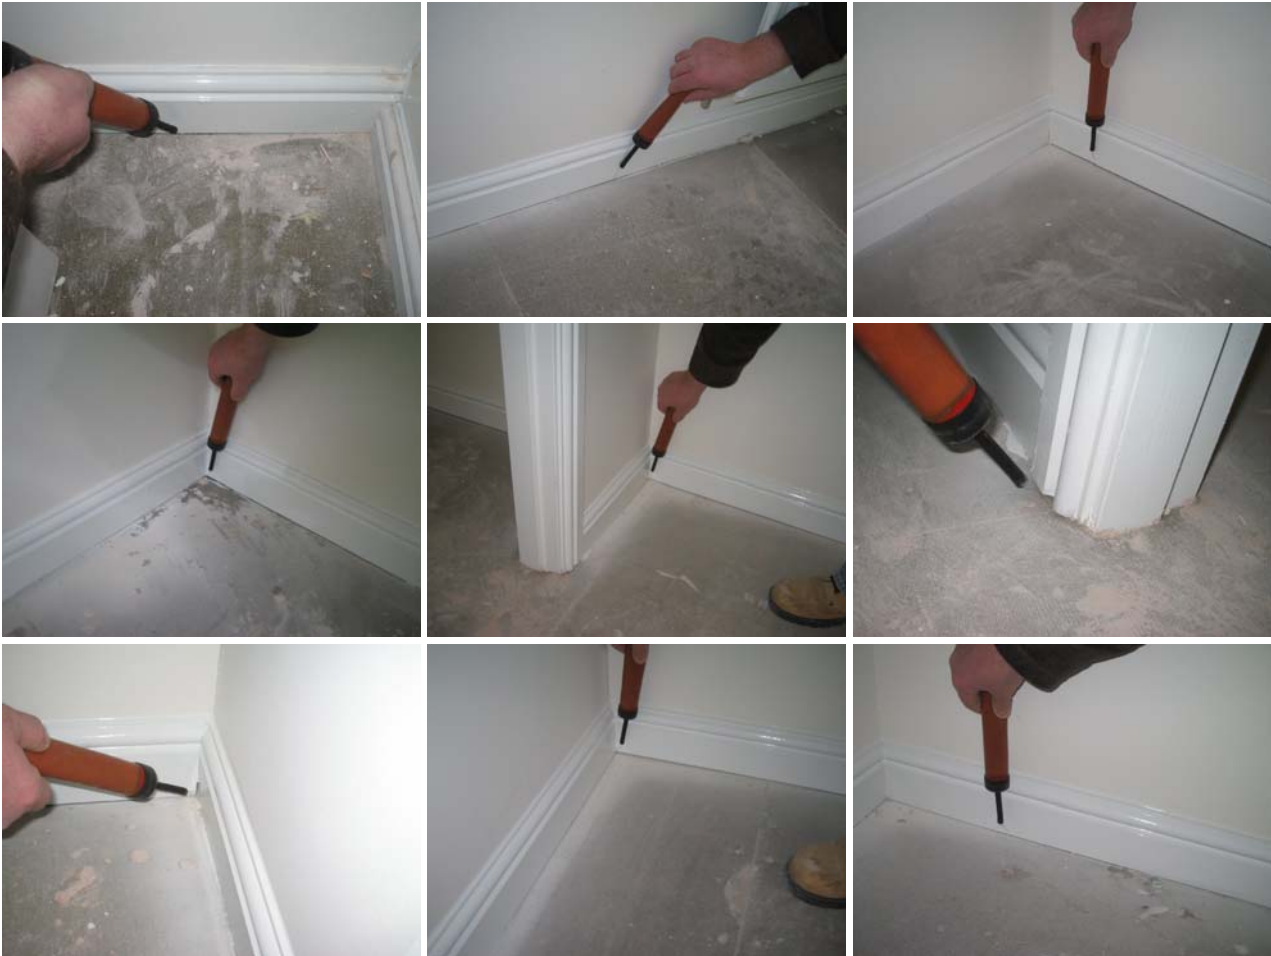
Figure 5.10 Air movement around the second floor perimeter, in the bathroom and both bedrooms, on internal, external and separating walls.
