## **List of Appendices**

## Appendix 1: Pressurisation Test of Bryant Plot 116

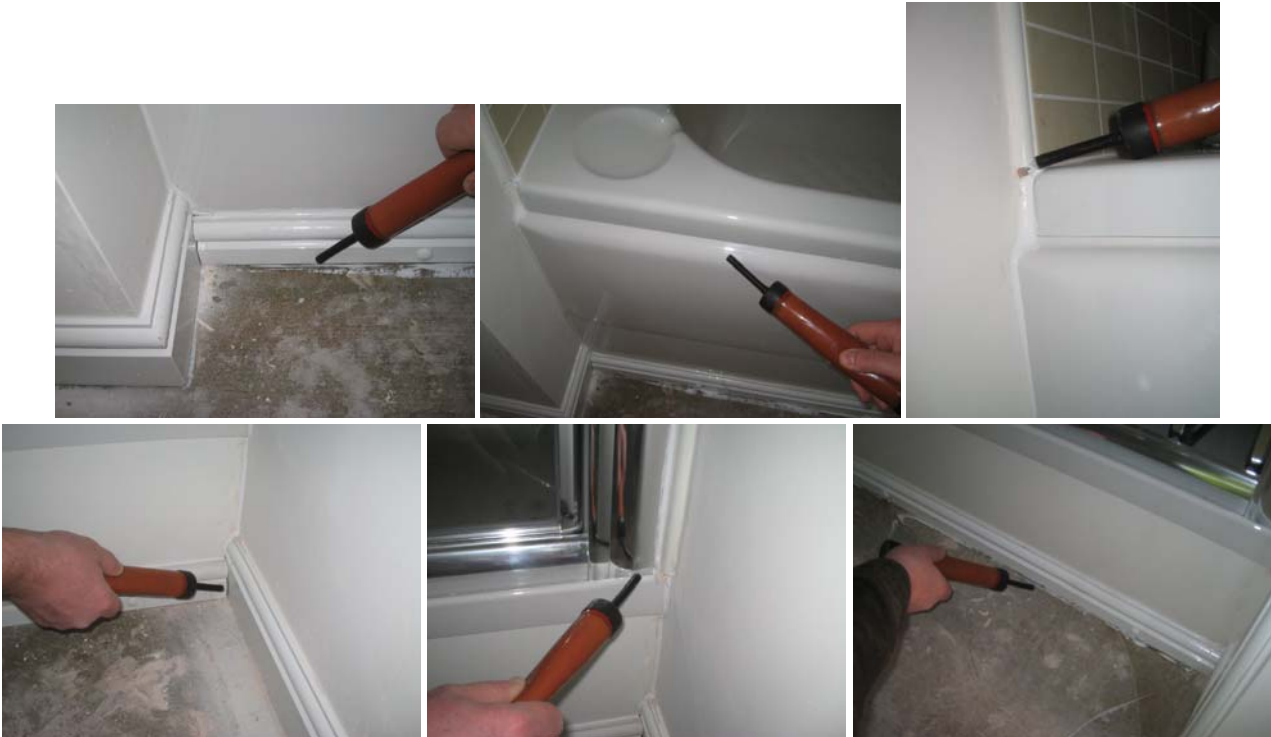
Figure 5.12 Air leakage around the bath panel in the first floor bathroom and around the shower tray fascias in the second floor bathroom and first floor en-suite.

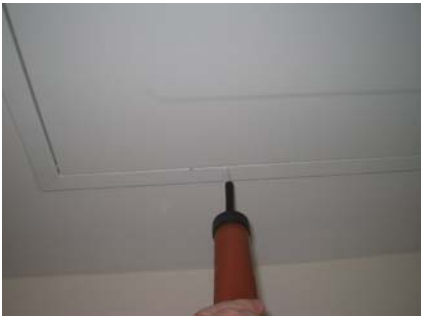
Figure 5.13 Leakage between the loft trap and door.

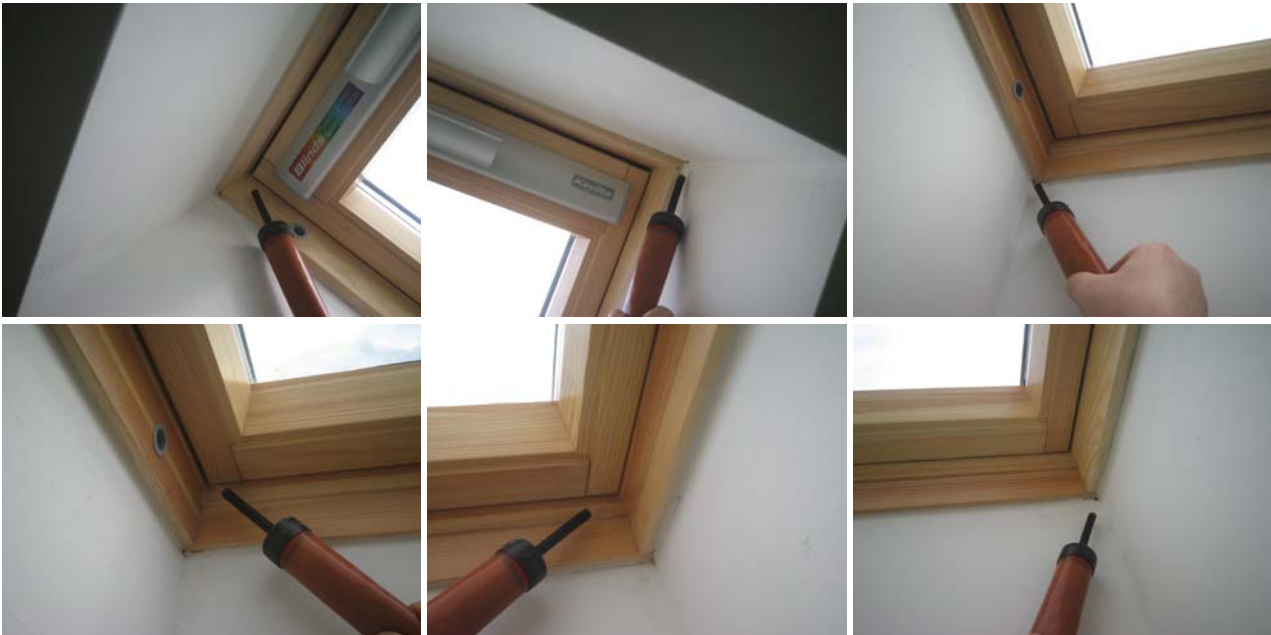
Figure 5.14 Air movement detected around the rooflight casements and frames.

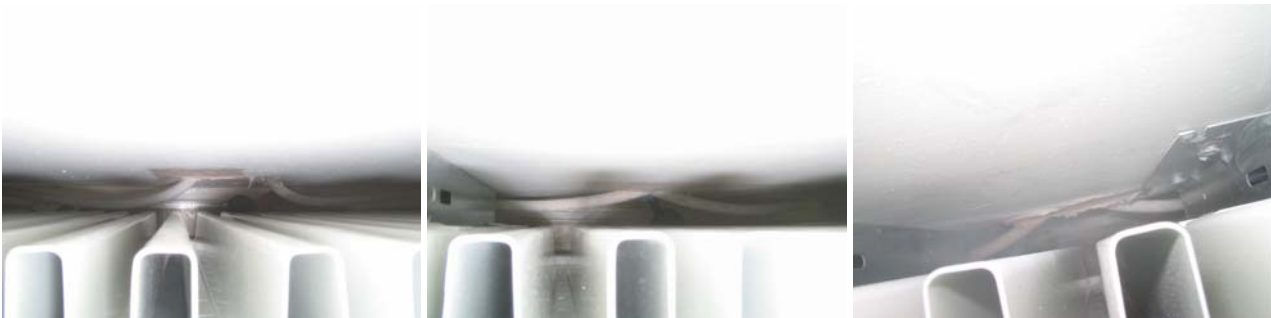
Figure 5.15 Leakage behind the radiators on the first and second floors.

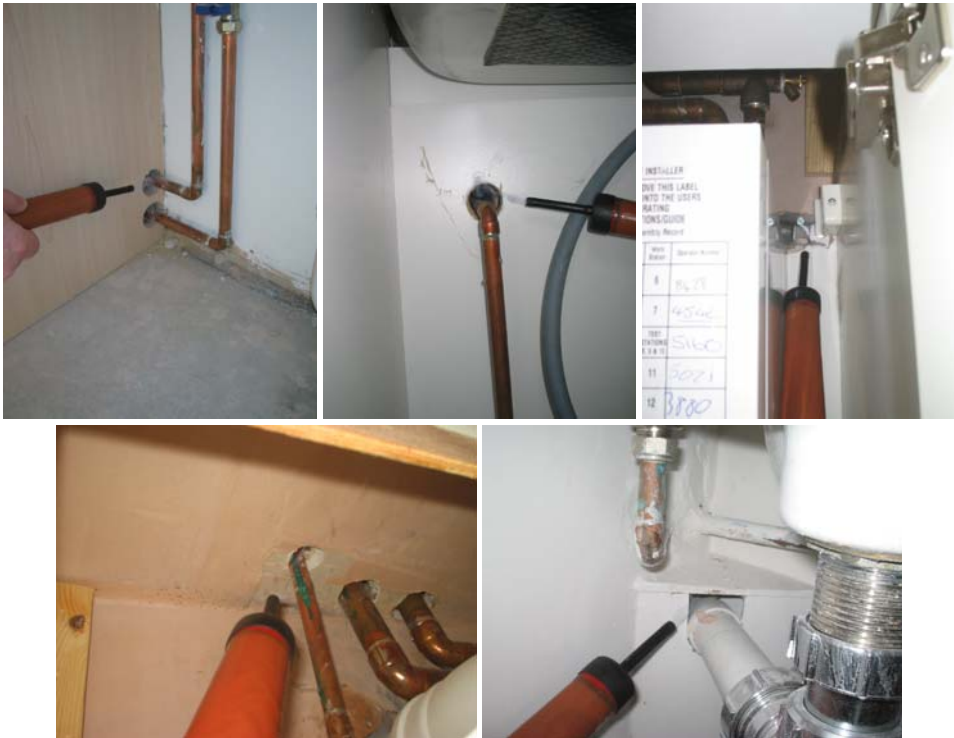
Figure 5.16 Air leakage into voids behind units, plasterboard and ceiling in the kitchen, and into the boxing in the downstairs WC around various plumbing penetrations.

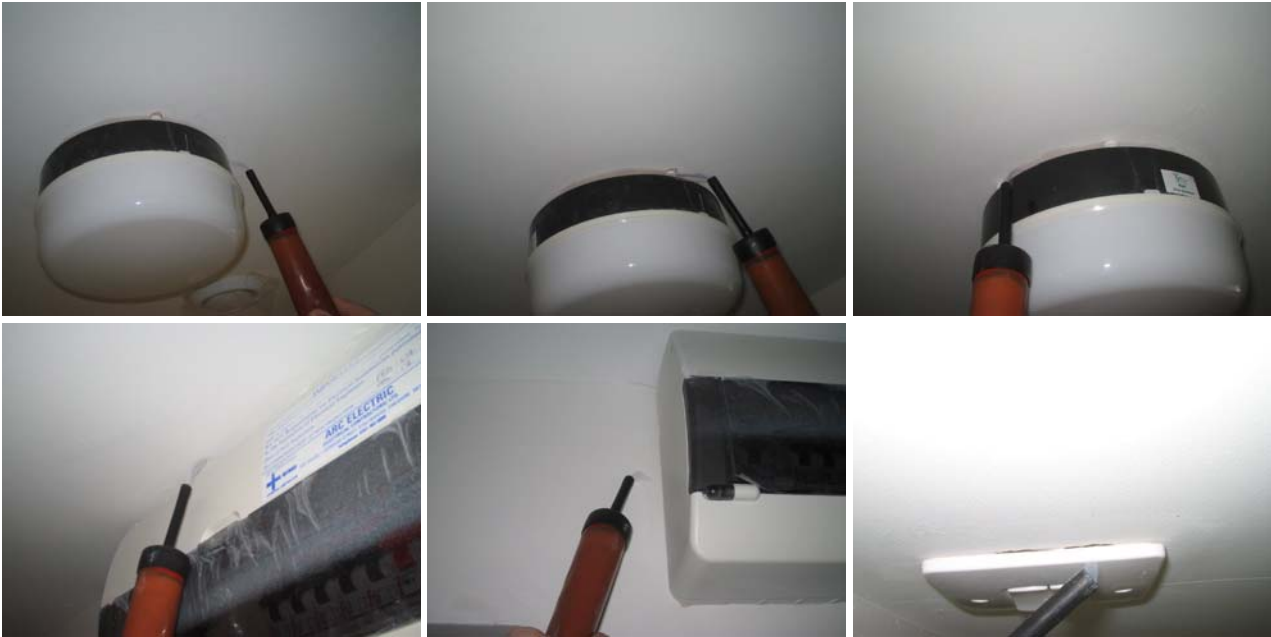
Figure 5.17 Air movement around the bathroom, en-suite and downstairs WC light fixings, around and through the electrical consumer unit and around an electrical penetration on a second floor internal wall.

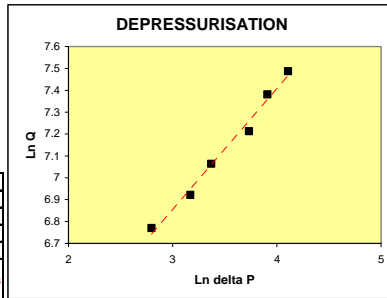
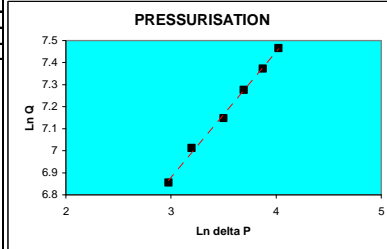
house height:	7.26 m		
floor area:	m2		
volume:	333.2 m3		
envelope area including floor:	302.3 m2		
Pressure Difference for ELA	10 Pa

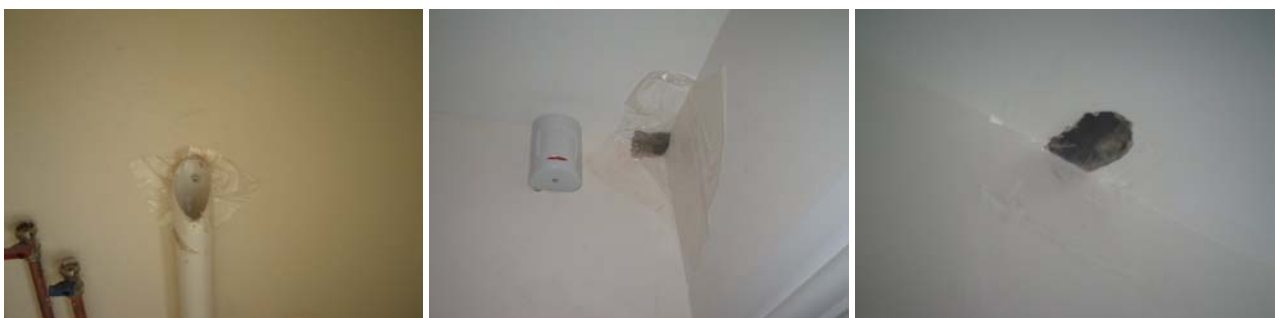
Figure 6.2 Temporary sealing to the washing machine waste pipe and to holes created during the installation of the security system.

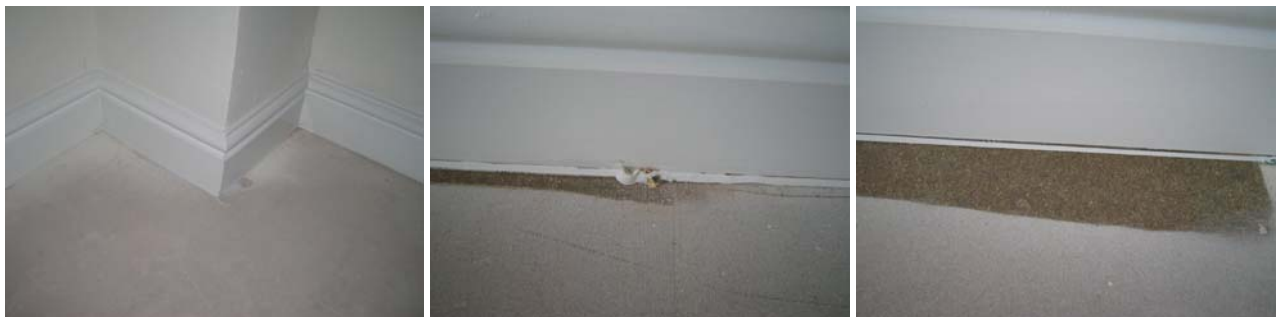
Figure 6.3 Examples of floor/wall junctions; well-sealed, with debris beneath the sealant, and failed joints.

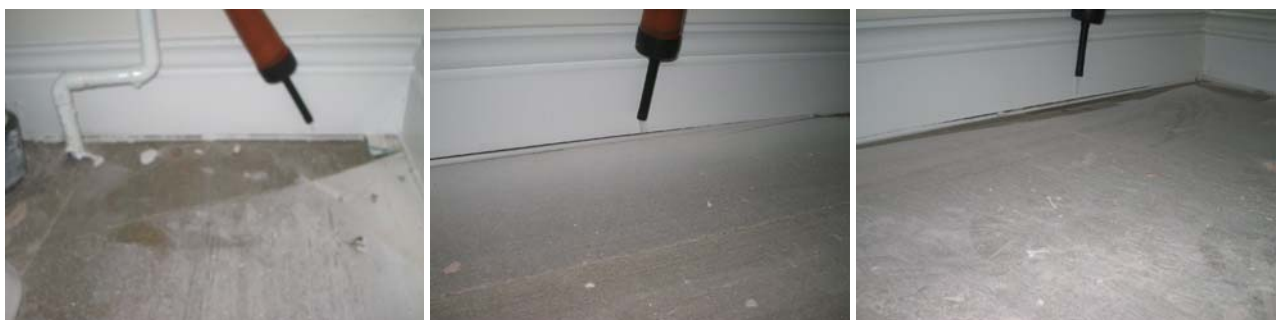
Figure 6.4 Air leakage detected where the sealing of the floor/wall junctions was impaired, either through the presence of debris, insufficient sealant or the sealant had already failed.

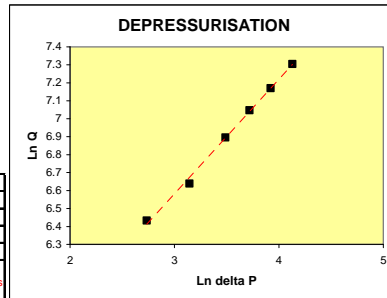
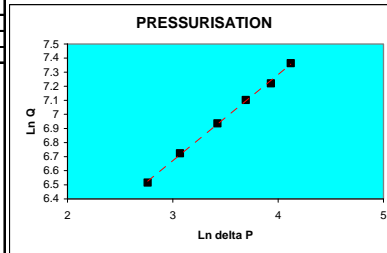
house width:	5.51 m		
house depth:	8.19 m		
house height:	7.26 m		
floor area:	m2		
volume:	333.2 m3		
envelope area including floor:	302.3 m2		
Pressure Difference for ELA:	10 Pa

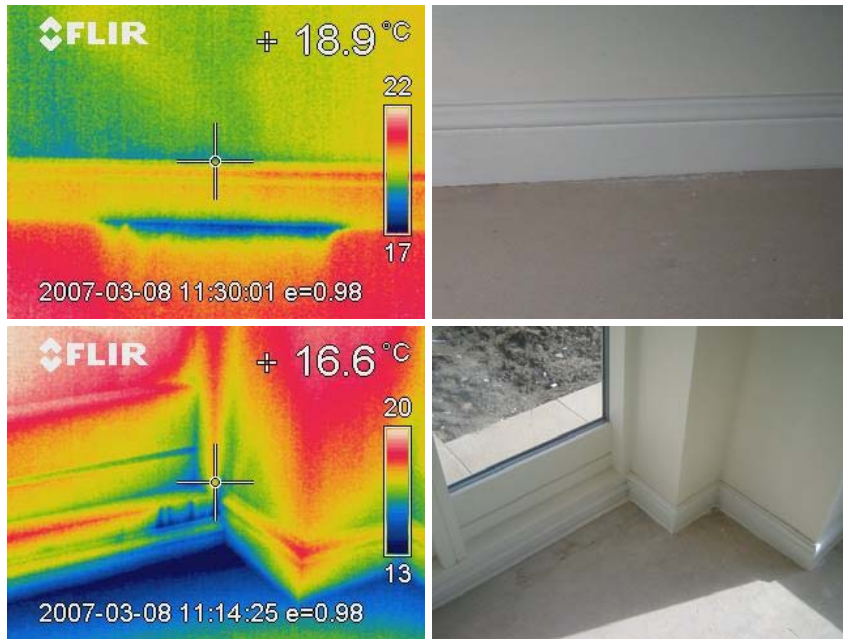
Figure 7.3 Infiltration at the ground floor junction with the external wall in the lounge and around the base of the gallery window in the kitchen/diner.

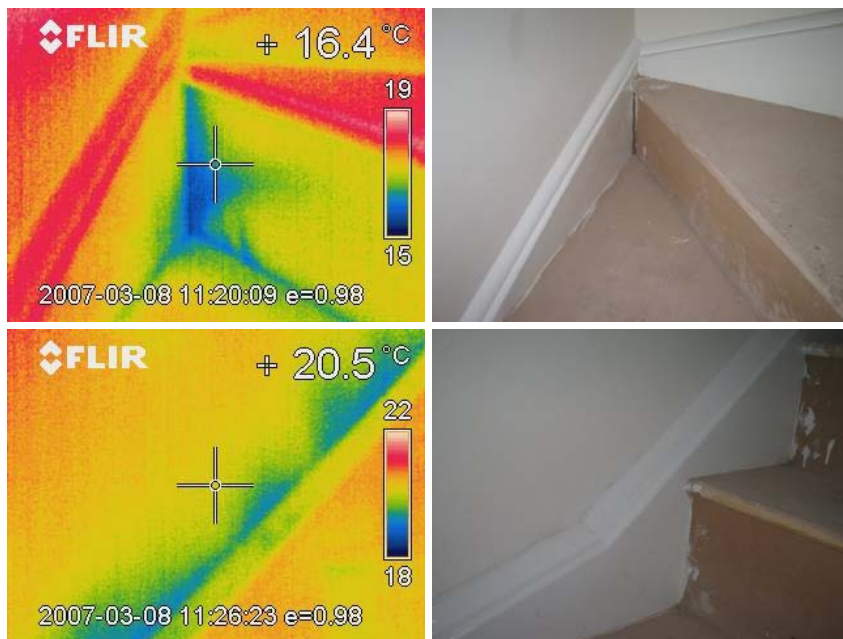
Figure 7.4 Air movement around the staircases.

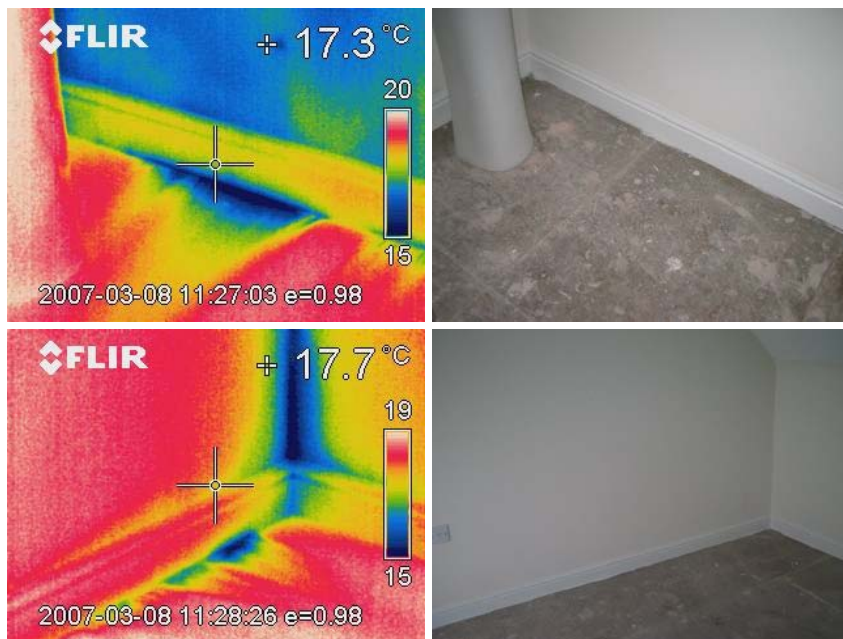
Figure 7.6 Air leakage at the second floor perimeter; at an external wall in the bathroom and at the junction of the separating and wall in front of a warm sloping roof void in the rear bedroom.

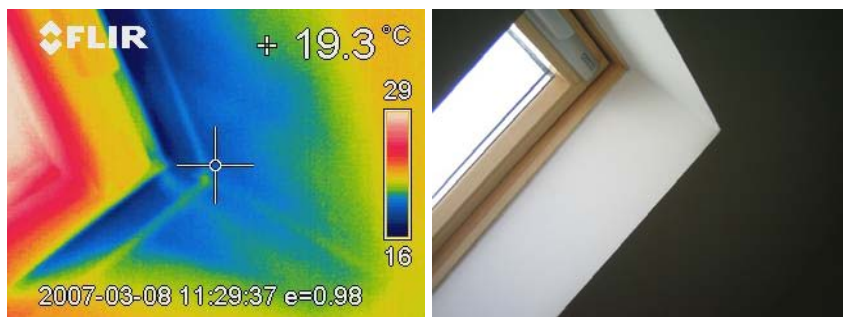
Figure 7.7 Air movement around a rooflight in the bedroom.

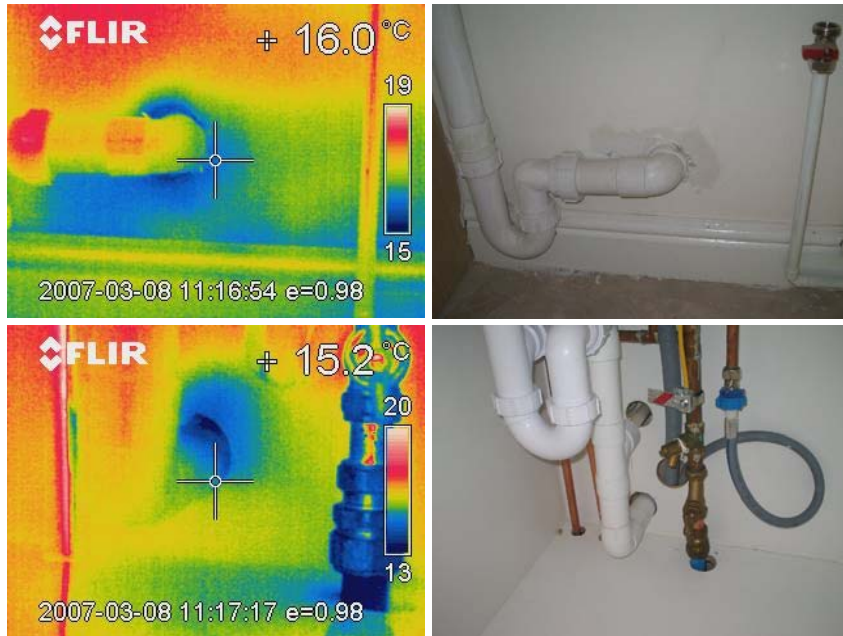
Figure 7.9 Air leakage around waste pipe for the washing machine and kitchen sink.

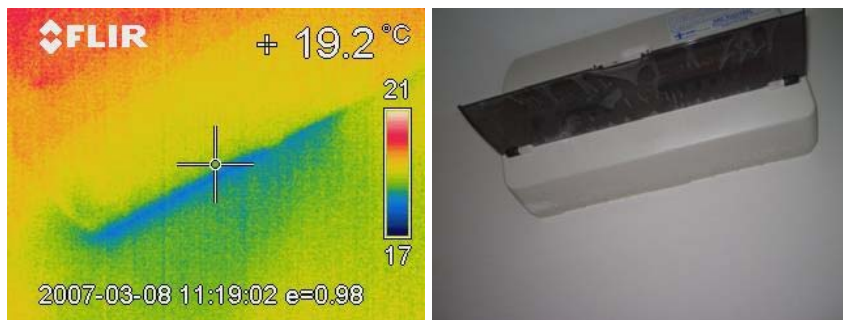
Figure 7.10 Infiltration around the electrical consumer unit

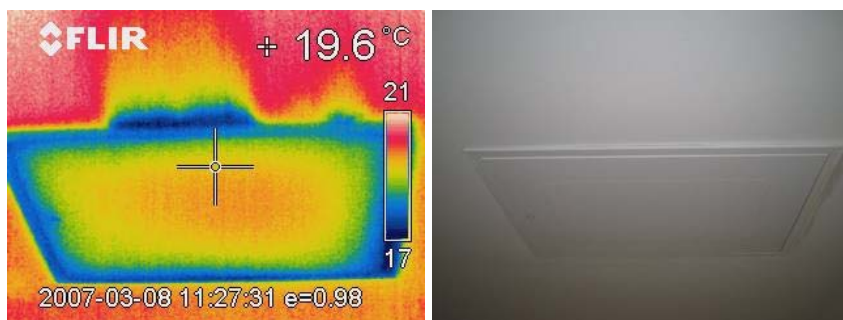
Figure 7.11 Cooler air entering the bedroom from the loft via gaps around the loft hatch.

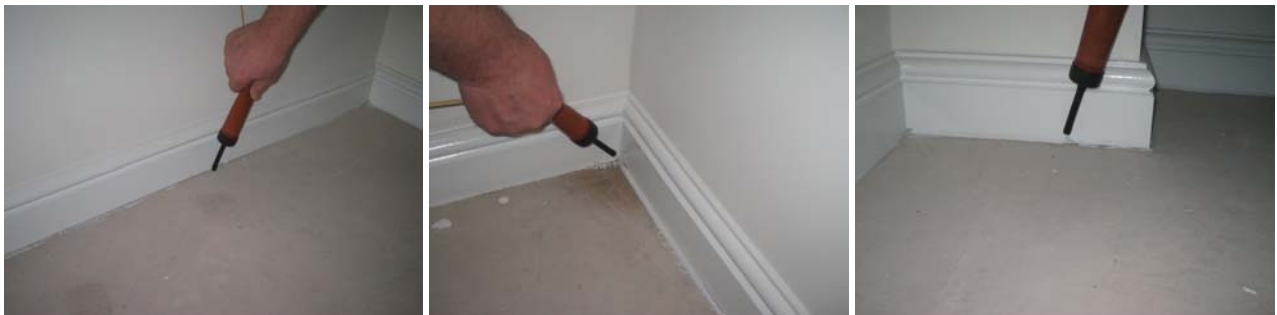
Figure 7.12 Air leakage in the lounge at the wall/floor junctions.

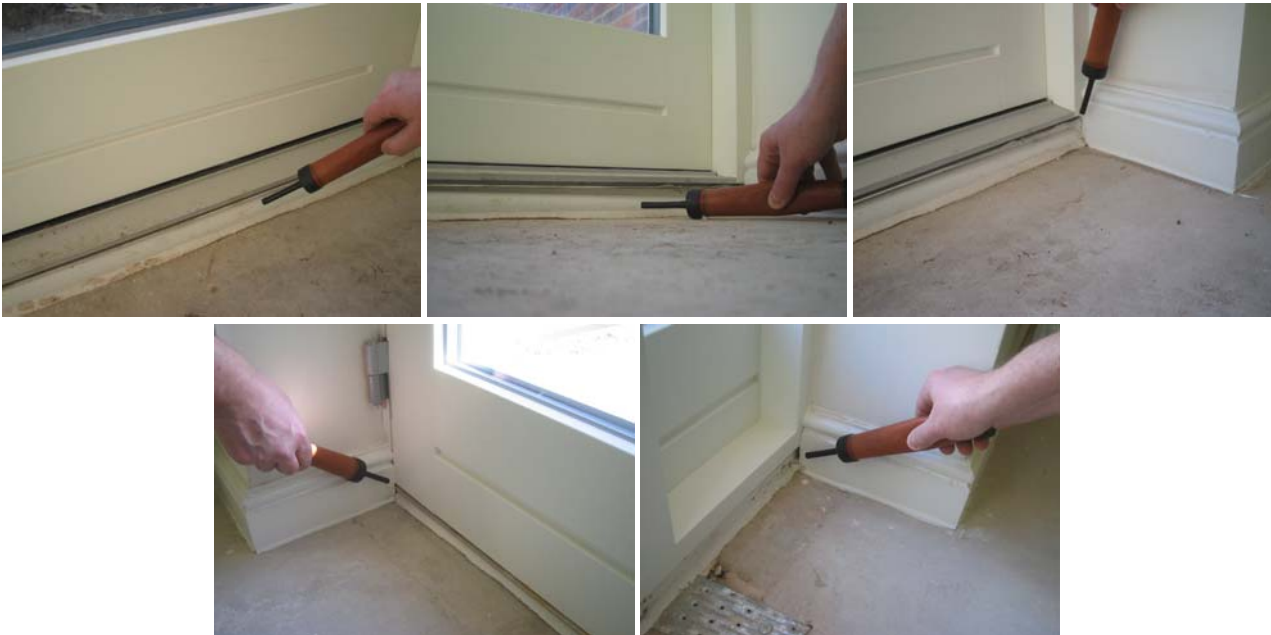
Figure 7.13 Air leakage through gaps around the patio door and rear door thresholds in the kitchen.

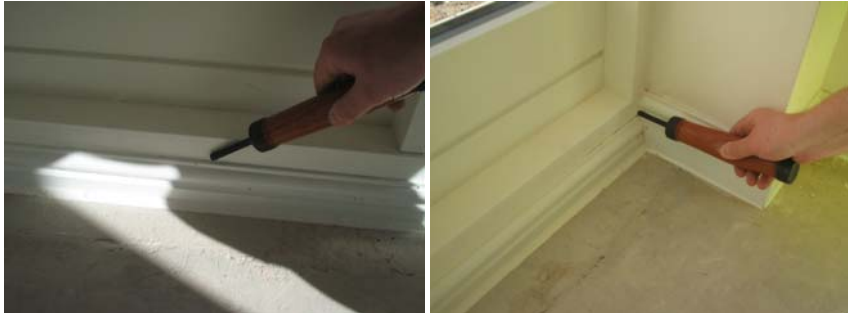
Figure 7.14 Leakage around the frame of the kitchen gallery window.

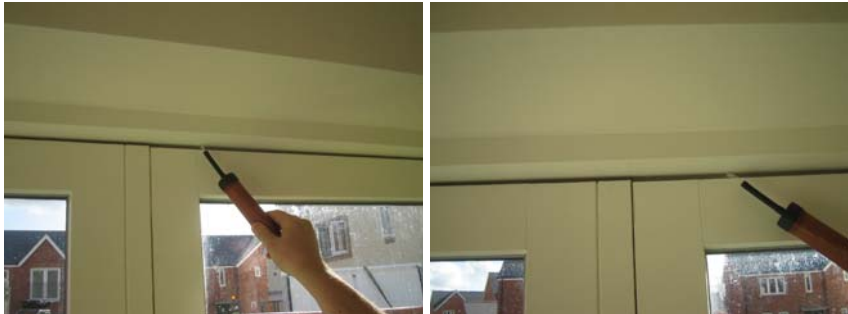
Figure 7.15 Air leakage about an incorrectly set patio door.

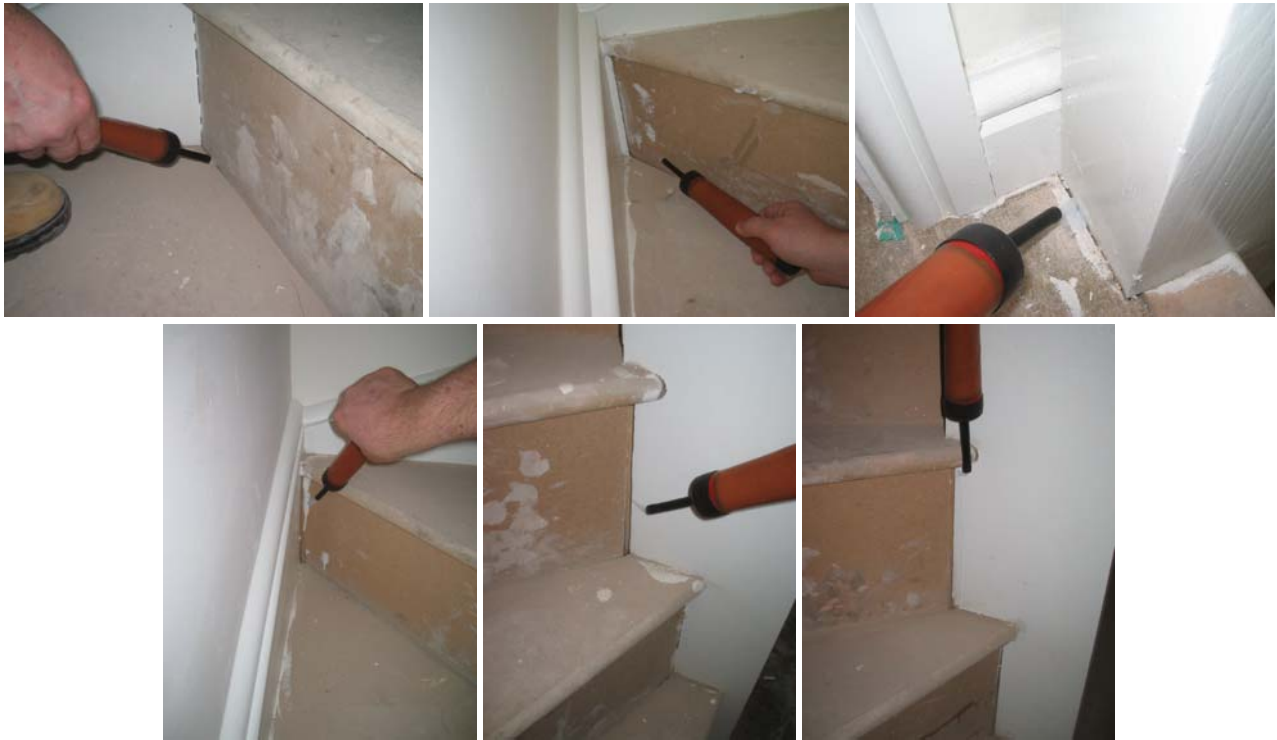
Figure 7.16 Air leakage into the voids surrounding both sets of stairs.

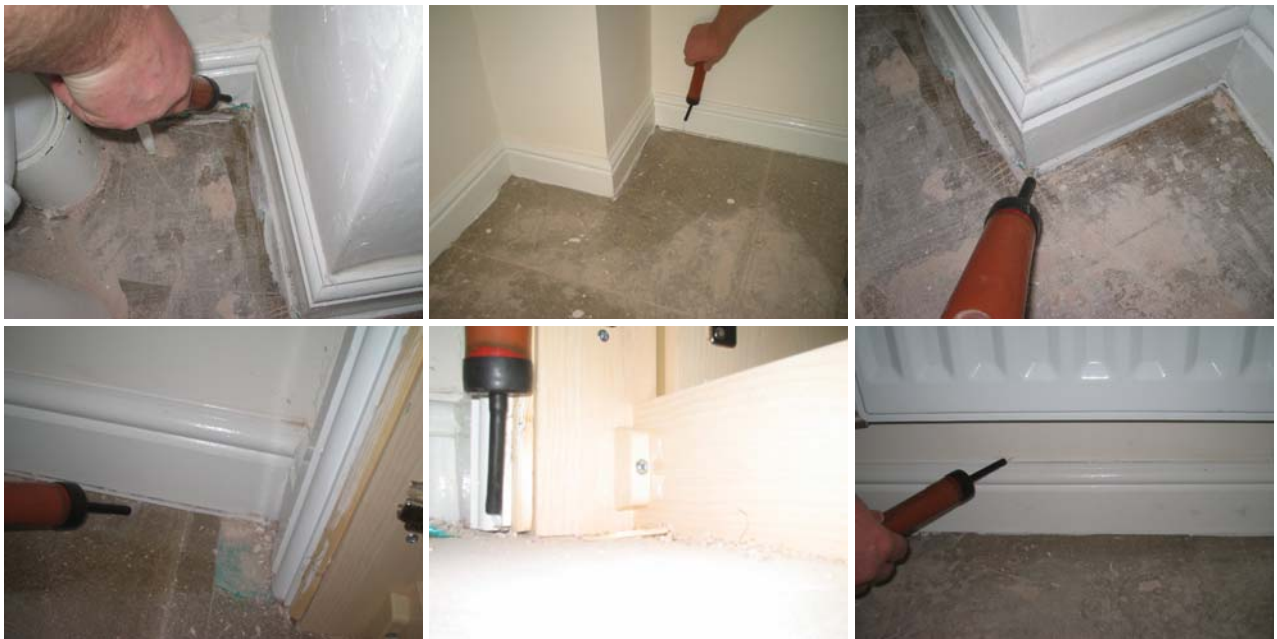
Figure 7.17 Air leakage around the first floor perimeter, where the sealing was ineffective, missing or had failed. The areas where the leakage appeared most severe were at corners and in less visible places such as inside the built-in wardrobe and under radiators.

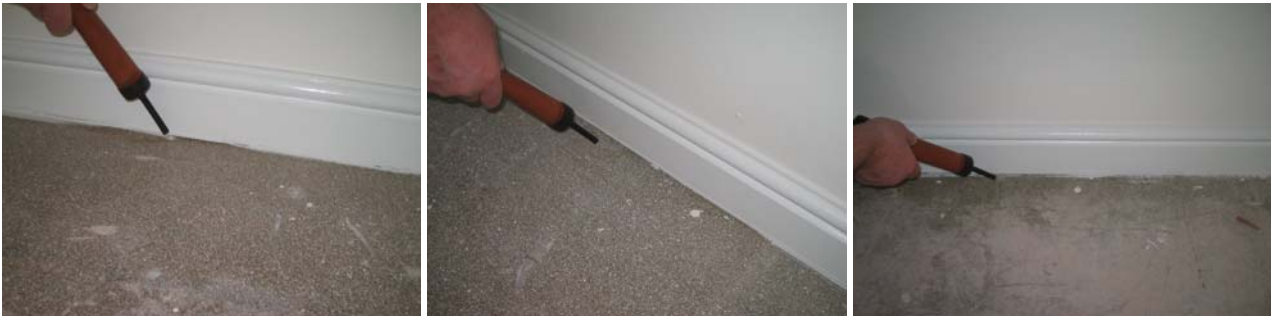
Figure 7.18 Air leakage around the second floor perimeter through gaps in the sealant in both bedrooms.

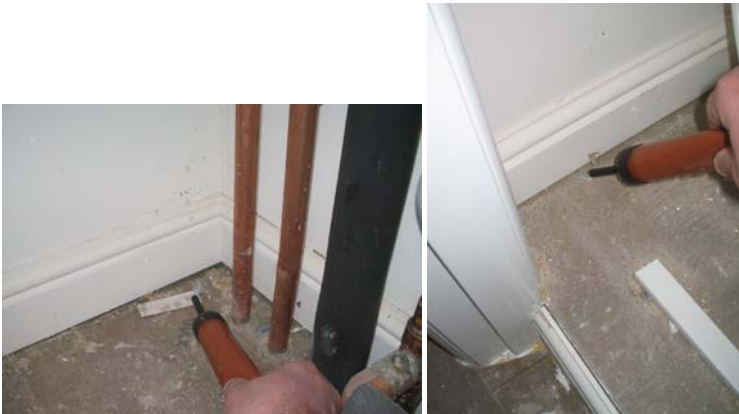
Figure 7.19 Air movement through unsealed gaps around the platform floor of the cylinder cupboard.

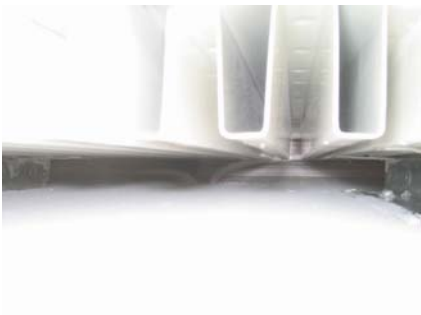
Figure 7.20 Leakage through the pipework penetrations for the radiator in the first floor bathroom.

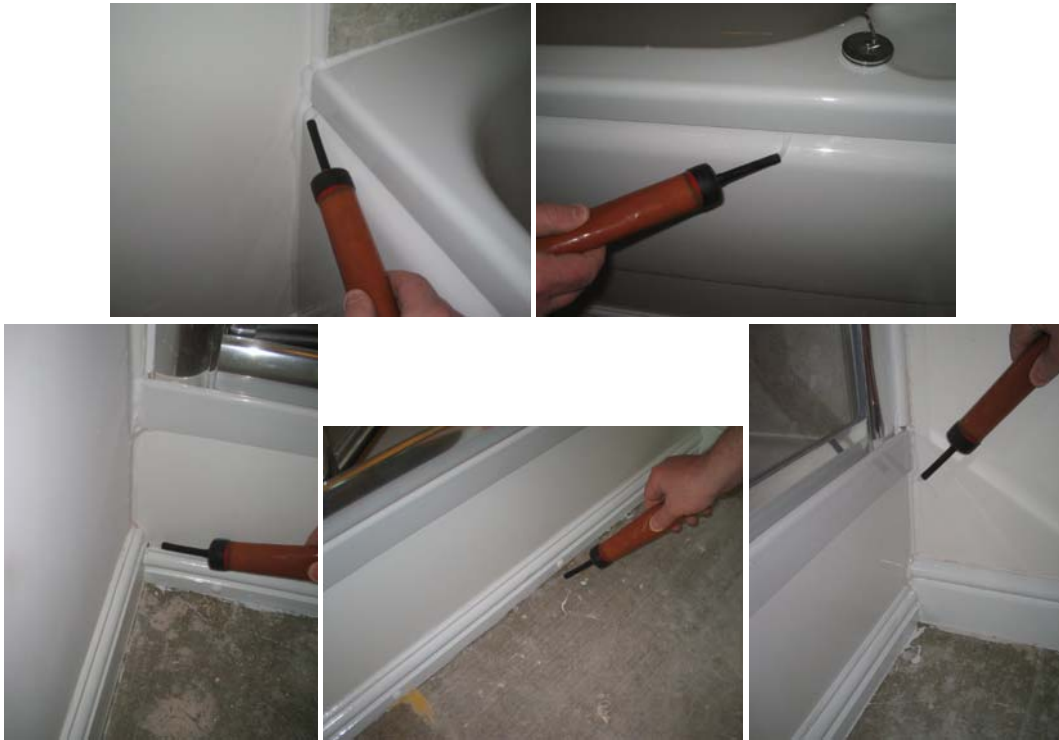
Figure 7.21 Points of air leakage around the bath panel and around the shower tray fascias.

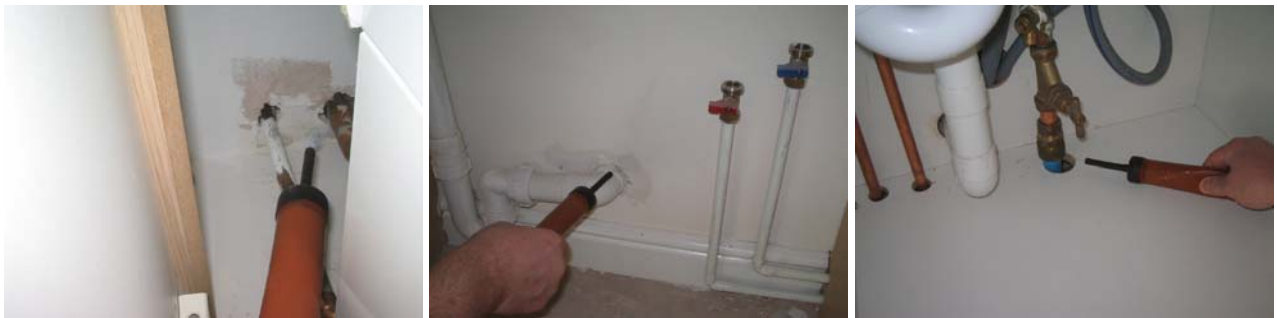
Figure 7.22 Gaps around plumbing penetrations in the kitchen allowing air leakage into intermediate floor void, the void behind the plasterboard and the void behind the kitchen units.

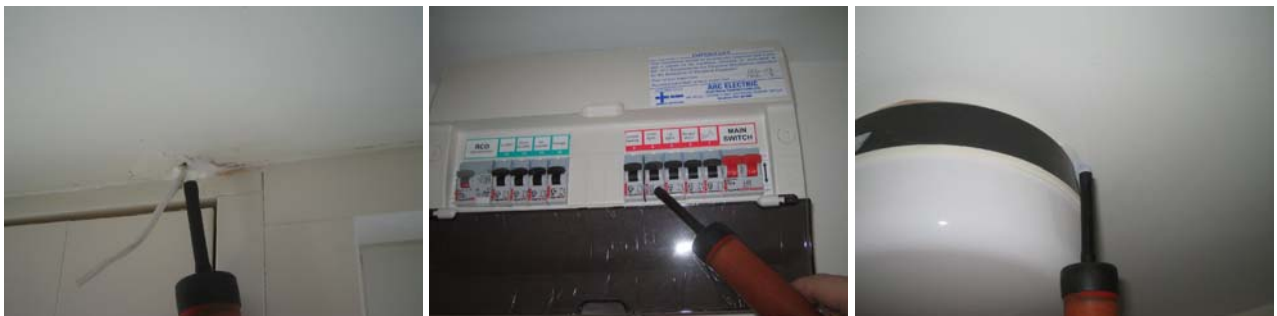
Figure 7.23 Air leakage around inadequately sealed electrical penetrations, including all the bathroom, ensuite and downstairs WC ceiling-mounted light fittings.

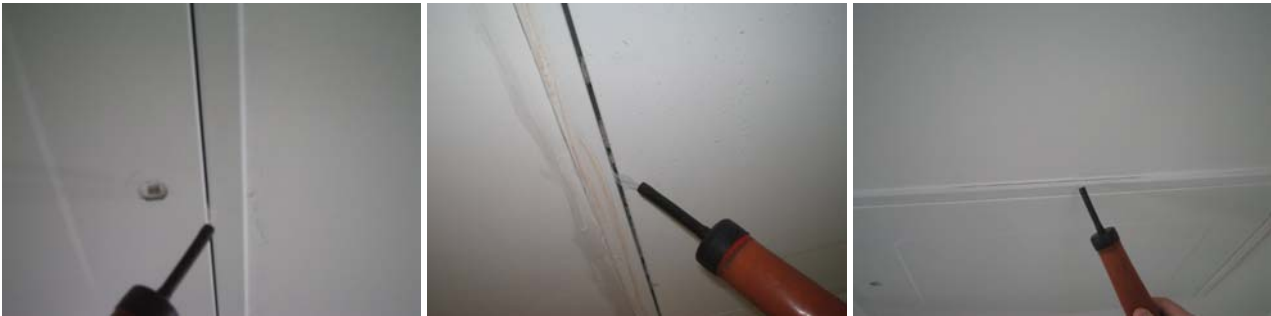
Figure 7.24 Air movement into the loft between the loft trap and door and at the junction of the loft hatch and bedroom ceiling.

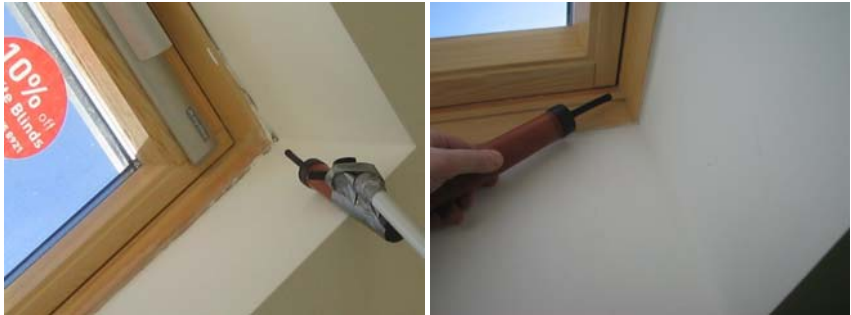
Figure 7.25 Air leakage at the rooflights in both the kitchen/diner and in the second floor rear bedroom.

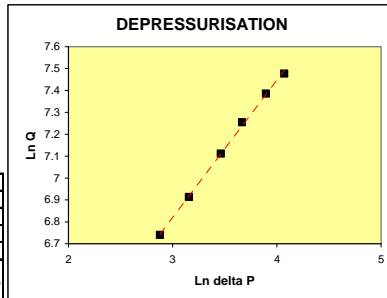
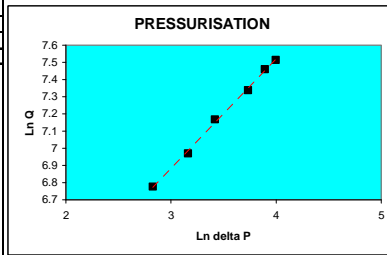
house depth:	8.19 m		
house height:	7.26 m		
floor area:	m2		
volume:	333.2 m3		
envelope area including floor:	302.3 m2		
Pressure Difference for ELA	10 Pa

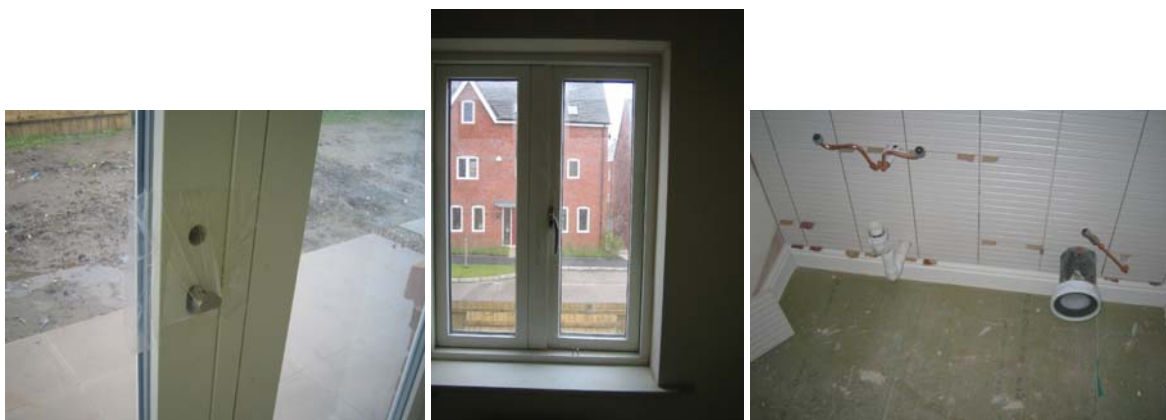
Figure 1.2 Temporary sealing prior to pressurisation test

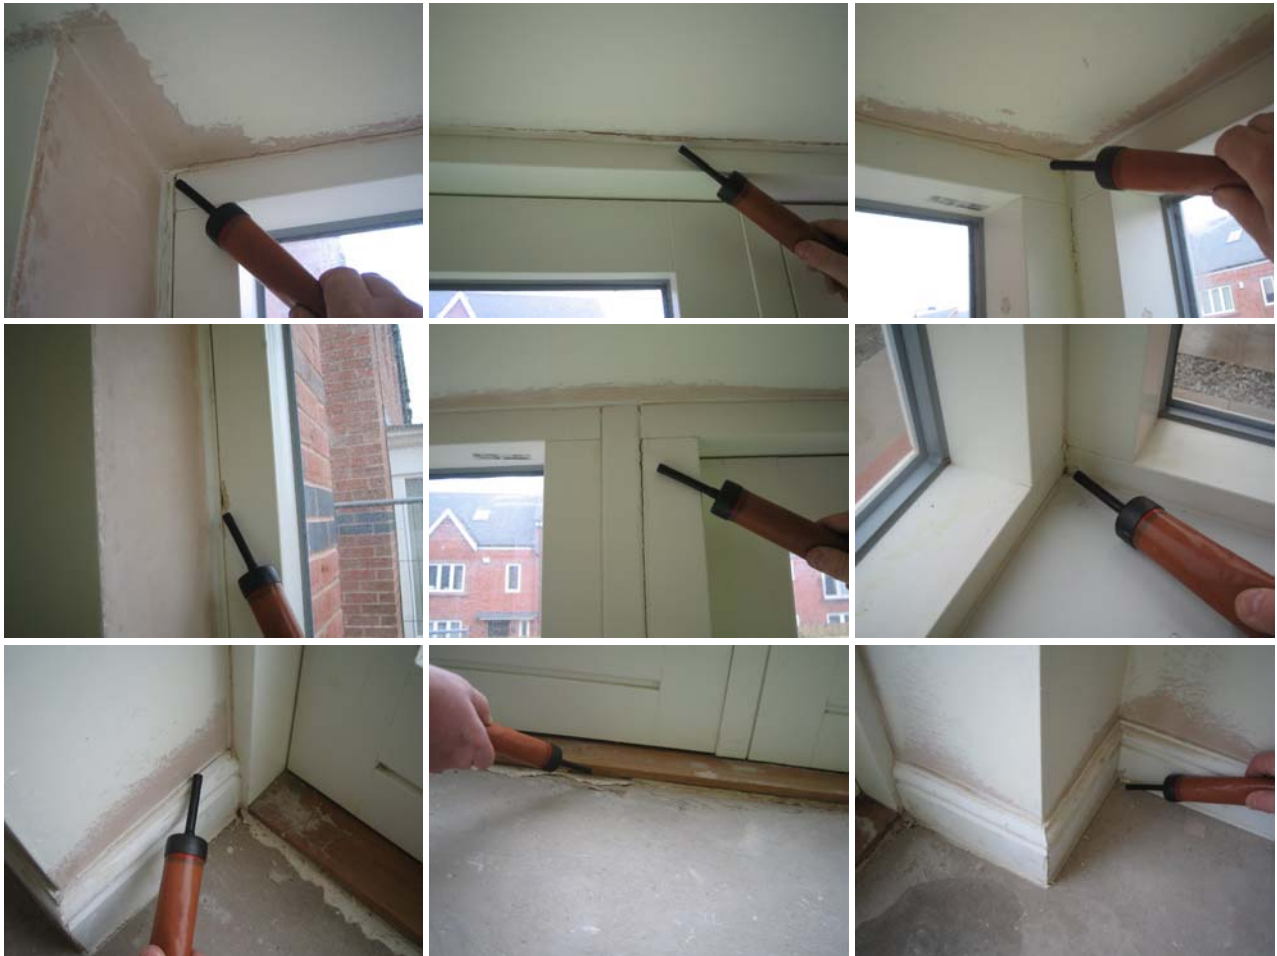
Figure 8.3 Air leakage at various places around the ground floor bay window.

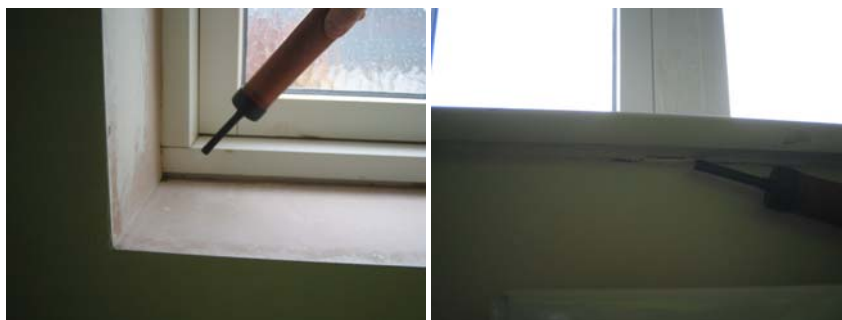
Figure 8.4 Air leakage at window sills.

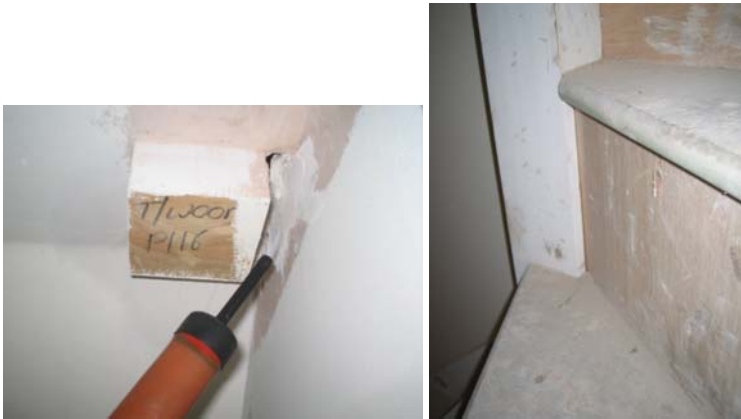
Figure 8.5 Gaps around the stairs remaining unsealed.

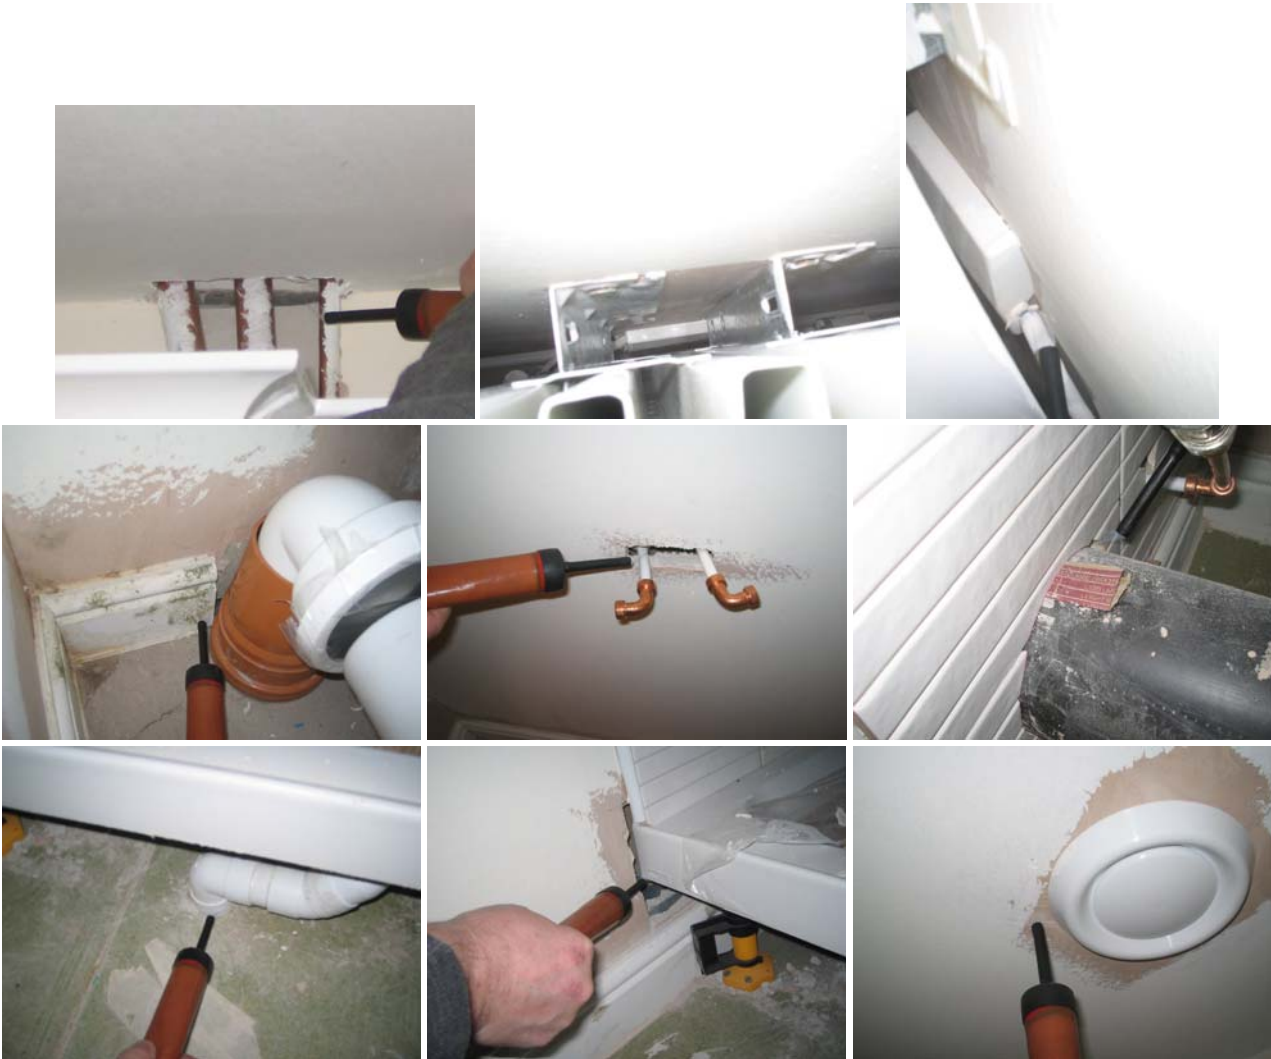
Figure 8.7 Air leakage around various penetrations for heating, plumbing and ventilation services.

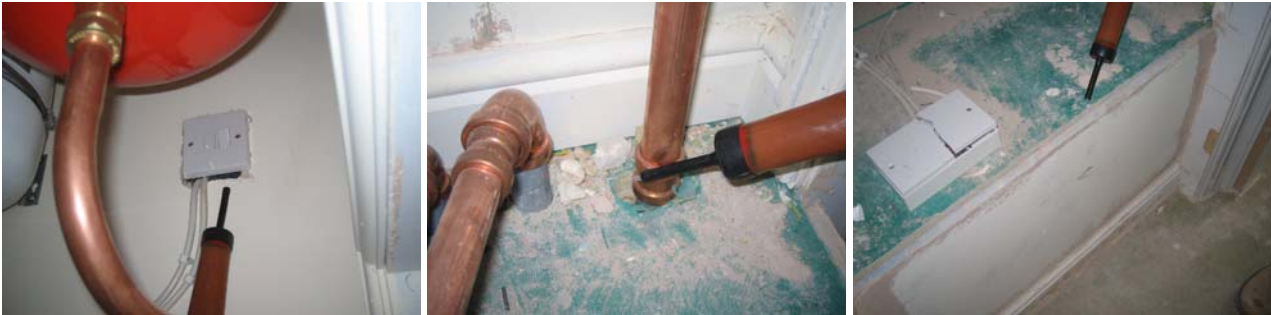
Figure 8.8 Air movement in the cylinder cupboard on the first floor.

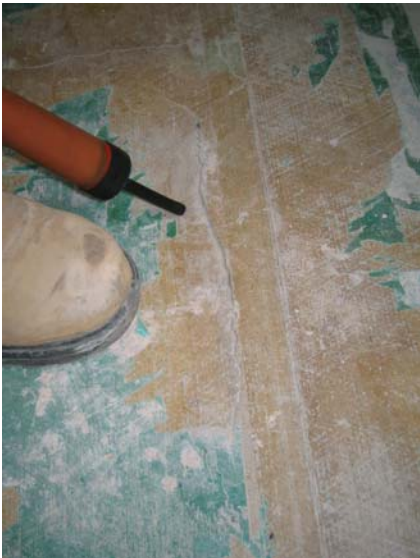
Figure 8.9 Damage to the intermediate floor in the front bedroom.

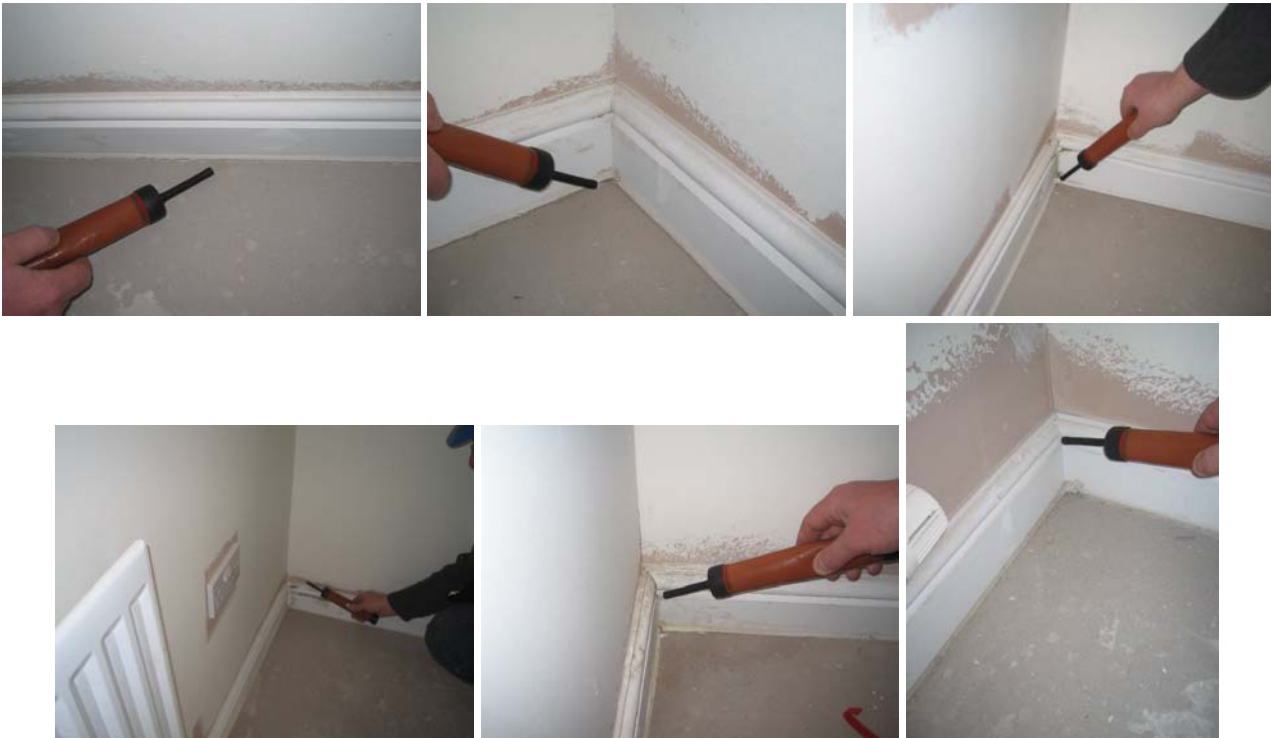
Figure 8.10 Junctions of the ground floor with external and separating walls displayed points of air leakage, this was particularly noticeable at room corners.

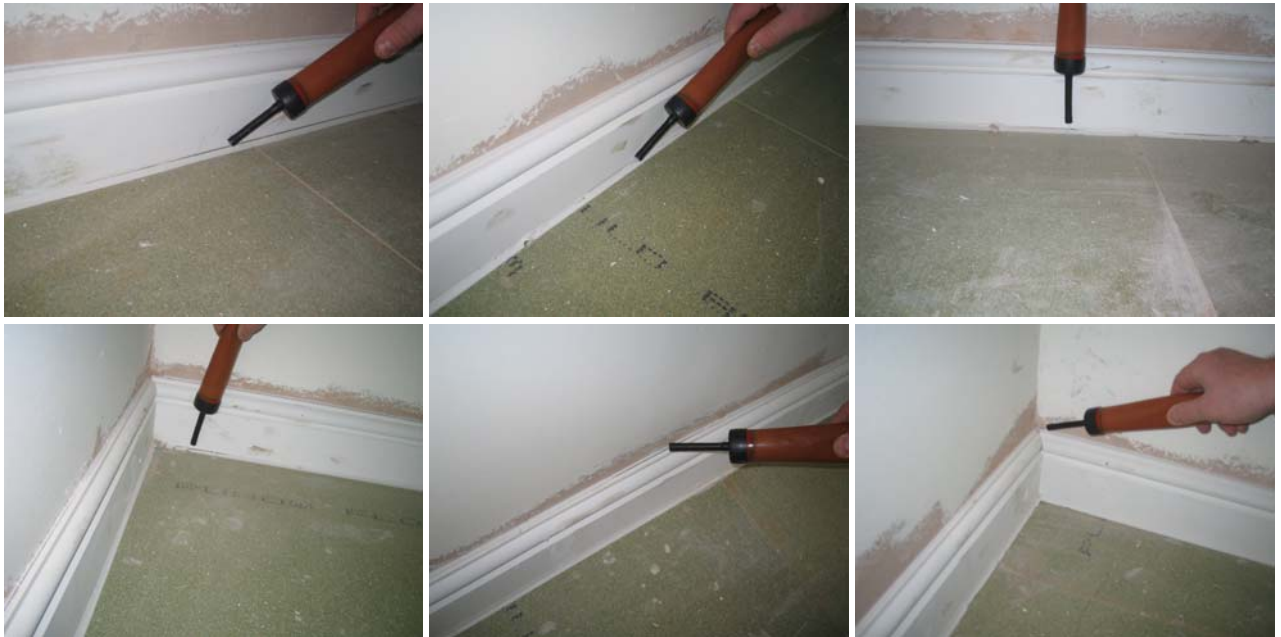
Figure 8.11 Air leakage detected at junctions of the intermediate floor with internal, external and separating walls where the sealant had failed and at shrinkage cracks above the skirting boards.

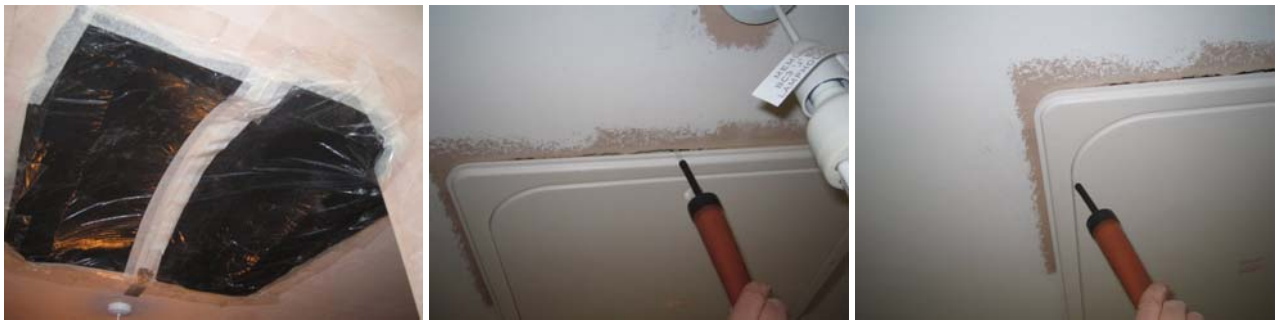
Figure 8.12 The temporary sealing of the loft hatch when the dwelling was previously tested compared with leakage around and through the loft hatch observed during the re-test.
