## **List of Appendices**

## Appendix 1: Pressurisation Test of Bryant Plot 116

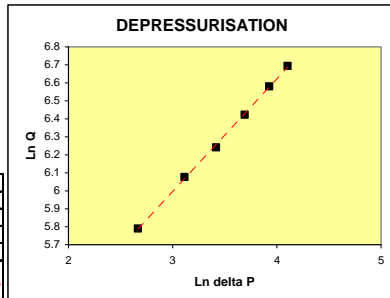
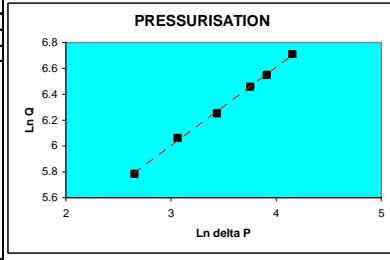
wind speed (m/s):	0.15		
baseline pressure diff (Pa) (+/-)	Pa		
house width:	4.61 m		
house depth:	7.738 m		
house height:	5 m		
floor area:	37.02 m2		
volume:	181.53 m3		
envelope area including floor:	200.69 m2		
Pressure Difference for ELA	10 Pa

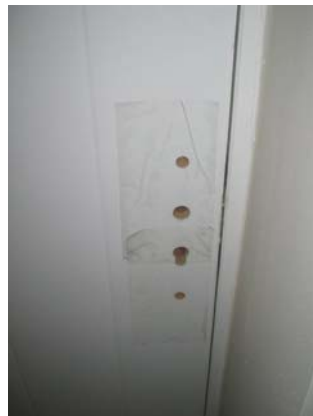
Figure 9.2 Temporary sealing to rear door.

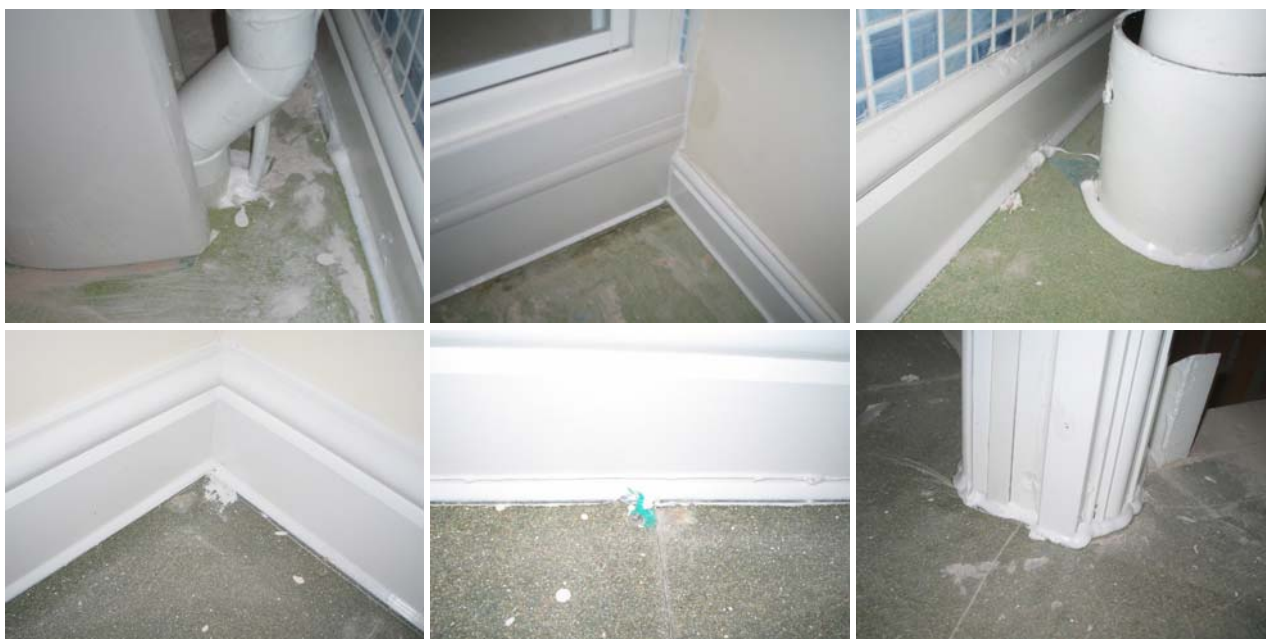
Figure 9.3 A high standard of secondary sealing of many service penetrations and wall/floor junctions was observed throughout most of plot B119.

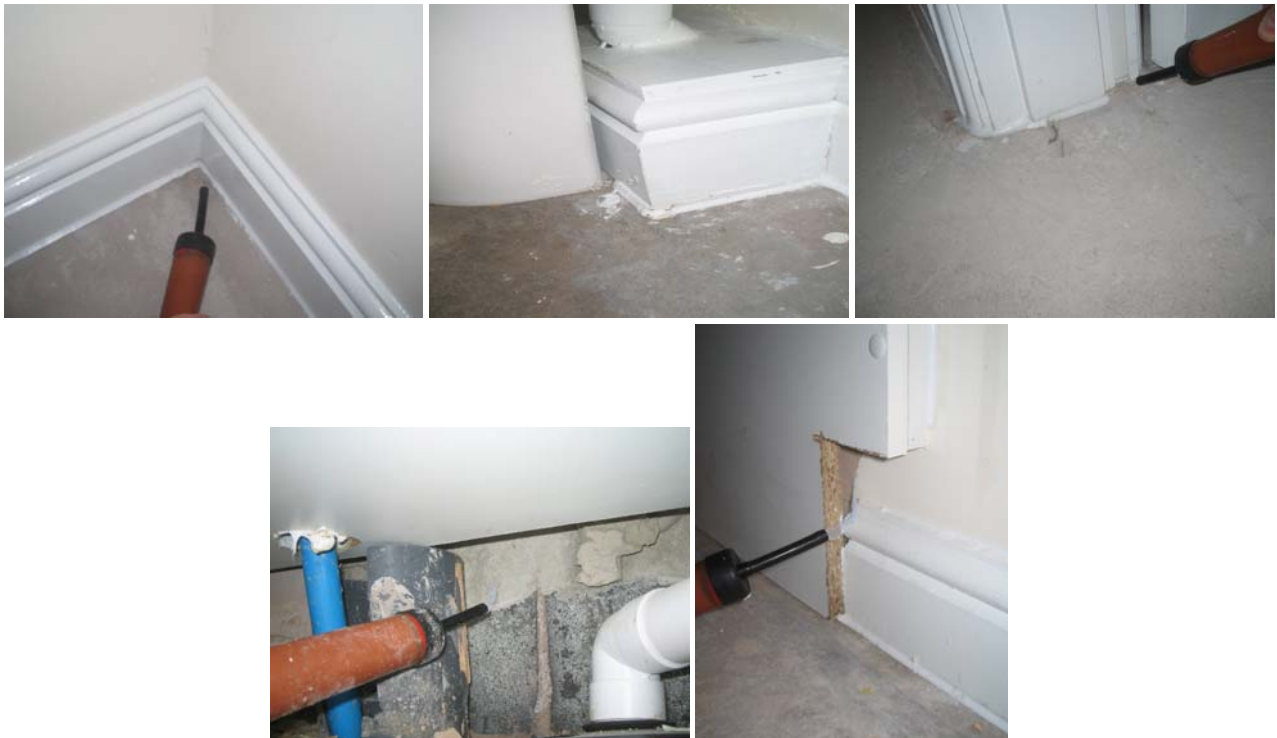
Figure 9.4 Minor air leakages at gaps in the sealant on the ground floor perimeter and at unfinished junctions in the utility room.

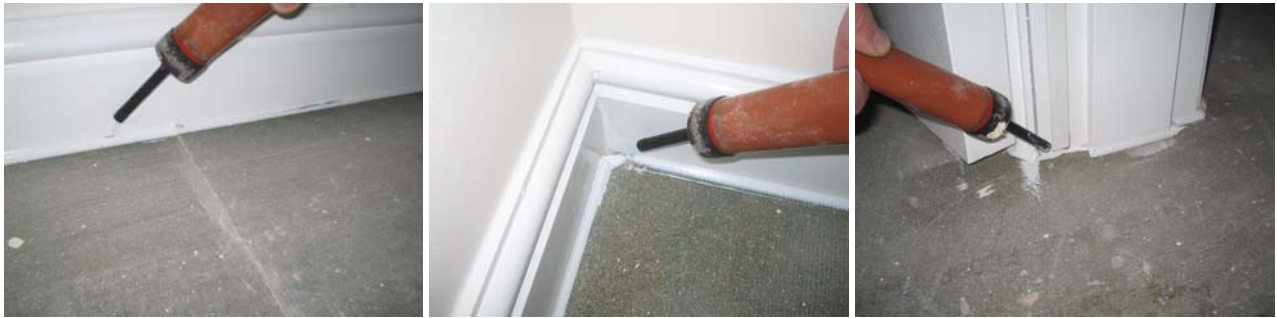
Figure 9.5 Air leakage was detected at gaps in the secondary sealing at the 1<sup>st</sup> floor bedroom perimeters and the door between the lounge and landing.

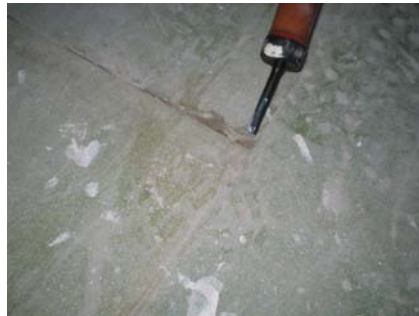
Figure 9.6 Air leakage through a gap in the 2<sup>nd</sup> intermediate floor in the front bedroom.

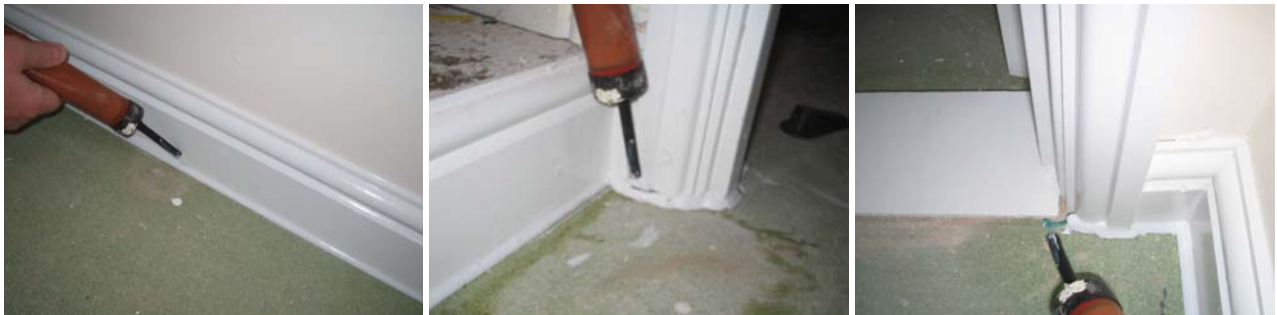
Figure 9.7 The 2<sup>nd</sup> floor/wall junctions performed very well apart from a few small gaps around the rear bedroom perimeter and in less visible areas, such as inside the cylinder cupboard and front bedroom built-in wardrobe.

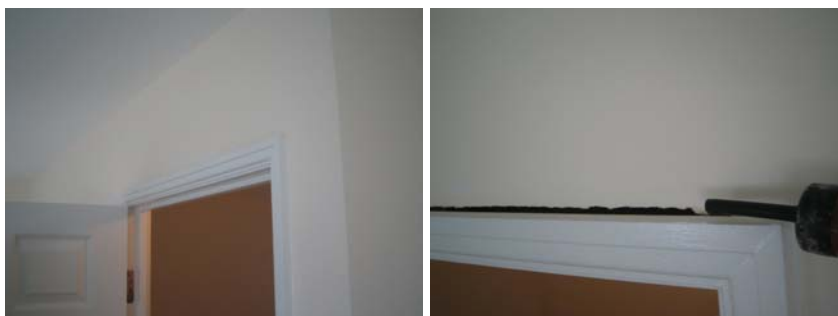
Figure 9.8 Air leakage was detected above a 2<sup>nd</sup> floor internal door frame in the rear bedroom, where the unsealed gap was hidden by the architrave.

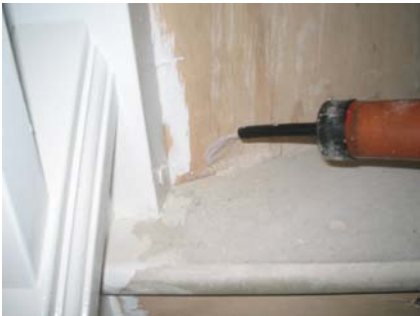
Figure 9.9 leakage at the stairs between the 1<sup>st</sup> and 2<sup>nd</sup> floors

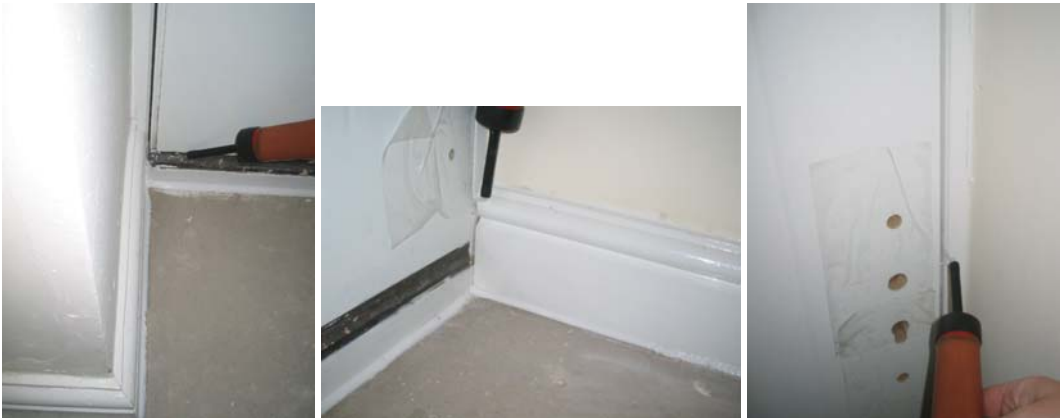
Figure 9.10 Air leakage around the back door

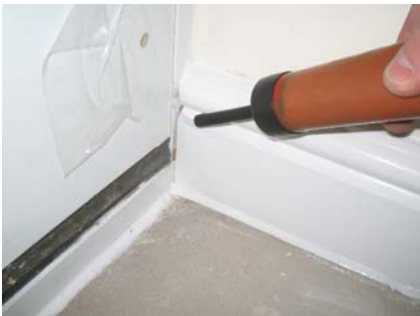
Figure 9.11 Air leakage around the back door threshold.

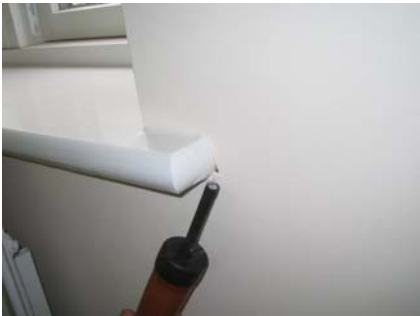
Figure 9.12 Very little air movement was detected around the windows, this small hole at the sill in the dining room was one of the few examples observed.

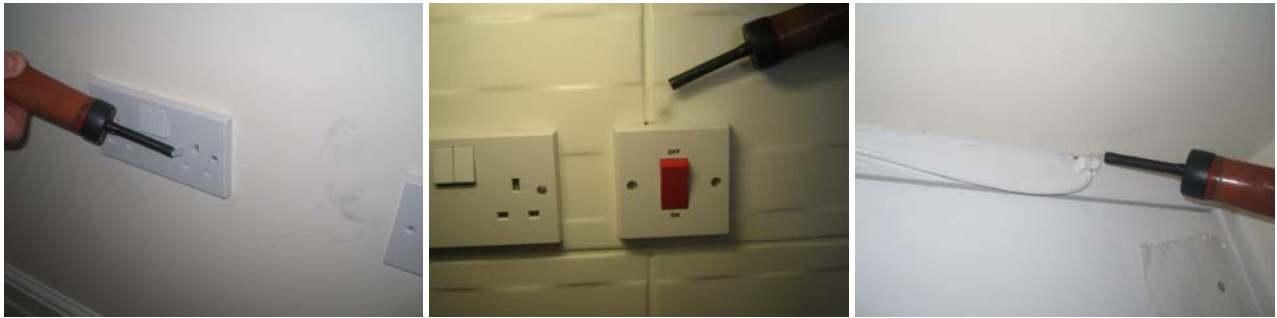
Figure 9.13 Air leakage through ground floor electrical penetrations in the dining room, kitchen and utility room.

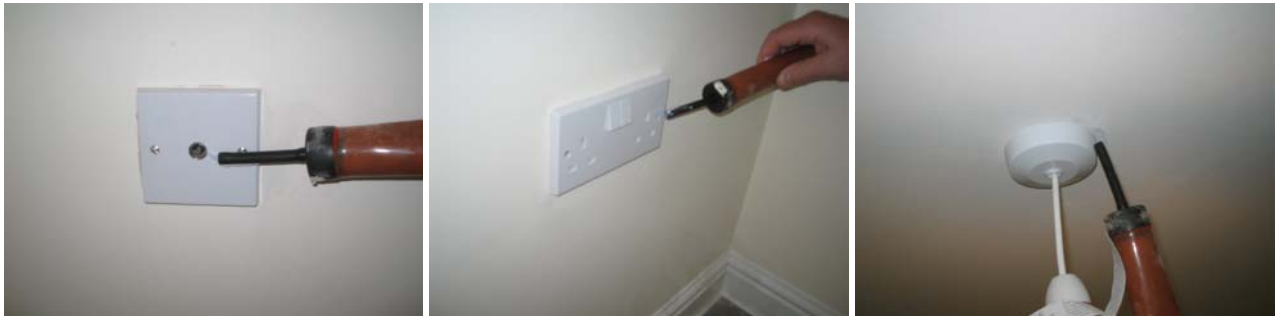
Figure 9.14 Air leakage at 1<sup>st</sup> floor electrical penetrations at a bedroom aerial socket and through a power socket and lighting rose in the lounge.

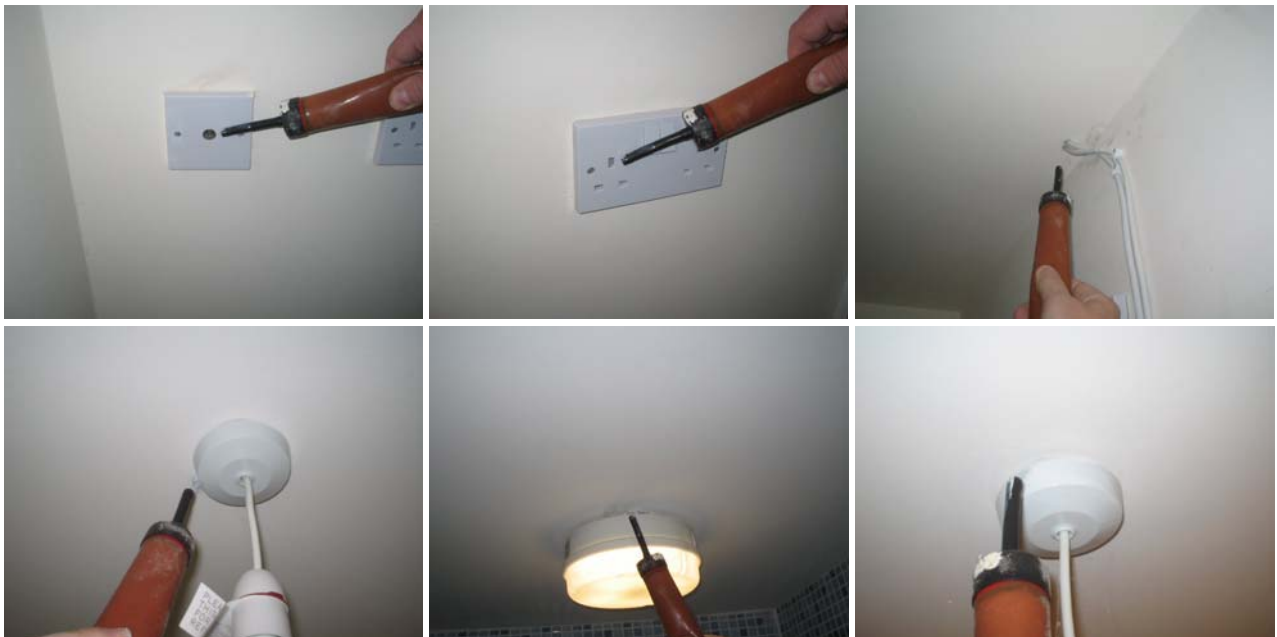
Figure 9.15 Air movement through 2<sup>nd</sup> floor electrical sockets in the front bedroom, and into the loft via cables in the cylinder cupboard and light fixings in the landing, en-suite and rear bedroom.

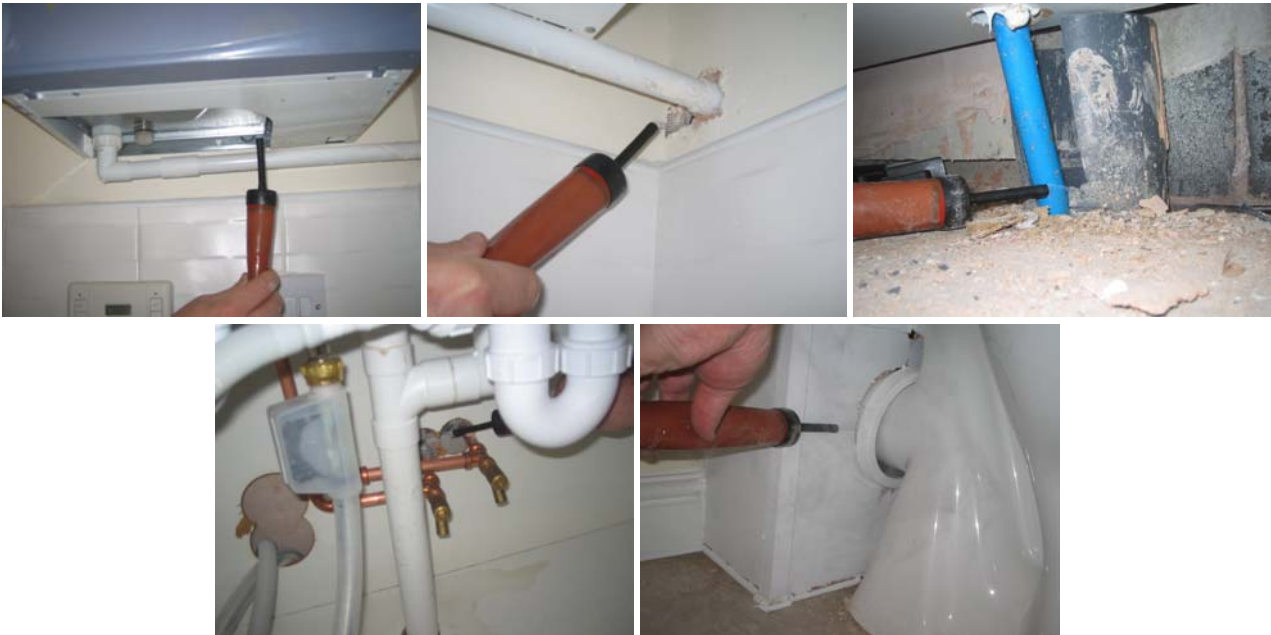
Figure 9.16 Air leakage around ground floor plumbing penetrations in the utility room, kitchen and WC.

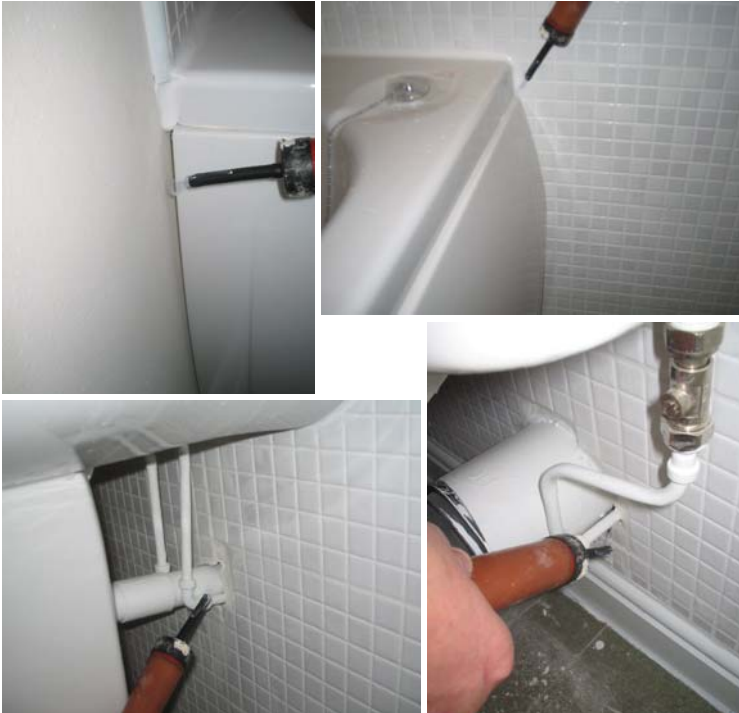
Figure 9.17 Air movement in the 1<sup>st</sup> floor bathroom was detected into the void under the bath and around plumbing penetrations into the service void.

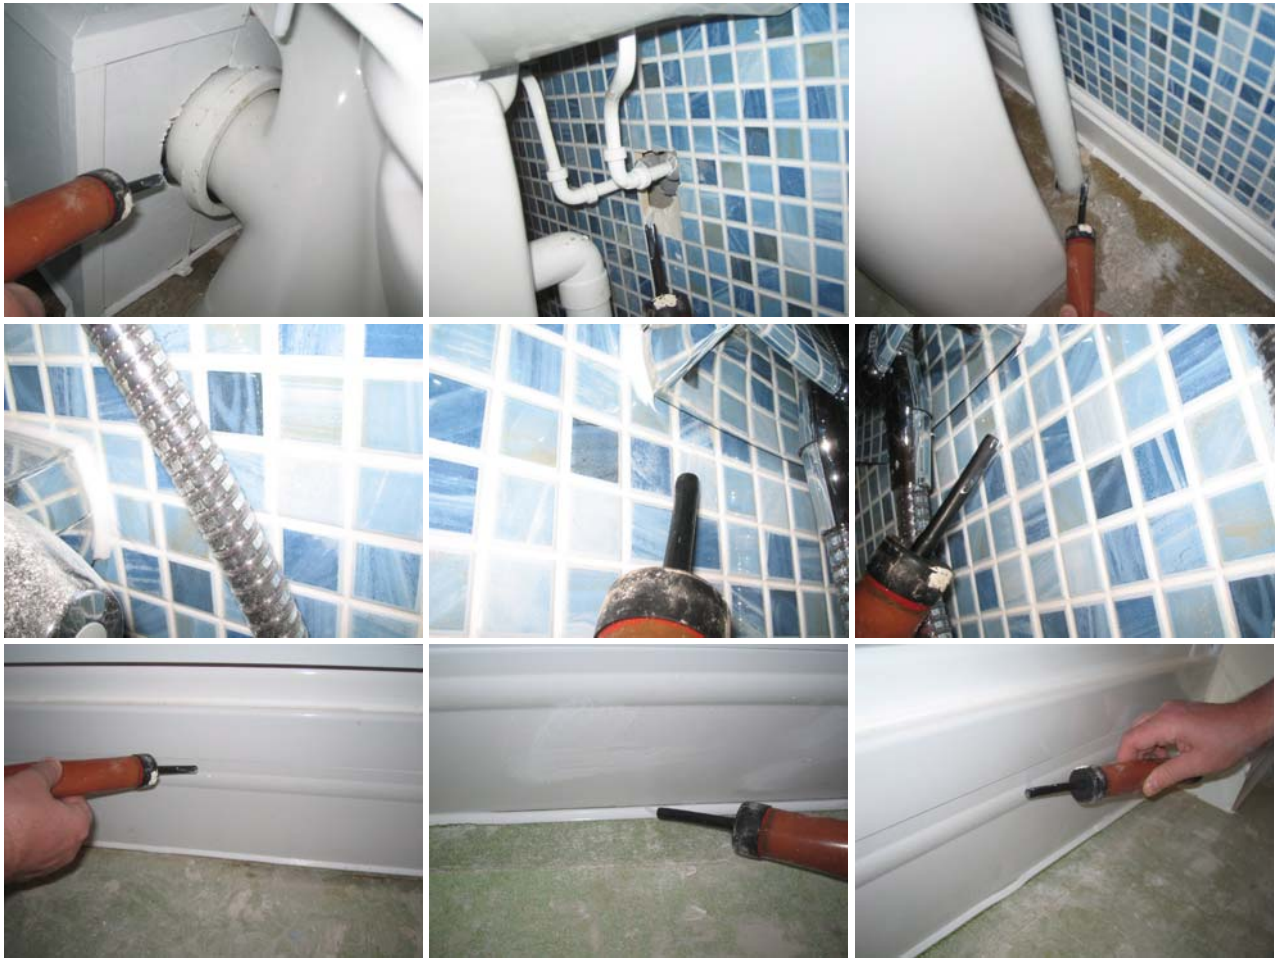
Figure 9.18 Air leakage around 2<sup>nd</sup> floor plumbing penetrations in both en-suite bathrooms, with no sealant applied to the underside of the shower control unit. Air leakage around the shower tray fascia panels was far less than expected due to capably applied sealant.

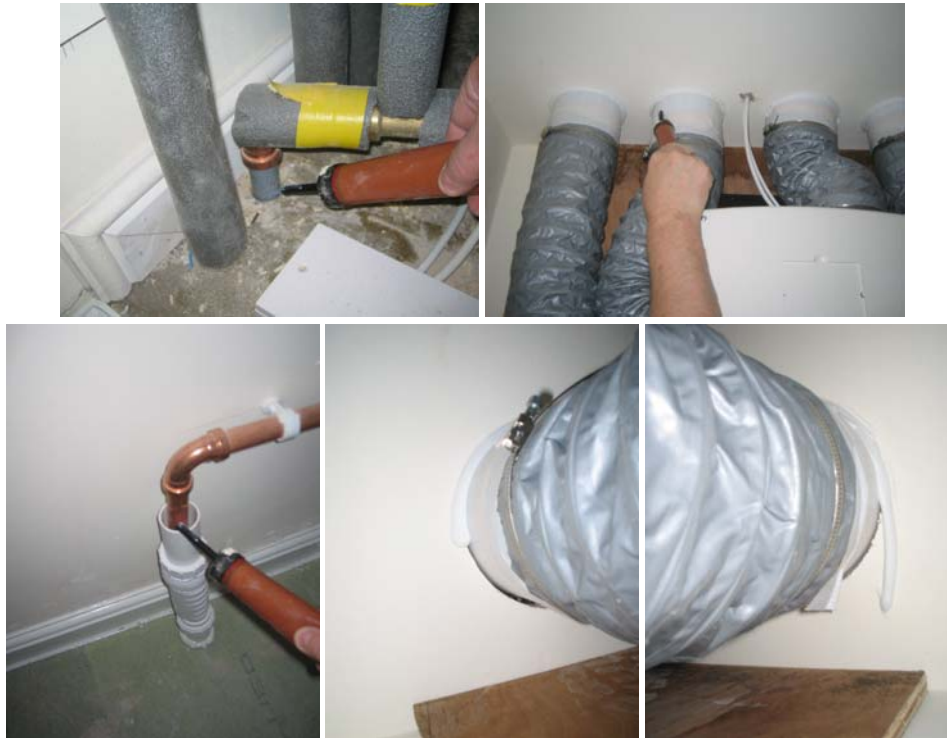
Figure 9.19 Air leakage around penetrations into the cylinder cupboard floor and ceiling, and photographs showing where the sealant was not applied comprehensively.

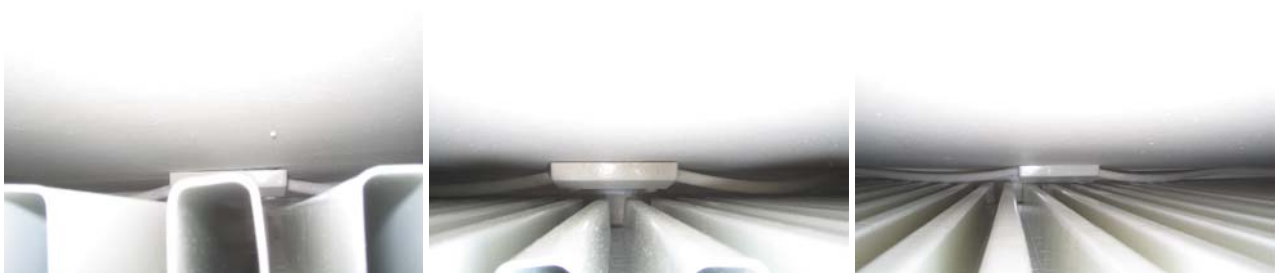
Figure 9.20 At all radiator pipework some air leakage was observed, with no apparent patterns between rate of leakage and position of radiator.

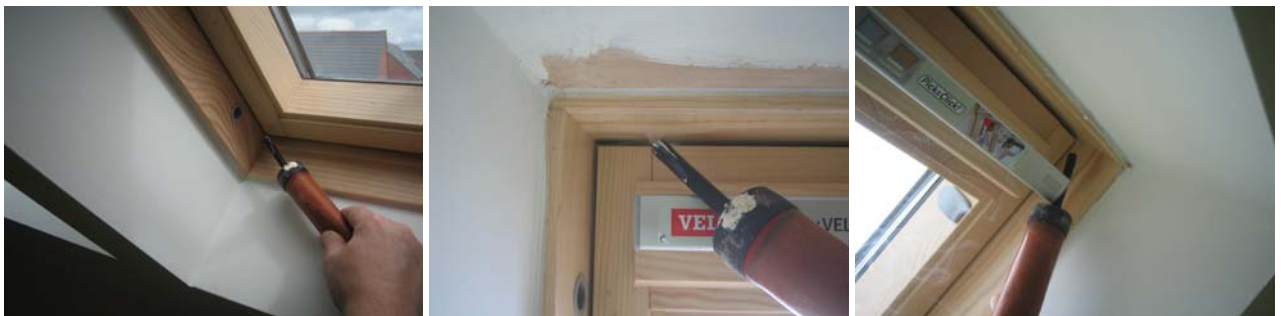
Figure 9.21 All 3 rooflights allowed some direct infiltration.

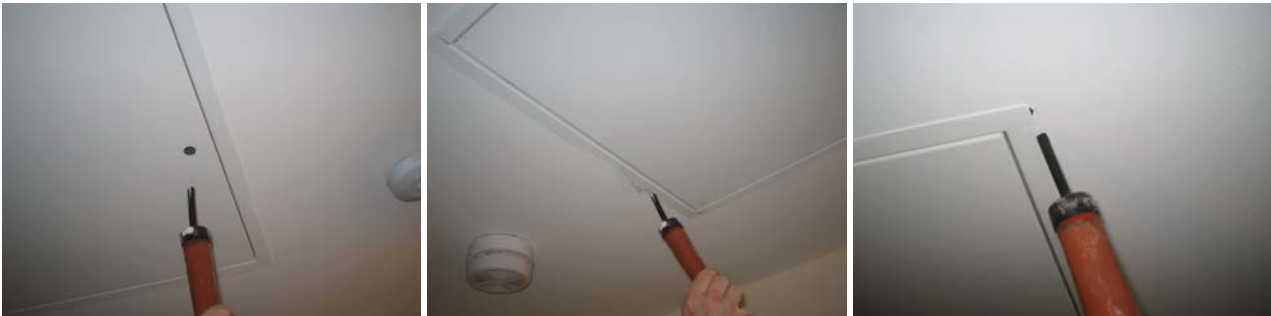
Figure 9.22 Air movement directly into the roof space through and around the loft hatch.

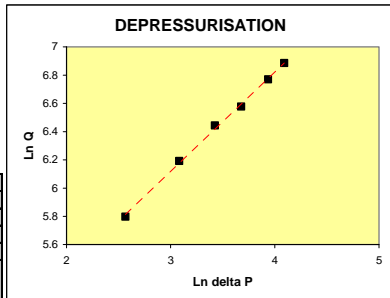
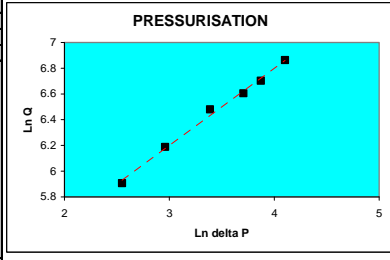
wind speed (m/s):	2.6		
baseline pressure diff (Pa) (+/-)	Pa		
house width:	5.18 m		
house depth:	9.31 m		
house height:	7.29 m		
floor area:	48.2 m2		
volume:	343.4 m3		
envelope area including floor:	297.5 m2		
Pressure Difference for ELA	10 Pa

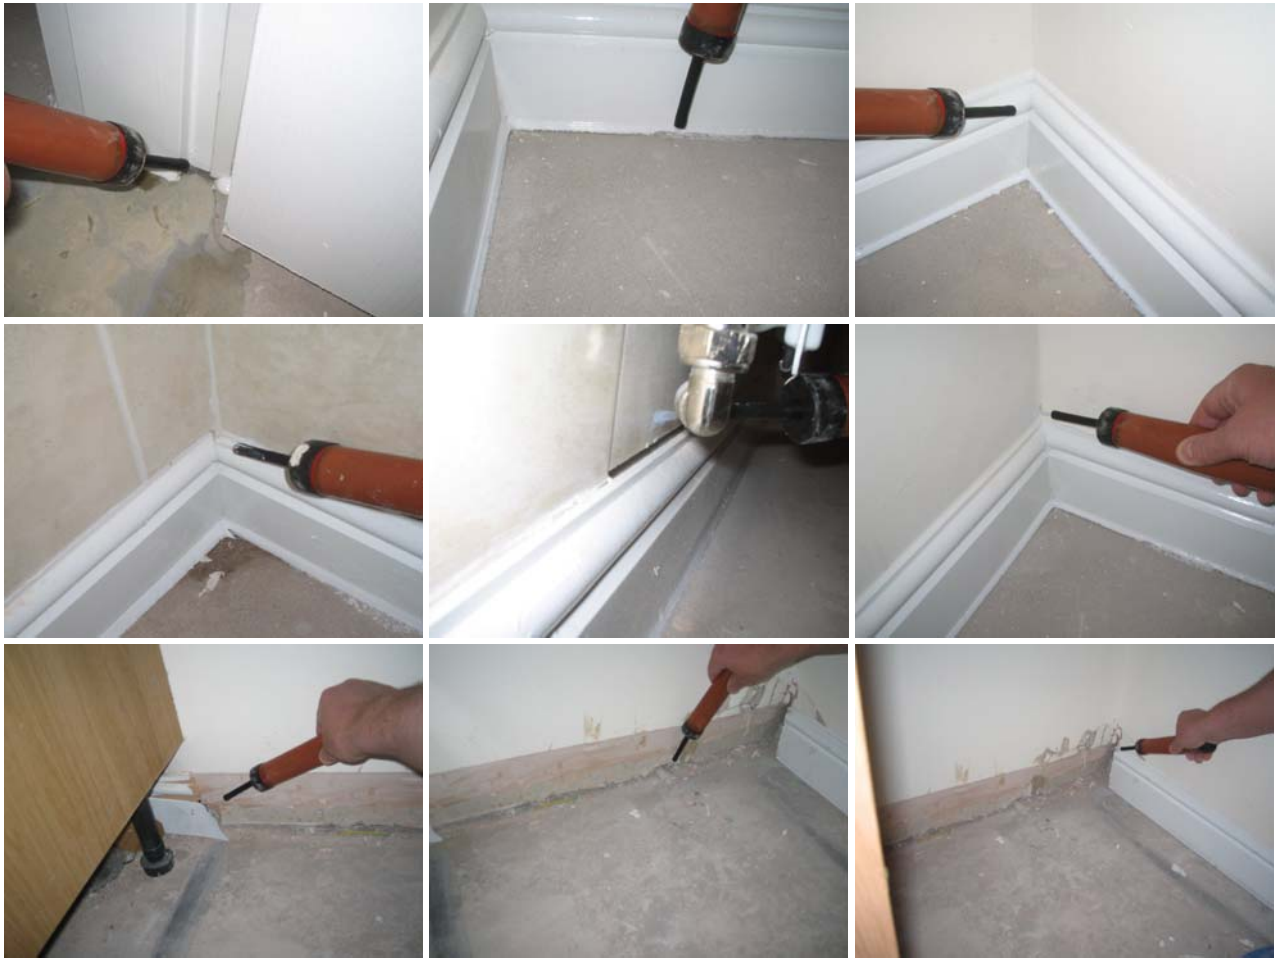
Figure 10.3 Air leakage at a doorframe and under the skirting in the dining room, and at junctions and over the skirting in the kitchen, WC and dining room. More significant leakage at the unfinished floor/wall junction in the utility room.

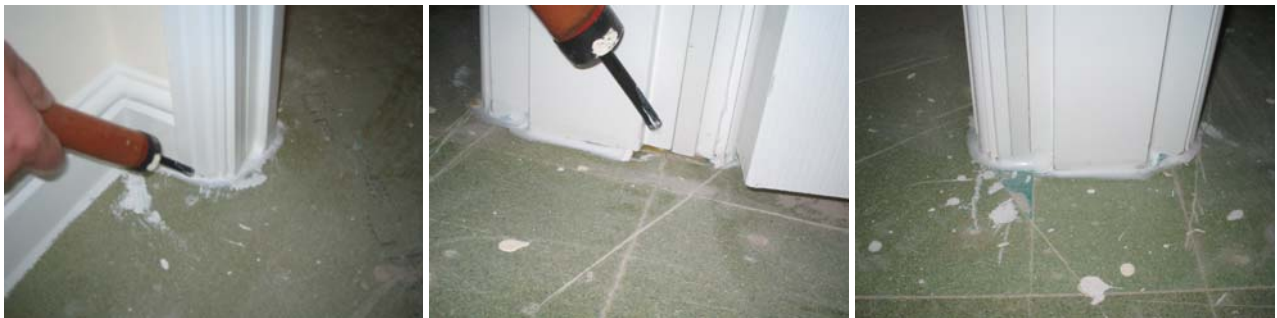
Figure 10.4 Air leakage at the frame/floor junctions on the 1<sup>st</sup> floor off the landing; at the bathroom and at either side of the lounge door with one side allowing air movement and the other side impeccably sealed.

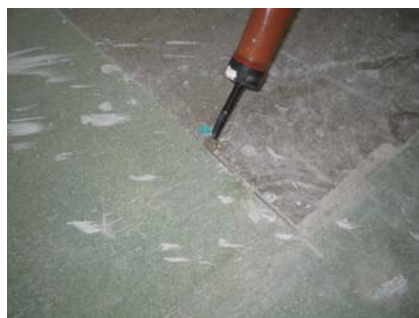
Figure 10.5 Air movement into the 1<sup>st</sup> floor void through gaps around repairs to the floor in the lounge.

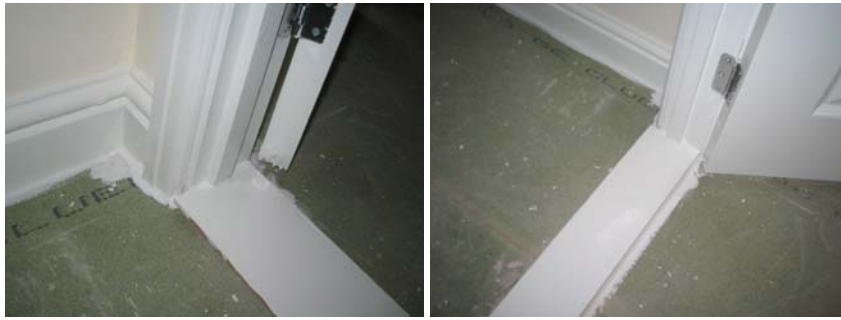
Figure 10.6 No air leakage was detected around the floor perimeters in the 2<sup>nd</sup> floor bedrooms due to the well applied sealant, even in the less visible areas such as the built-in wardrobe.

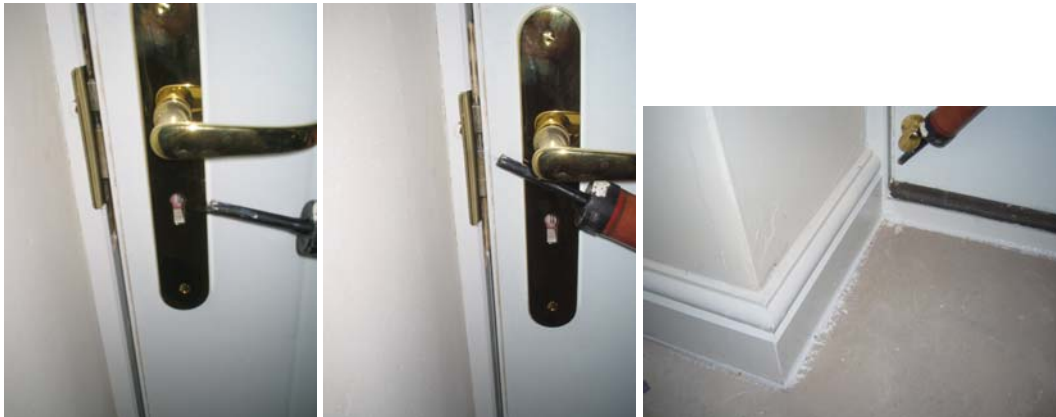
Figure 10.7 With no key drop fitted air leakage occurred through the keyhole of the back door, also air movement was detected between the door and frame where the locks were situated.

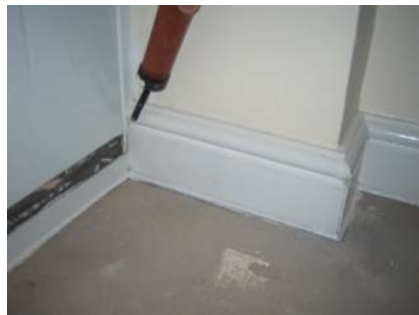
Figure 10.8 At the rear door threshold leakage was detected only at the frame/skirting board junction.

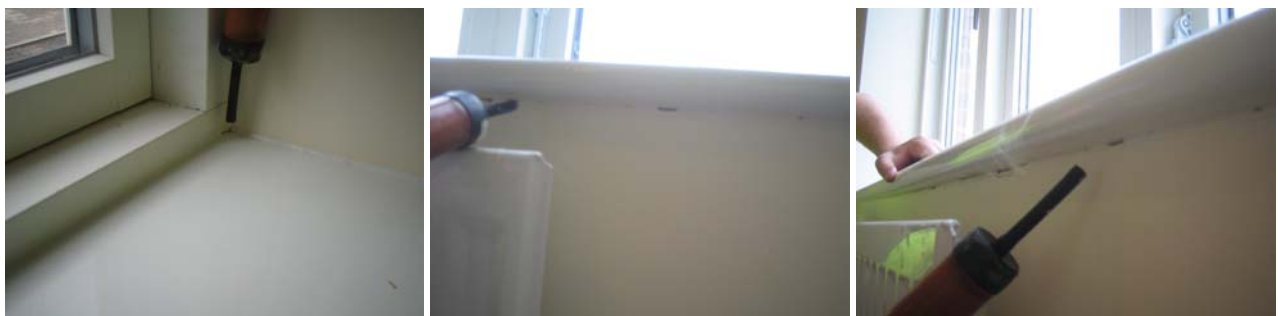
Figure 10.9 Air leakage detected around the window sills in the dining room and kitchen.

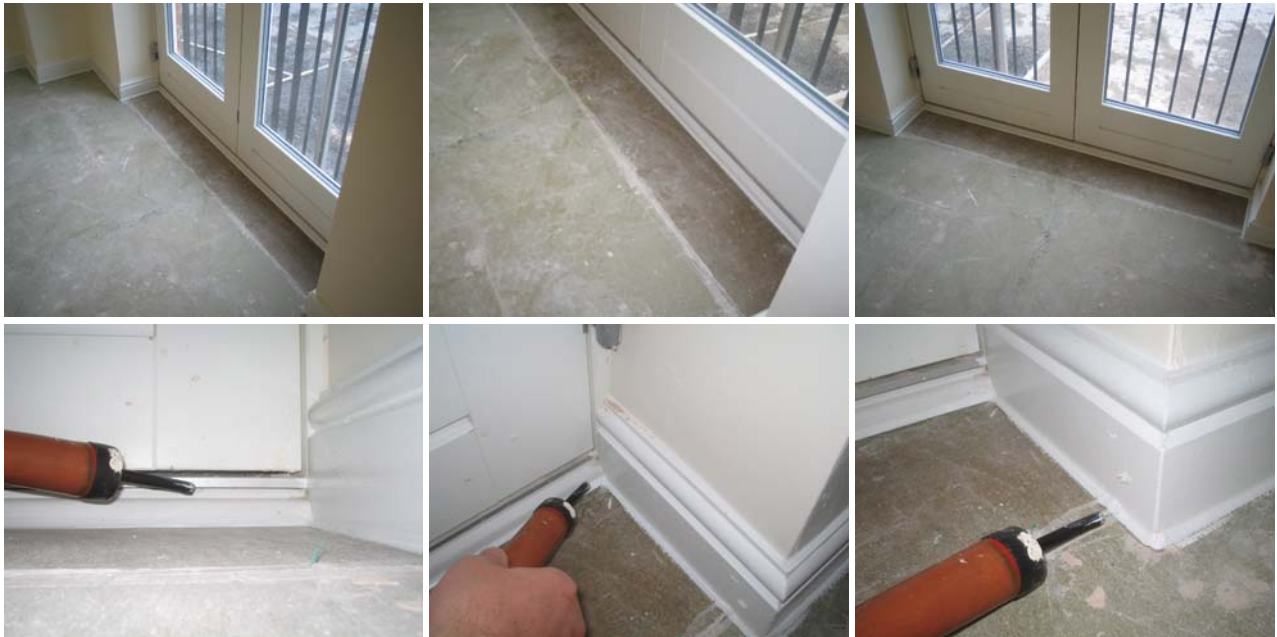
Figure 10.10 The 1<sup>st</sup> floor balcony doors had been sealed well, with only a small amount of air leakage detected at the threshold and around the skirting board at the return.

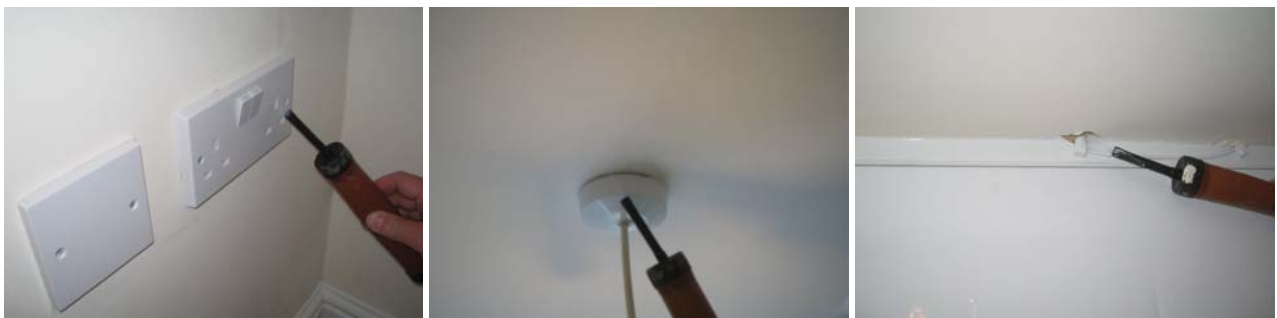
Figure 10.11 Air leakage around ground floor electrical penetrations in the dining room, kitchen and utility room.

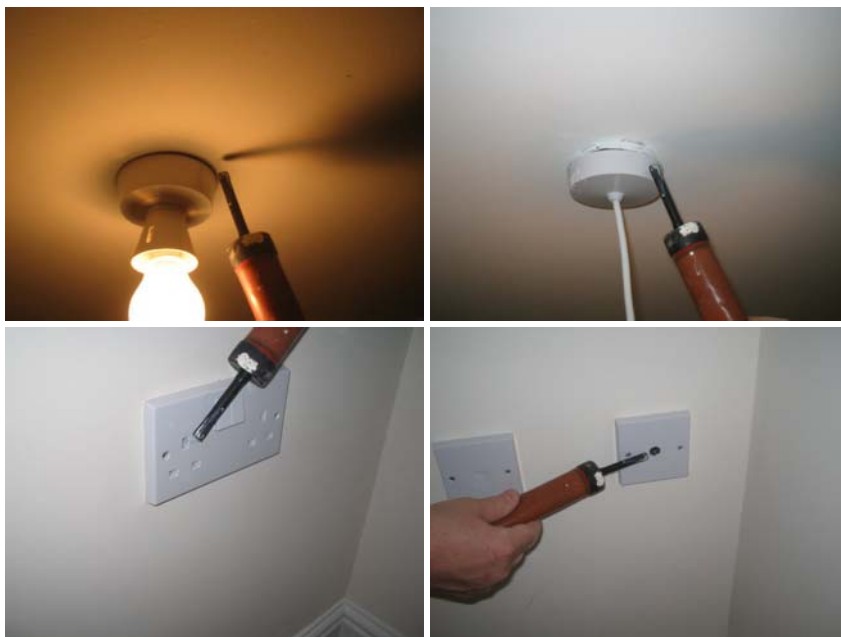
Figure 10.12 Air leakage into the intermediate floor void around central light fittings in the bathroom and a bedroom, and through wall penetrations in a bedroom and the lounge.

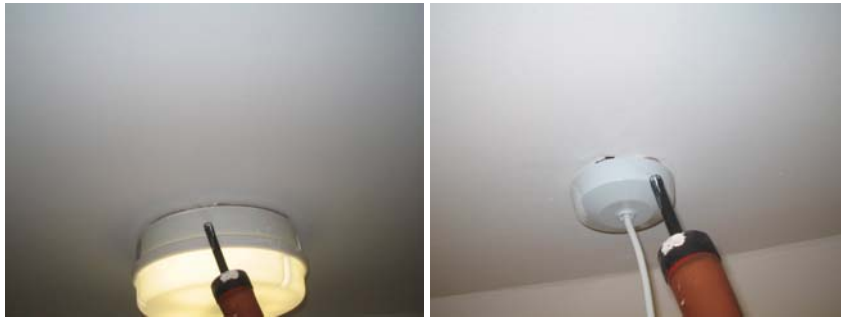
Figure 10.13 Direct air leakage into the loft space around light fittings in an en-suite and the rear bedroom.

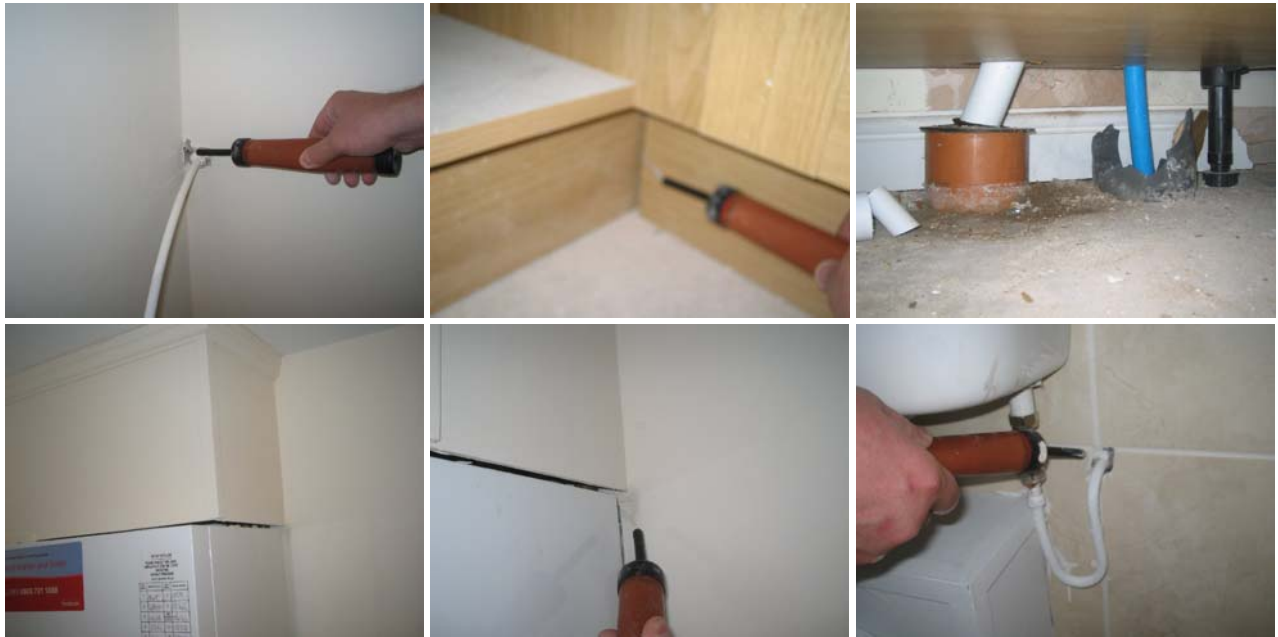
Figure 10.14 On the ground floor around plumbing penetrations in the kitchen (around the water supply for the fridge/freezer and under the units), in the utility room (around the boiler and under the units), and in the downstairs WC.

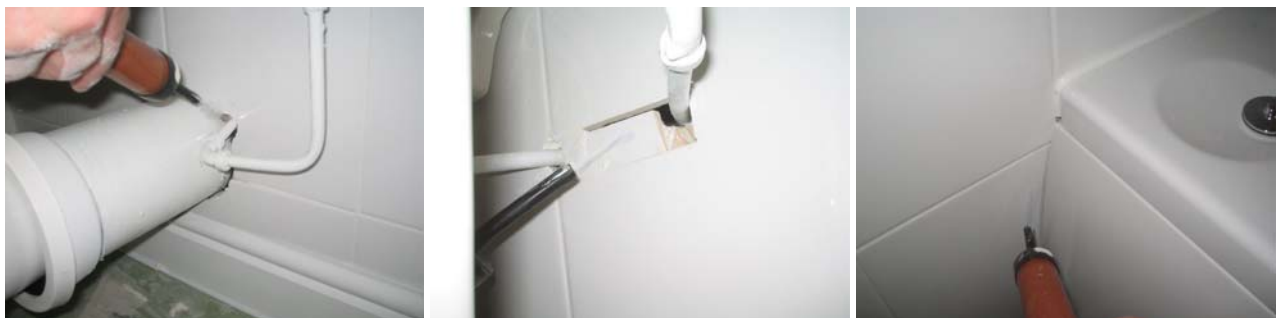
Figure 10.15 Air leakage was detected into the service void in the 1<sup>st</sup> floor bathroom around plumbing penetrations for the toilet and basin water supplies and also around the bath panel.

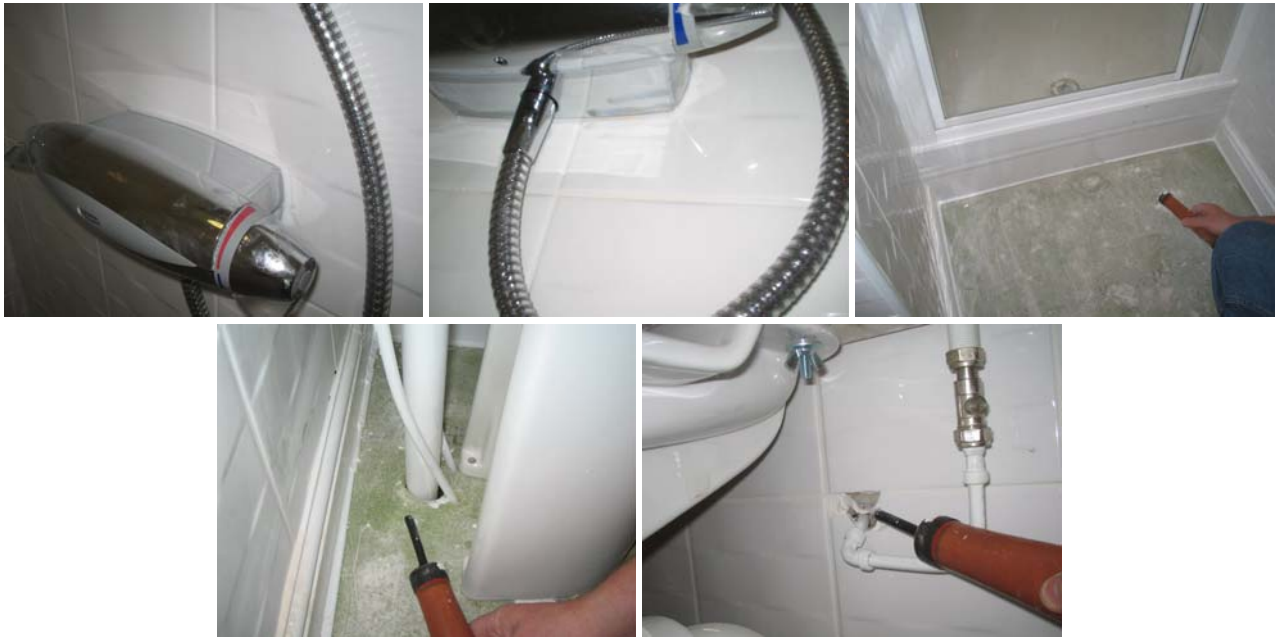
Figure 10.16 On the 2<sup>nd</sup> floor the en-suite off the front bedroom had all plumbing penetrations sealed around very well except the shower control unit and air leakage was also detected between the shower tray and fascia panel; in the en-suite off the rear bedroom air leakage was observed around most floor and wall penetrations as they had not yet been sealed.

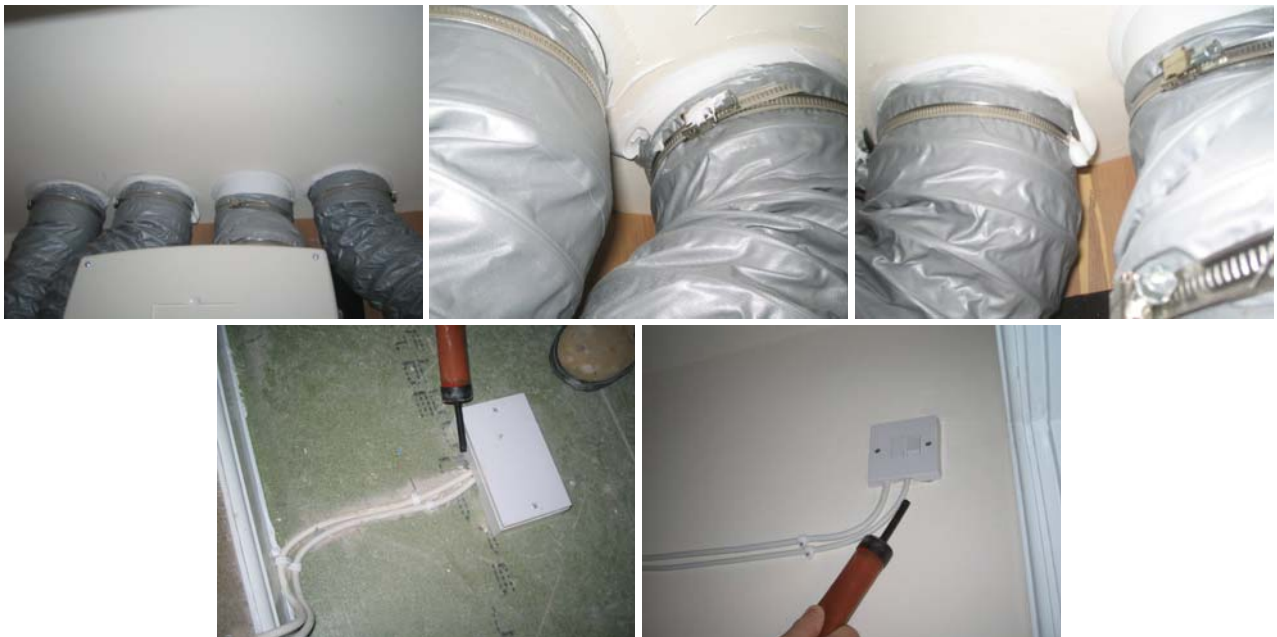
Figure 10.17 In the cylinder cupboard air leakage directly into the loft around the ventilation ducting was reduced from that observed in plot B119, but still detectable. Air movement through electrical penetrations in both the floor and wall was appreciably larger than in plot B119.

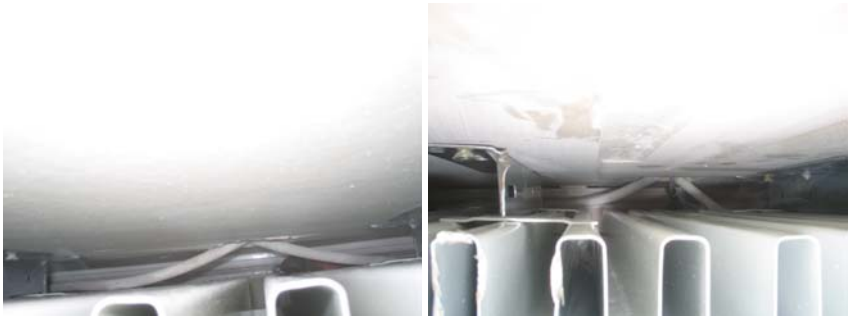
Figure 10.18 Behind the radiators air movement into the walls, around the pipework, was normal, examples shown are from the a first floor bedroom on an external wall and from the ground floor WC on a masonry internal wall.

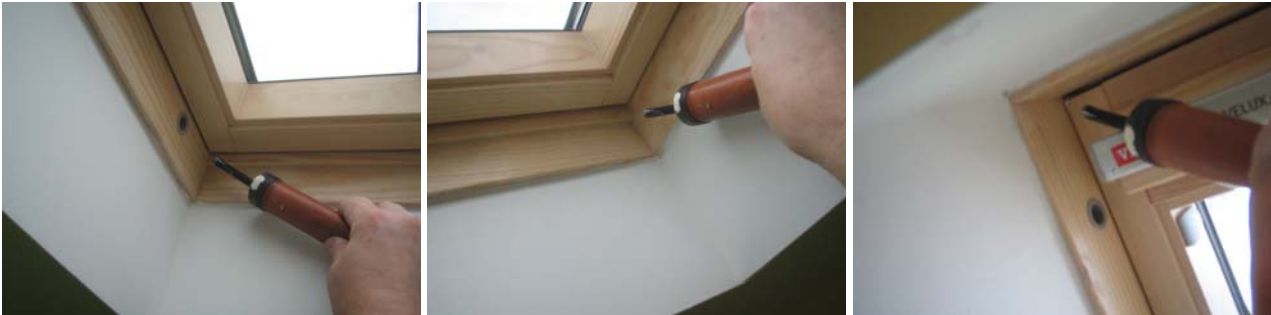
Figure 10.19 Air leakage through the rooflights in the 2<sup>nd</sup> floor rear bedroom.

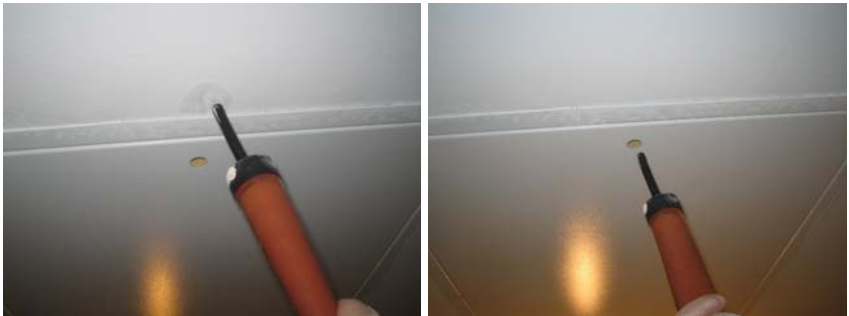
Figure 10.20 Direct air leakage into the loft around and through the loft hatch.

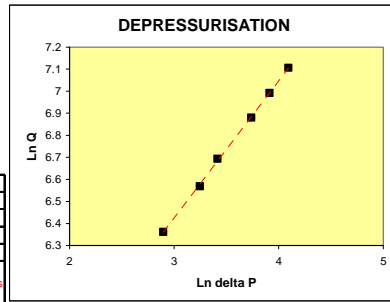
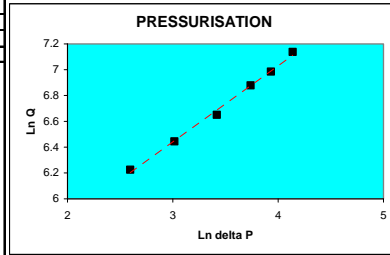
baseline pressure diff (Pa) (+/-)	Pa		
house width:	5.18		
house depth:	9.31		
house height:	7.29		
floor area:	48.2		
volume:	343.4		
envelope area including floor:	297.5		
Pressure Difference for ELA	10

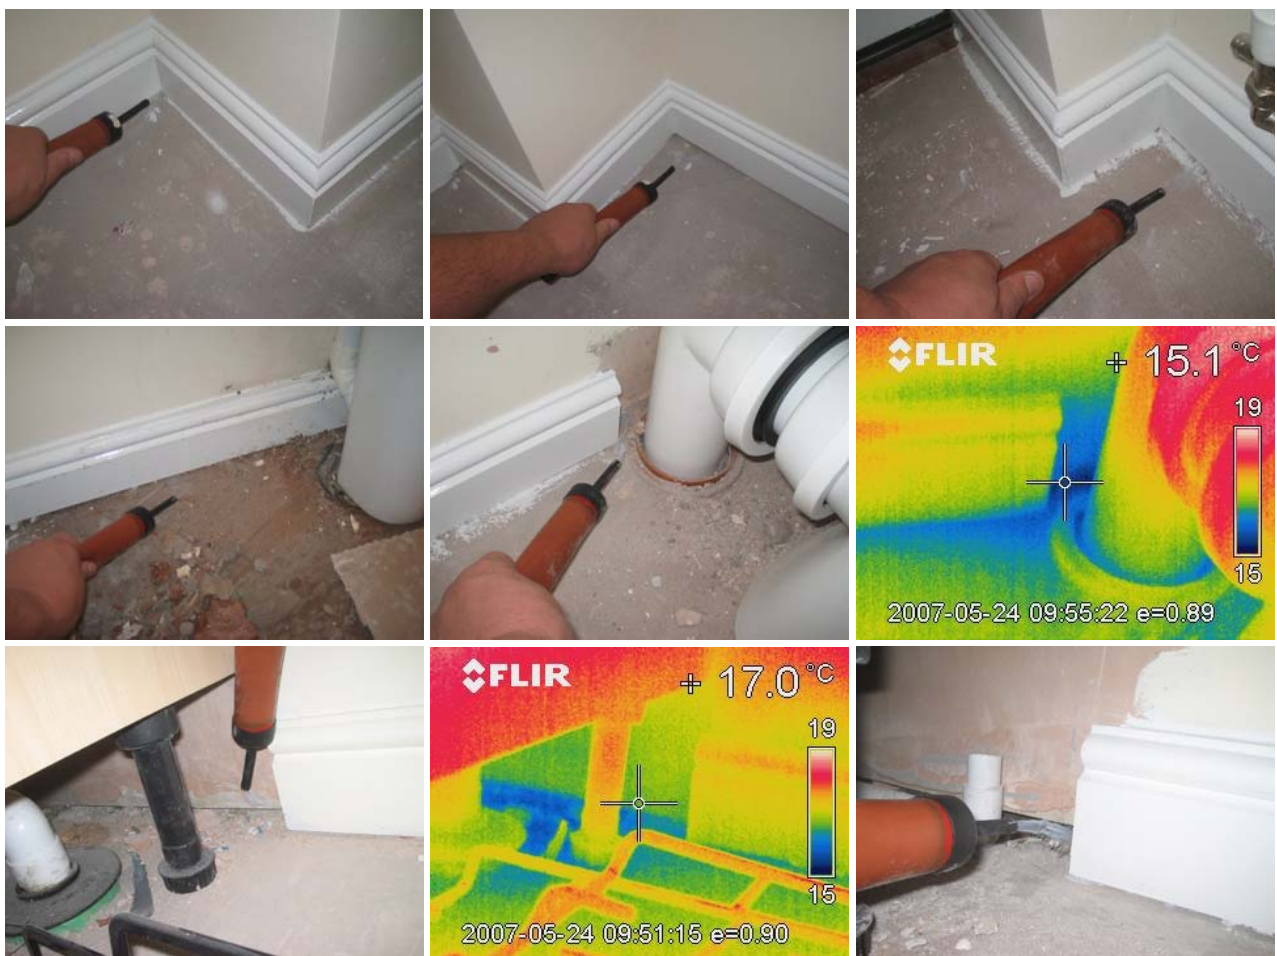
Figure 11.3 Air leakage at wall/floor junctions on the ground floor, under the skirting in the dining room and utility room, in the downstairs WC, and in hidden areas behind units in the kitchen and utility.

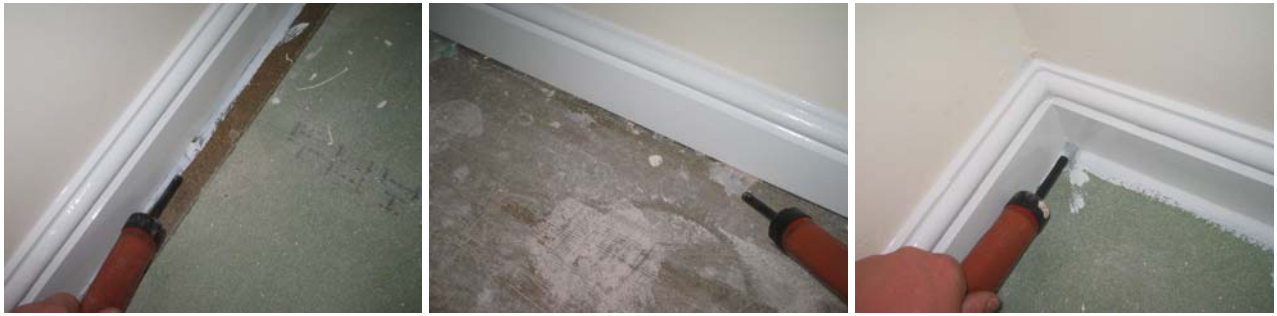
Figure 11.4 Air leakage at the unsealed wall/floor junctions on the 1<sup>st</sup> floor; along and internal wall, the separating wall and the corner of 2 external walls.
