## **List of Appendices**

## Appendix 1: Pressurisation Test of Bryant Plot 116

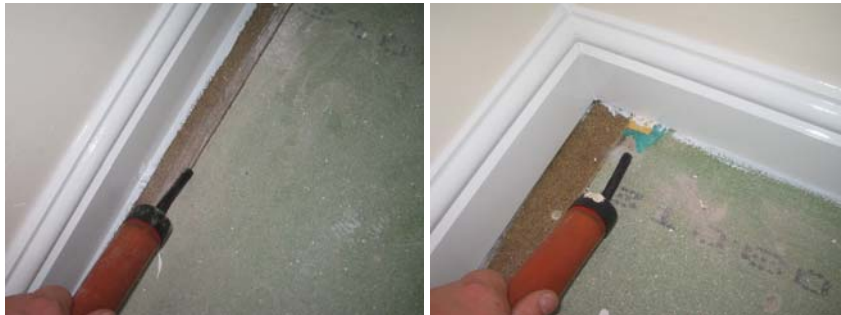
Figure 11.5 Air movement into the 1<sup>st</sup> floor void through gaps in the flooring panels.

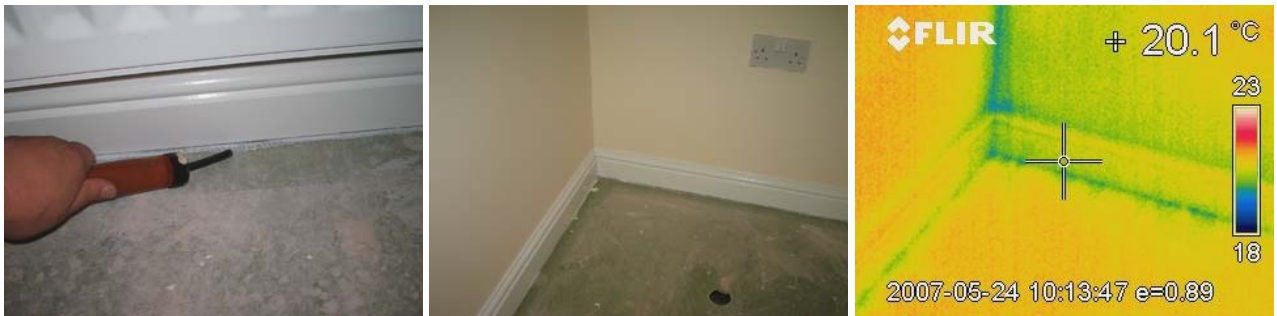
Figure 11.6 Infiltration detected at wall/floor junctions in the 2<sup>nd</sup> floor front bedroom on the external wall and adjacent party wall.

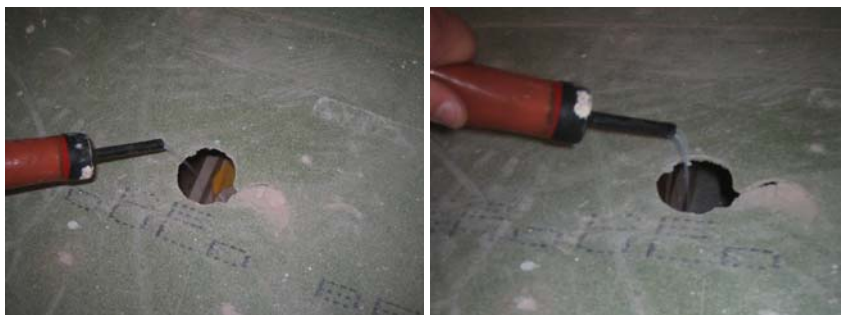
Figure 11.7 A hole in the 2<sup>nd</sup> floor in the lounge allowing air to enter the floor void.

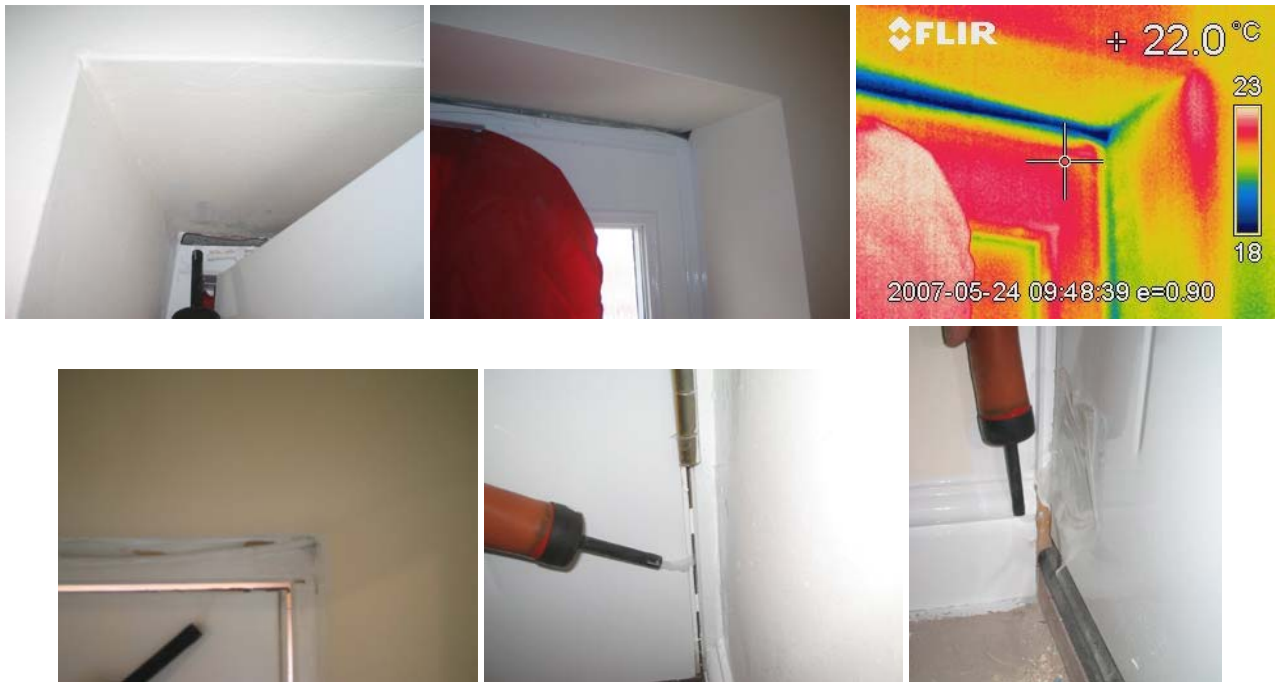
Figure 11.8 Air leakage at the unfinished head of the front door and at the back door, where the draughtstripping was not yet installed and at the threshold.

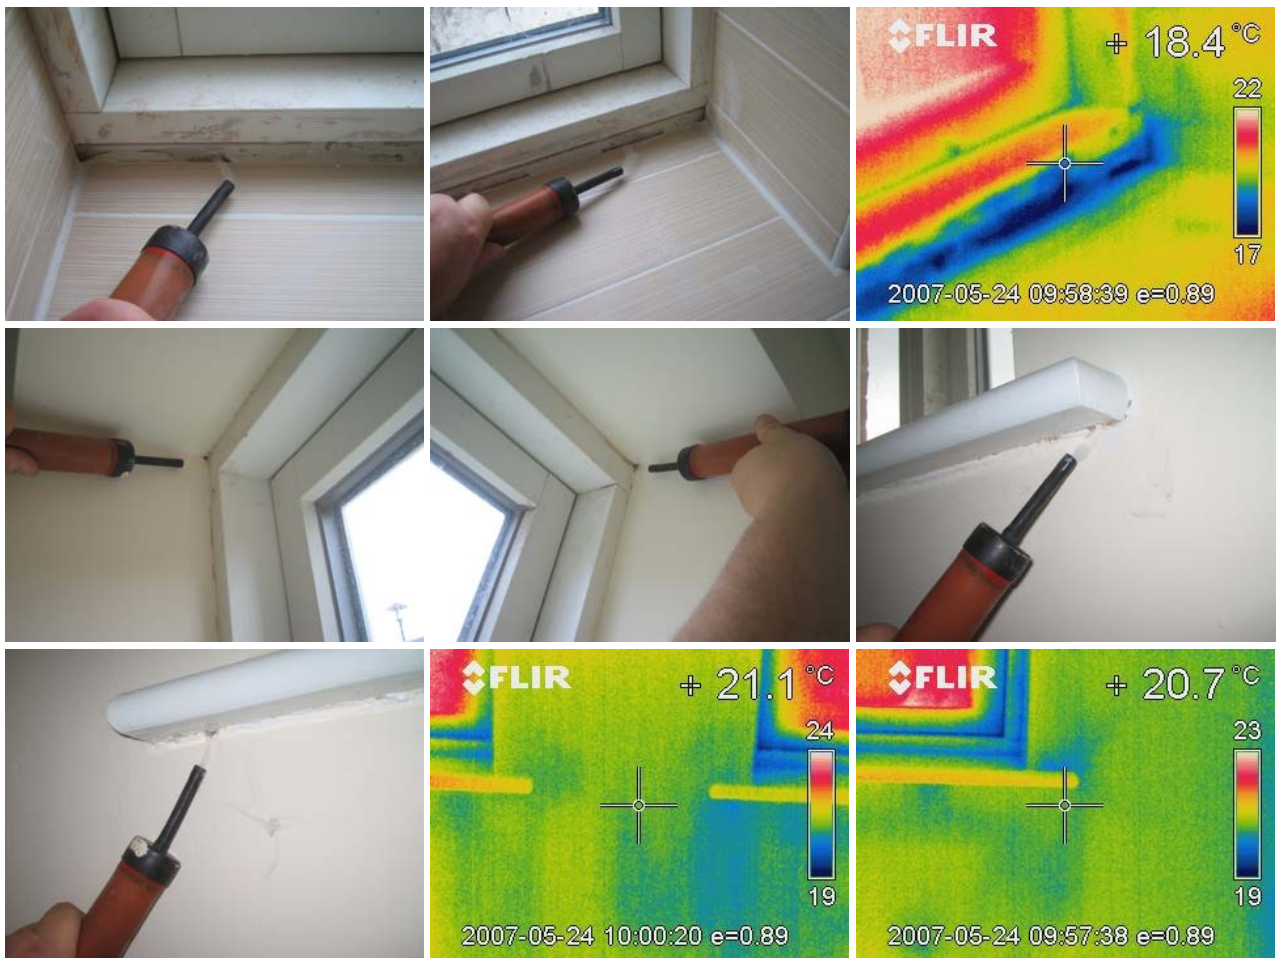
Figure 11.9 Air leakage through unfinished gaps at the 1<sup>st</sup> floor bathroom window sill, around the kitchen window frame and beneath window sills on the 1<sup>st</sup> and 2<sup>nd</sup> floor. IR images show cooler air entering the void behind the plasterboard dry-lining from around the window sills under dwelling depressurisation.

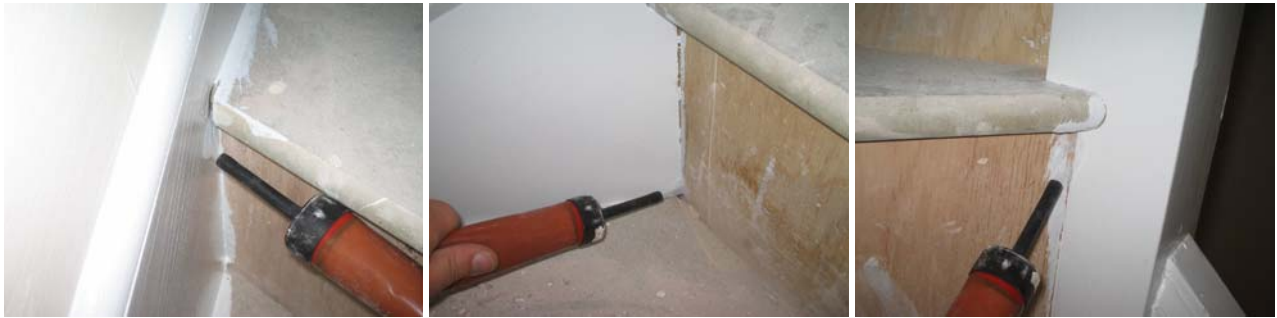
Figure 11.10 Air movement through gaps in the staircase between the 1<sup>st</sup> and 2<sup>nd</sup> floors.

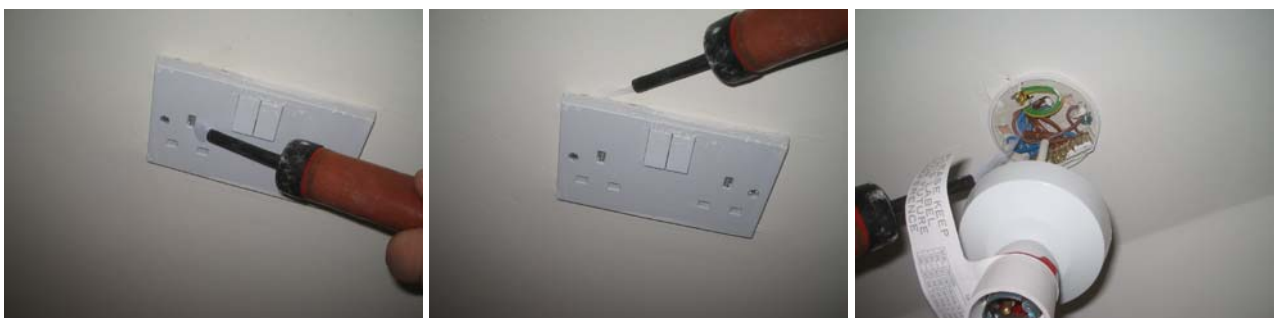
Figure 11.13 Indirect air leakage into walls and direct leakage into the loft space around electrical penetrations on the 2<sup>nd</sup> floor,

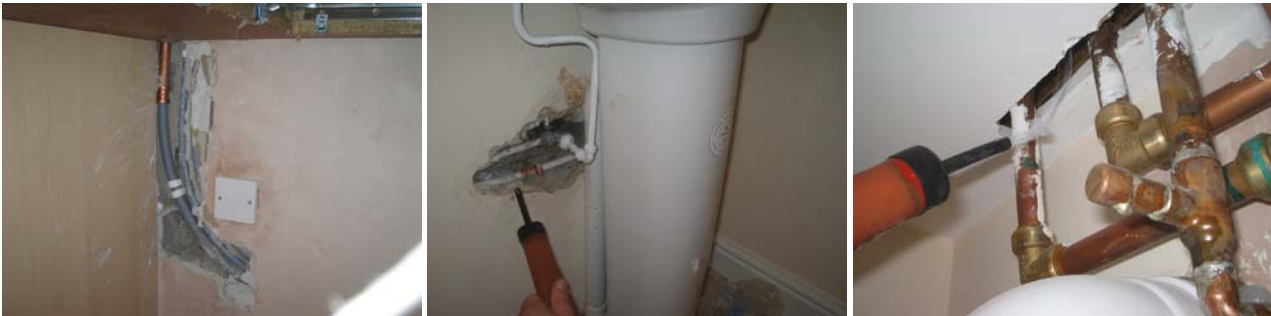
Figure 11.14 Unfinished plumbing penetrations on the ground floor.

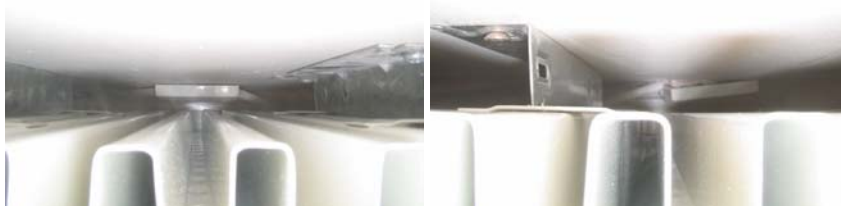
Figure 11.18 Leakage was detected around the radiator pipework behind the radiators, which appeared most severe on internal partition walls.

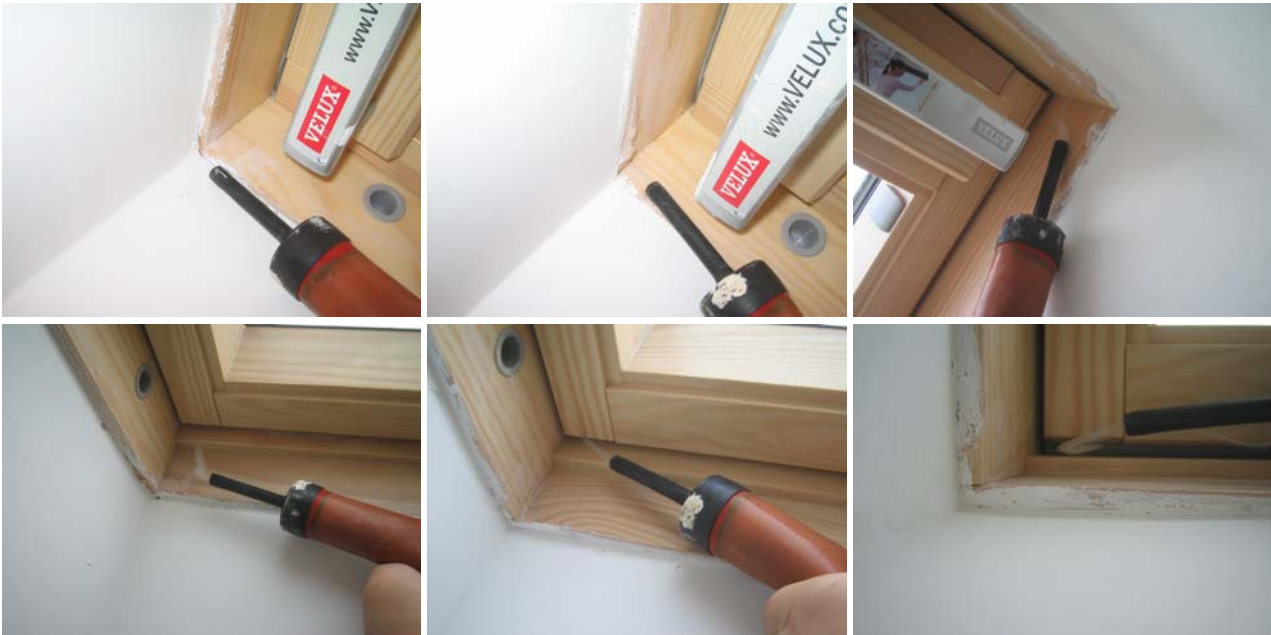
Figure 11.19 All 3 of the rooflights in the 2<sup>nd</sup> floor rear bedroom displayed some degree of air leakage.

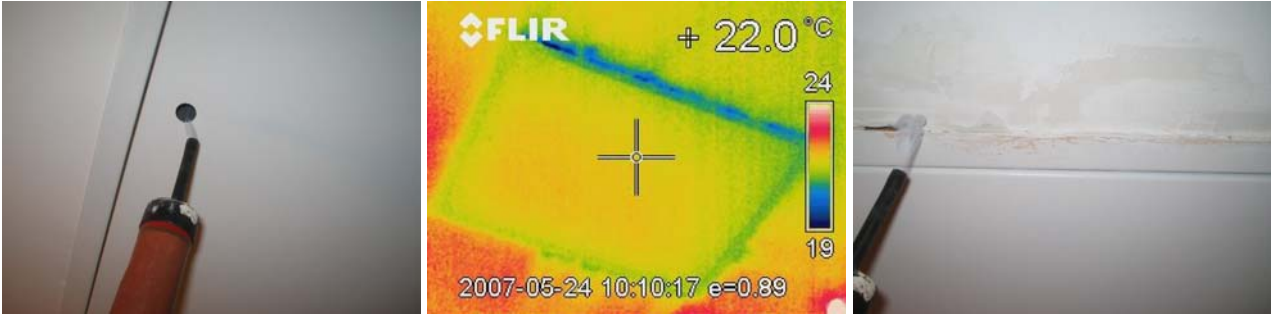
Figure 11.20 Infiltration at the loft hatch was detected through the loft hatch keyhole and around the frame.

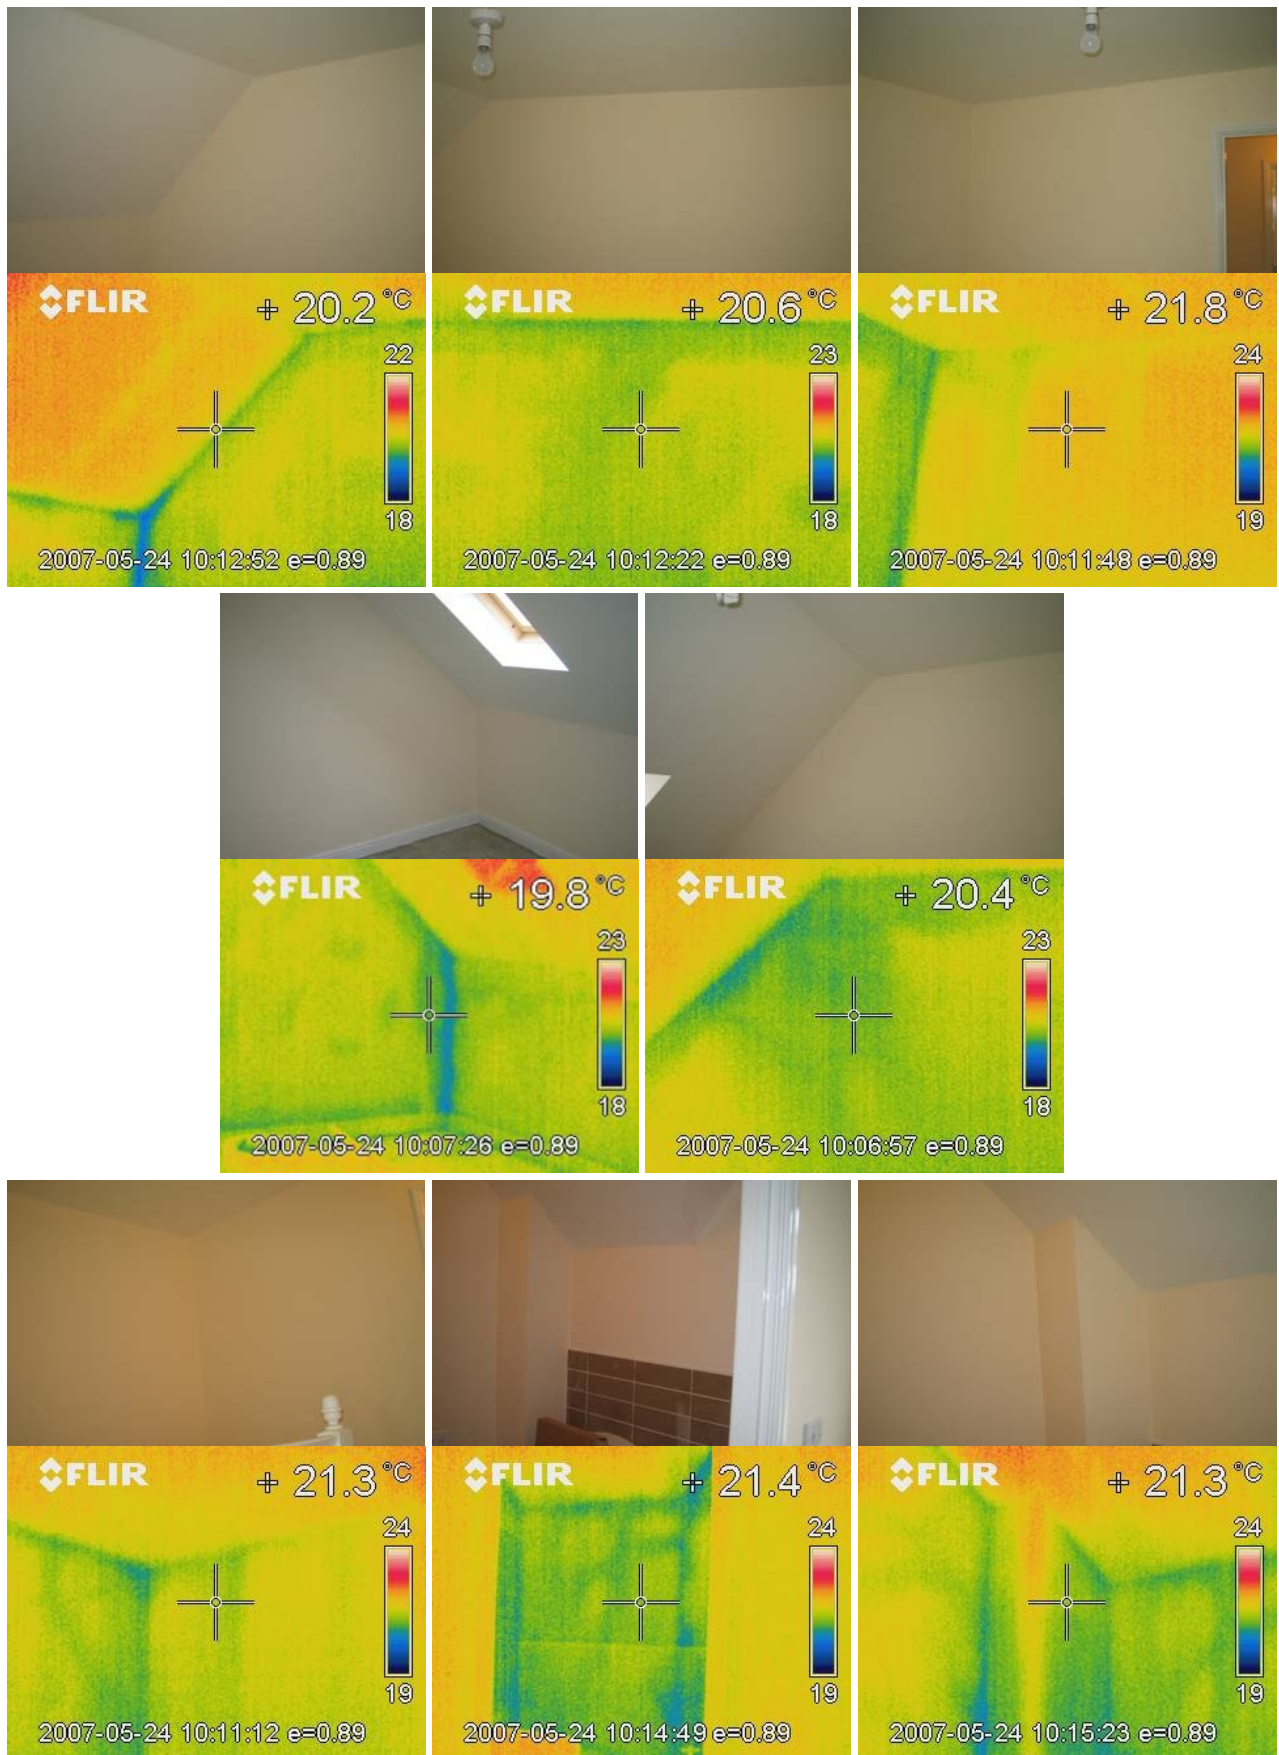
Figure 11.21 Thermal imaging of the dry-lining at the left boundary on the 2<sup>nd</sup> floor; along the party wall in the front bedroom, around the sloping roof section in the rear bedroom, at the party/internal wall junction on the landing and in the front en-suite bathroom.

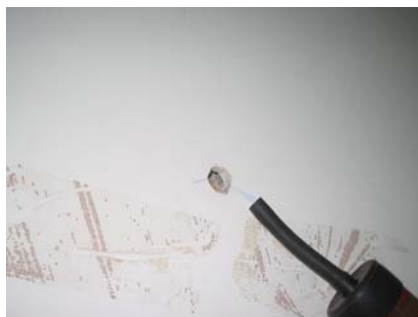
Figure 12.2 Air leakage into the void behind the plasterboard on the party wall, under dwelling pressurisation, through a hole drilled for placement of the thermocouples during the coheating test.

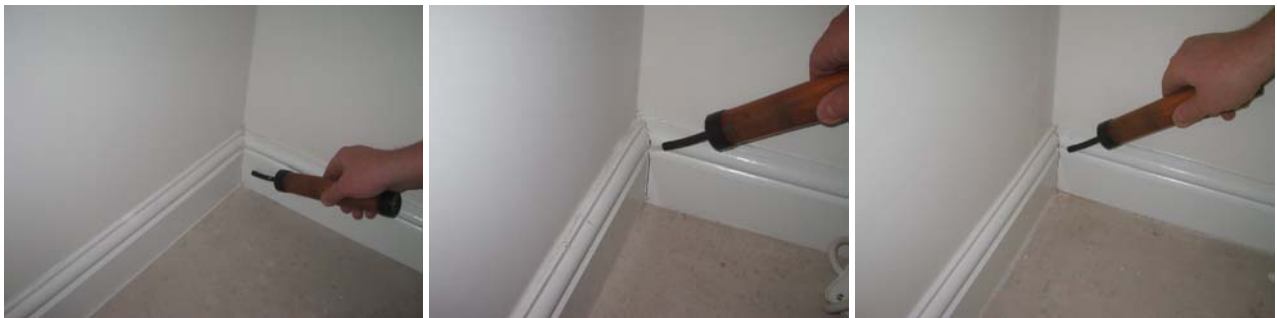
Figure 12.3 Air leakage at the ground floor skirting board junctions appeared more severe than when tested prior to the coheating test.

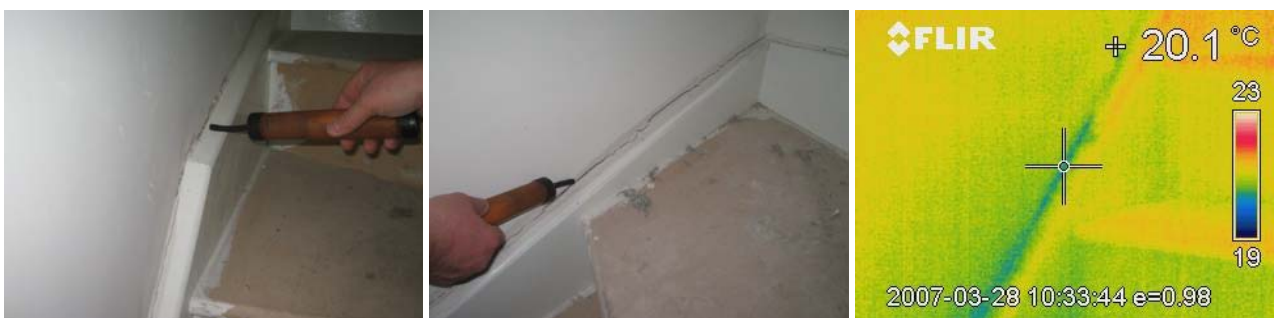
Figure 12.4 Air leakage around the stairs.

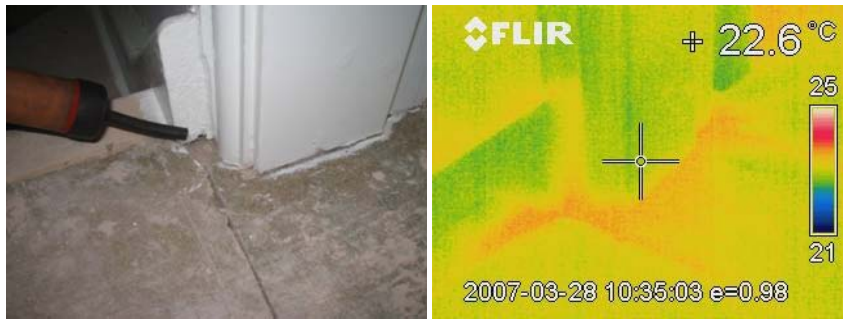
Figure 12.5 Air leakage at the junction of the 1<sup>st</sup> intermediate floor with the stairs.

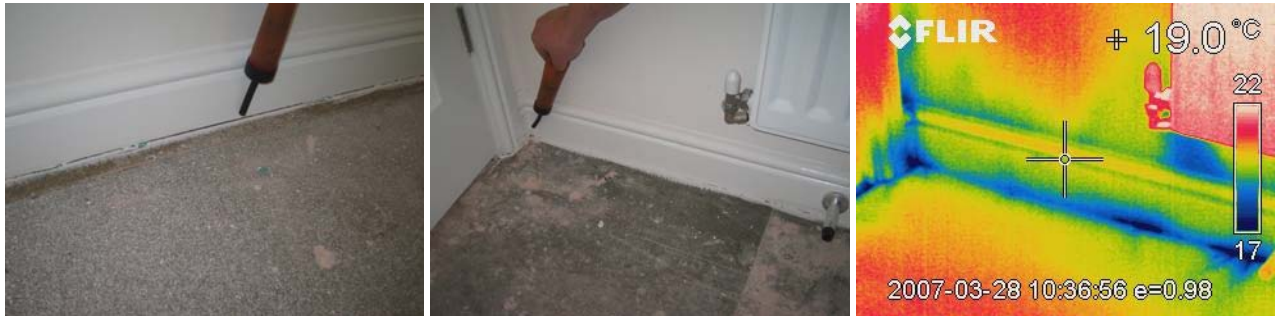
Figure 12.6 Air movement through gaps at the 1<sup>st</sup> floor junction with separating and external walls.

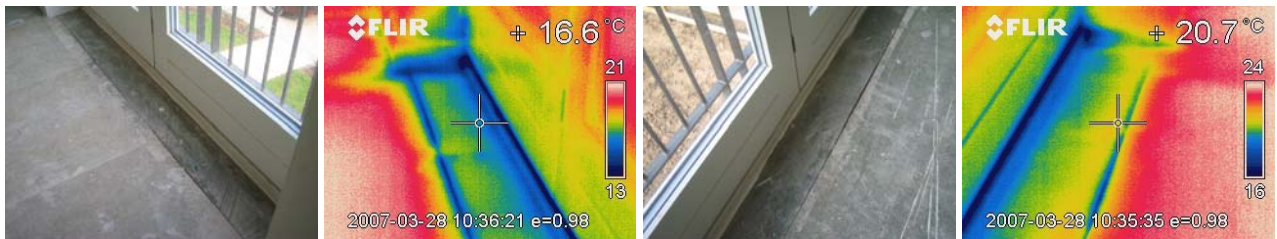
Figure 12.7 Direct infiltration at both front and rear 1<sup>st</sup> floor balcony doors.

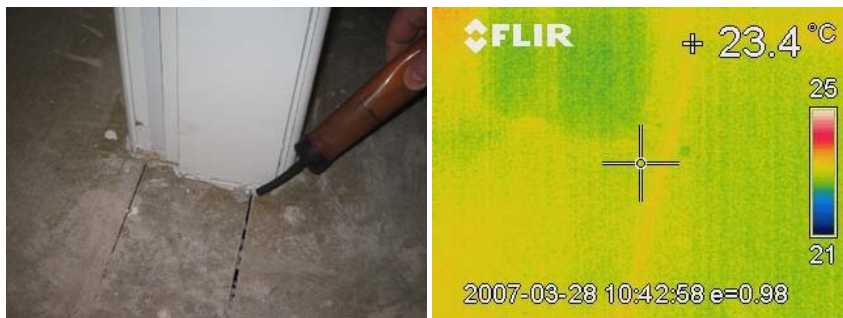
Figure 12.8 Air movement into and out of the 1<sup>st</sup> floor void.

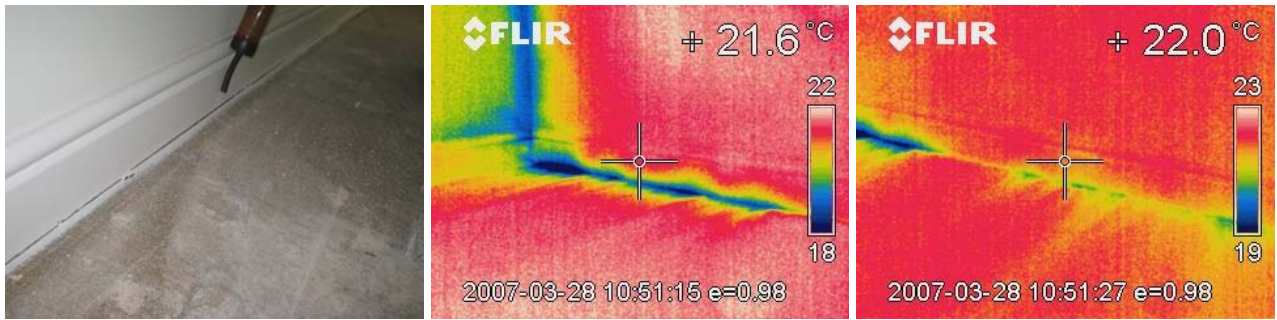
Figure 12.9 Air movement around failed sealant at the 2<sup>nd</sup> floor perimeter.

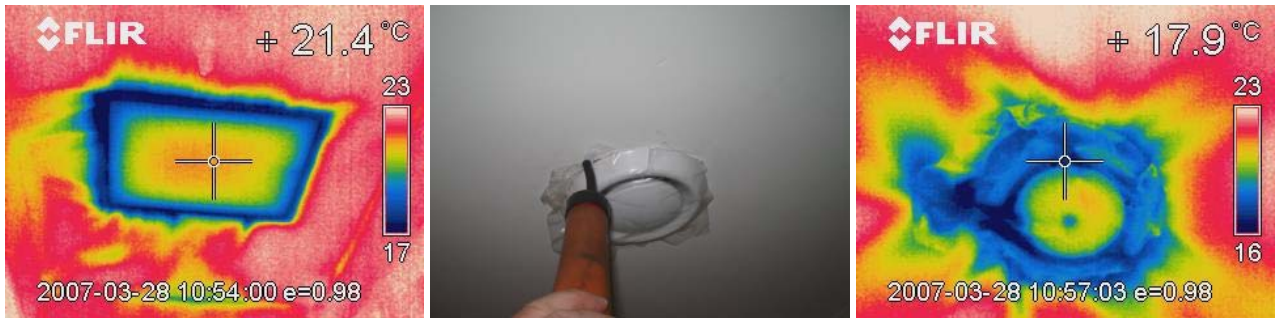
Figure 12.10 Air movement directly through the top floor ceiling.

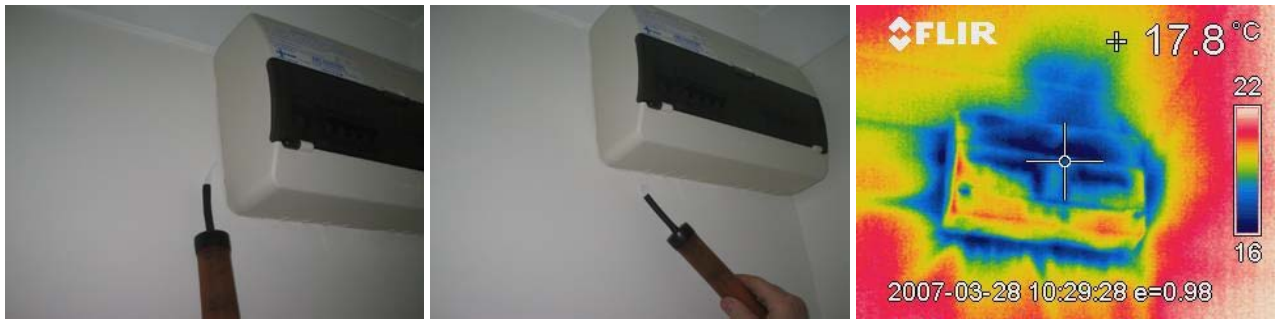
Figure 12.13 Air leakage around the electrical consumer unit.

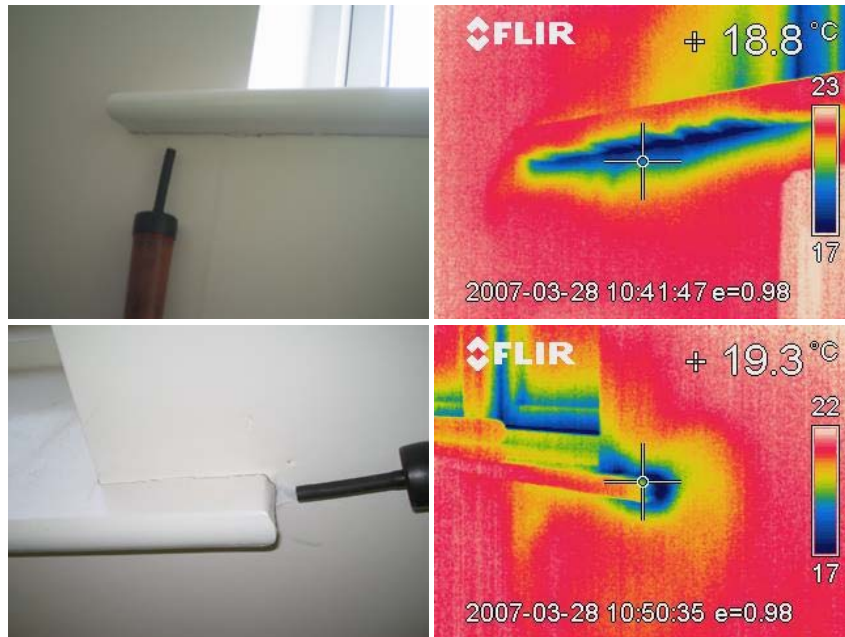
Figure 12.16 Air leakage at visible shrinkage cracks around window sills.

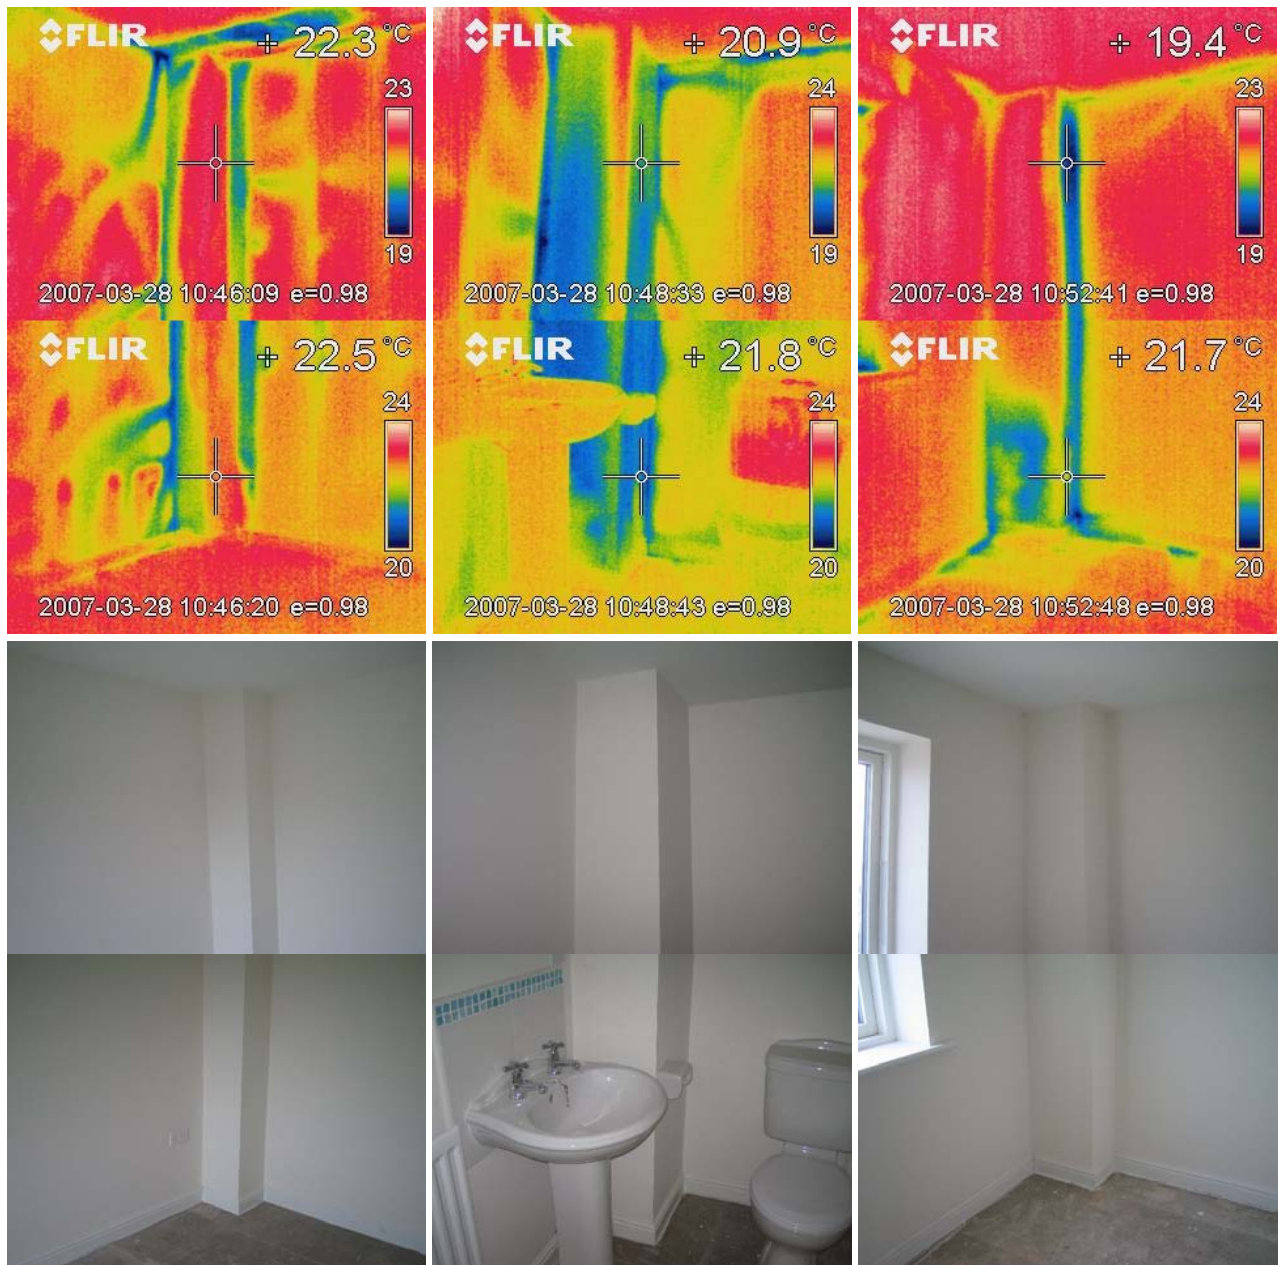
Figure 12.17 Cooler air being drawn into the dwelling from the loft through 2<sup>nd</sup> floor service voids

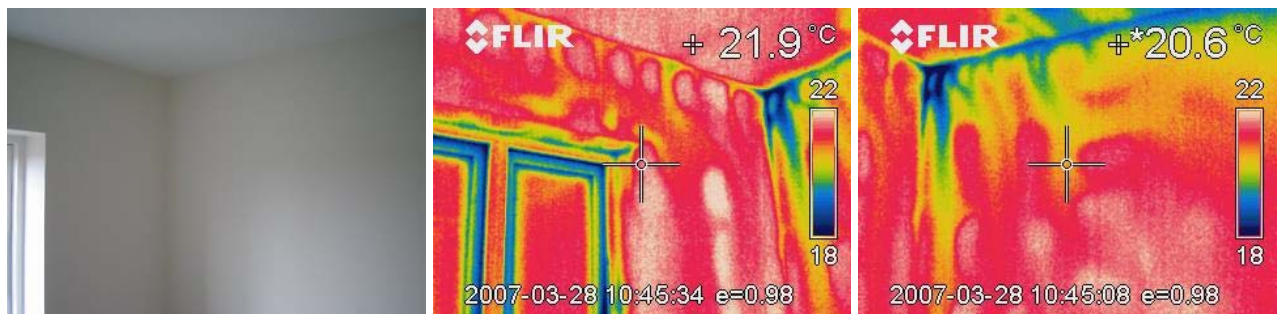
Figure 12.18 Air infiltration into the void behind the plasterboard at the loft boundary on an external and party wall.

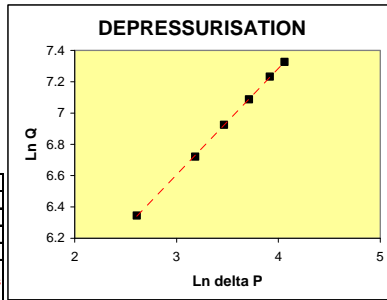
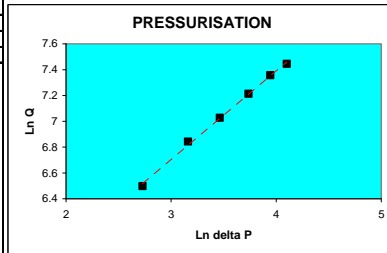
house width:	m		
house depth:	m		
house height:	m		
floor area:	m2		
volume:	356 m3		
envelope area including floor:	305 m2		
Pressure Difference for ELA	10 Pa

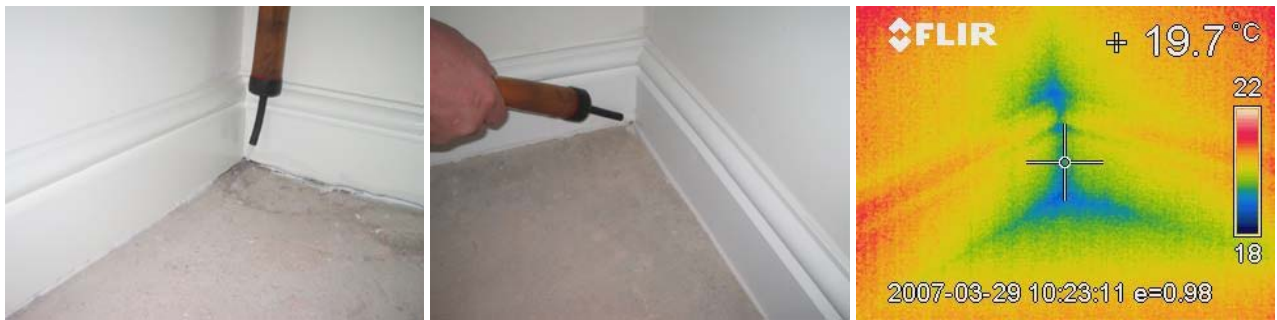
Figure 13.2 Ground floor room corners.

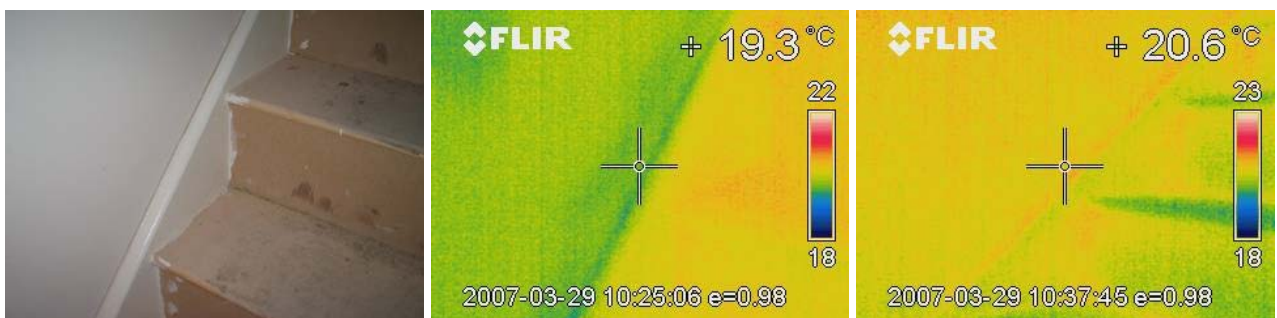
Figure 13.4 Air movement through shrinkage cracks on the lower and upper sets of stairs, with cooler air emerging at the lower staircase and warmer air at the upper staircase.

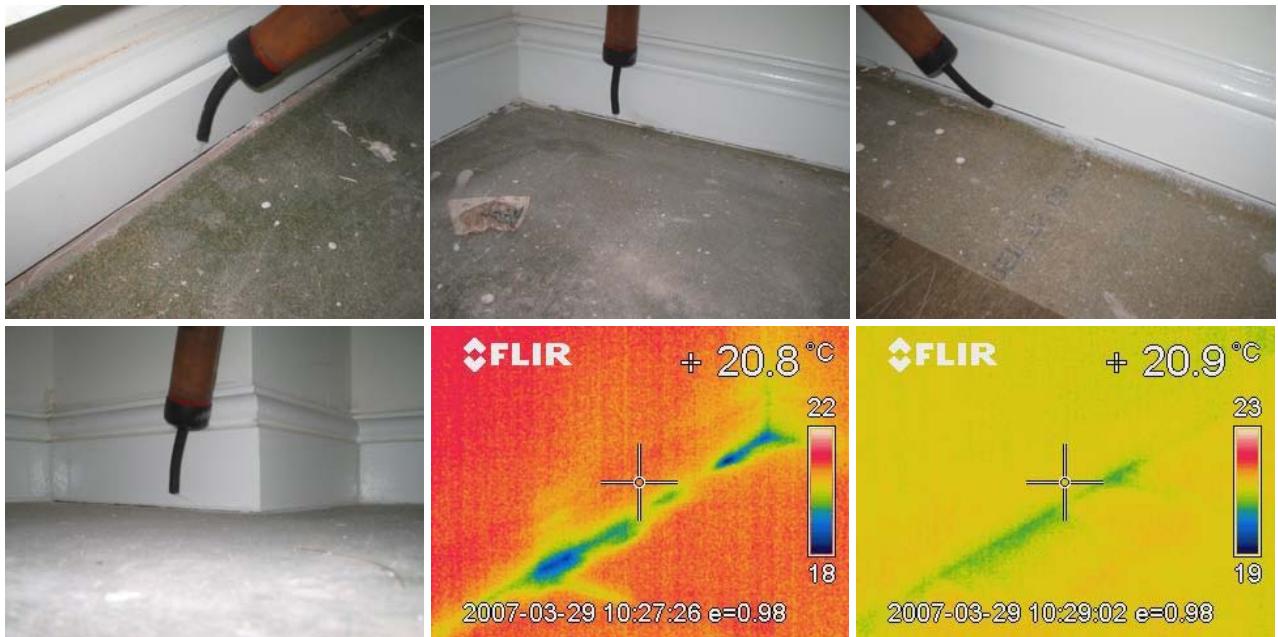
Figure 13.5 Failure of the flexible sealant on 1<sup>st</sup> floor wall junctions, with cooler air entering the dwelling on external walls than on internal walls under dwelling depressurisation.

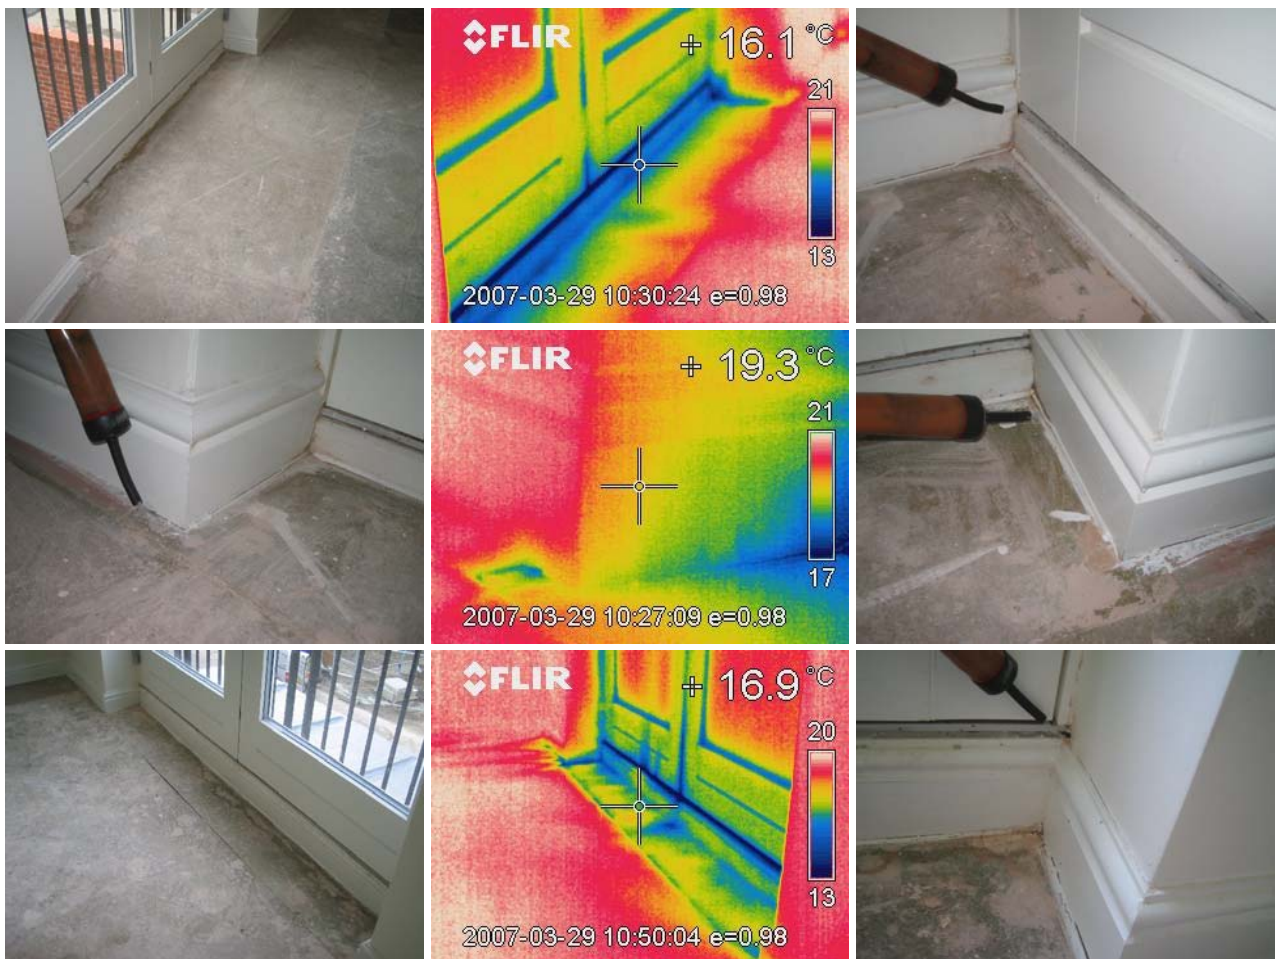
Figure 13.6 Air leakage around the bottoms of the balcony doors on the 1<sup>st</sup> and 2<sup>nd</sup> floors

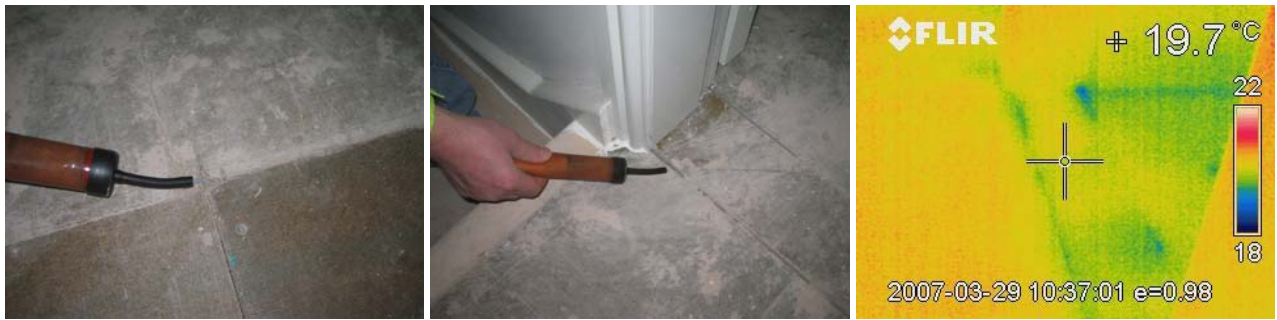
Figure 13.7 Air movement through holes in the intermediate floors.

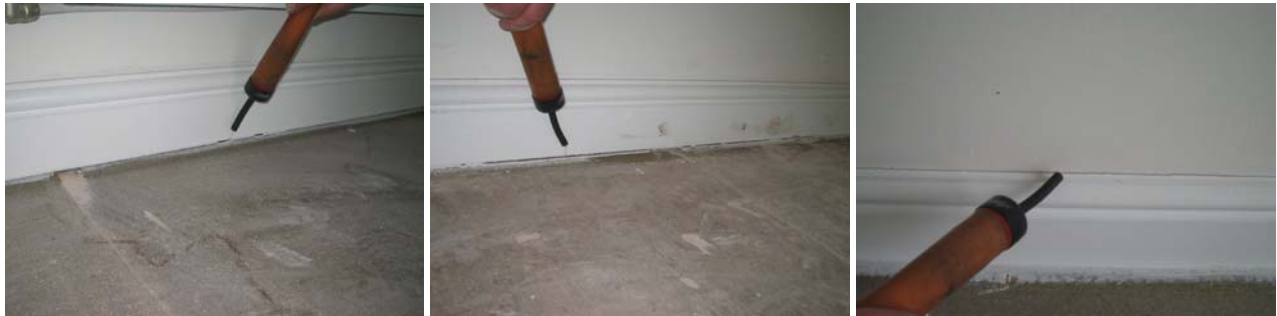
Figure 13.8 Air leakage at the 2<sup>nd</sup> floor/wall junctions.

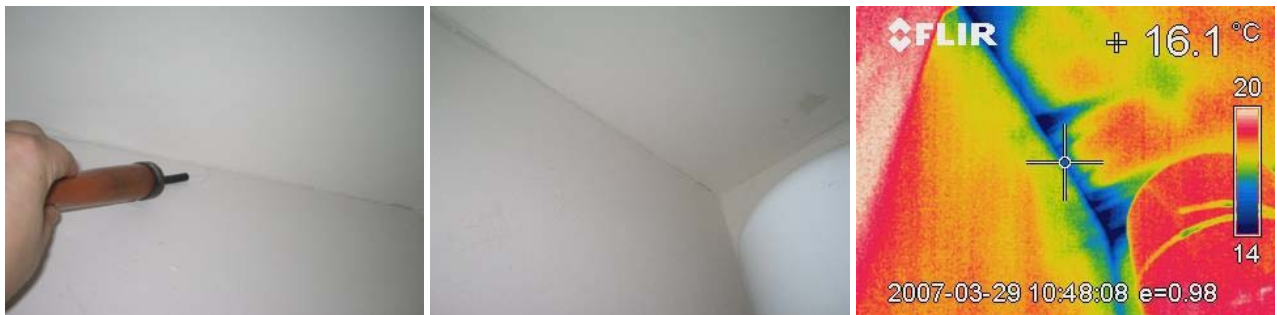
Figure 13.9 Air leakage at the cylinder cupboard ceiling.

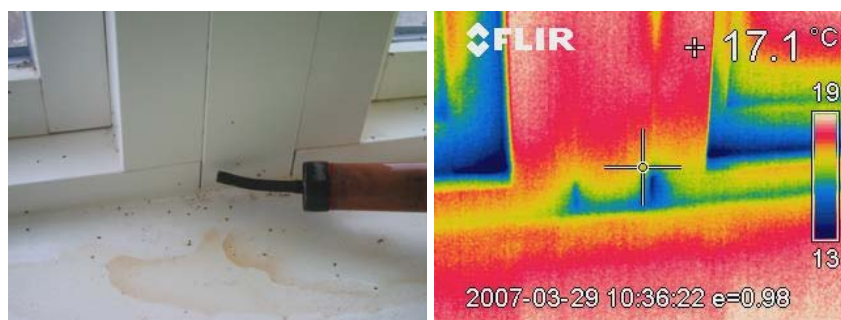
Figure 13.10 Direct air leakage gaps between individual frame elements of the bay window.

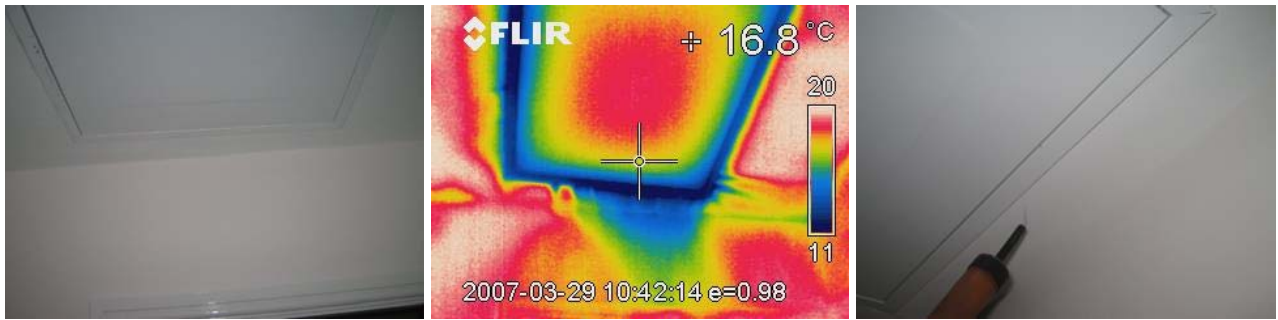
Figure 13.11 Direct air leakage around the loft hatch.

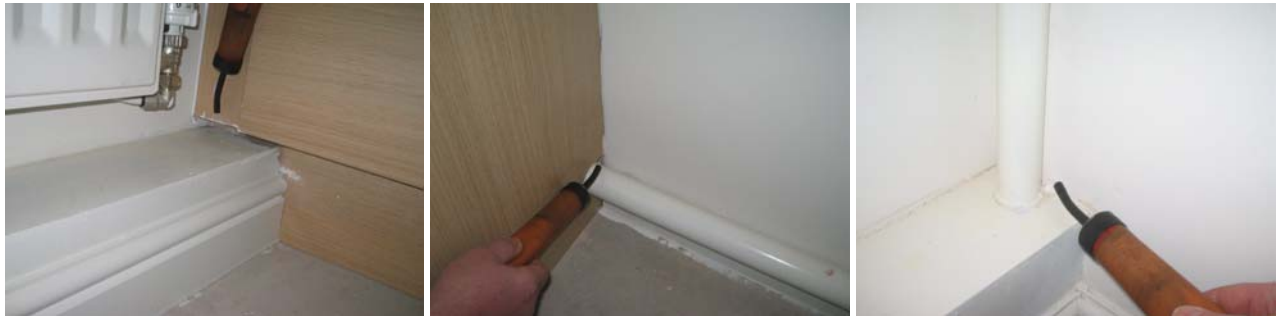
Figure 13.12 Increased air leakage at pipework boxing.

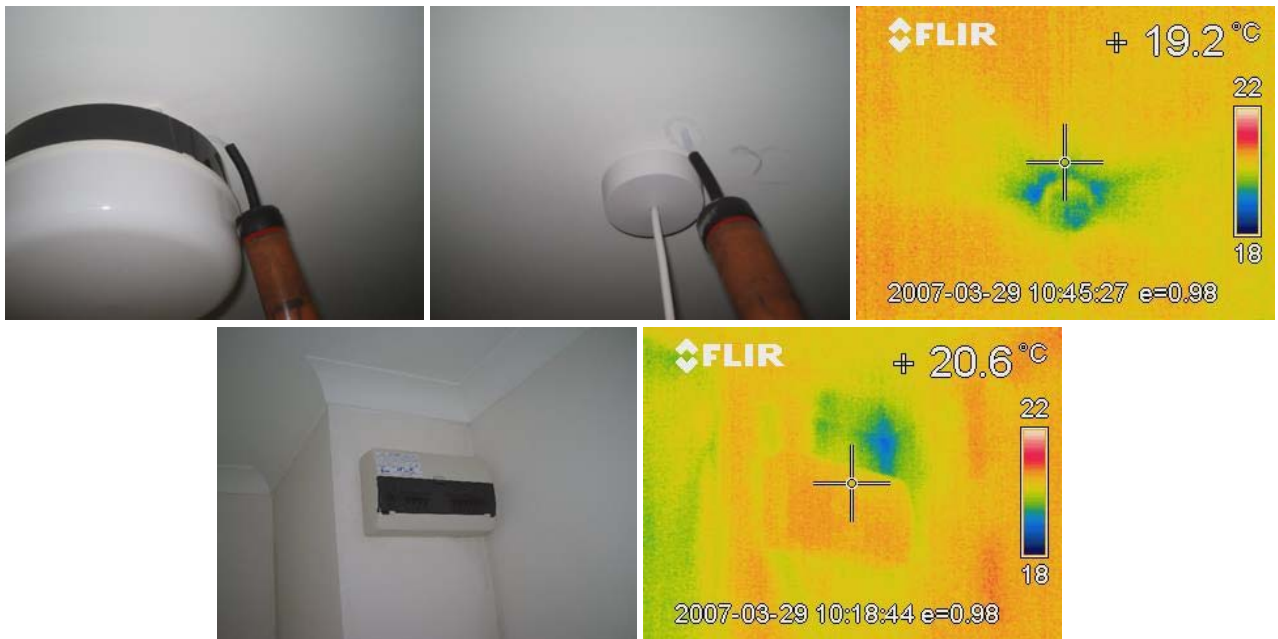
Figure 13.13 Air leakage around ceiling light fittings on the 2<sup>nd</sup> floor, but still no leakage detected around the electrical consumer unit

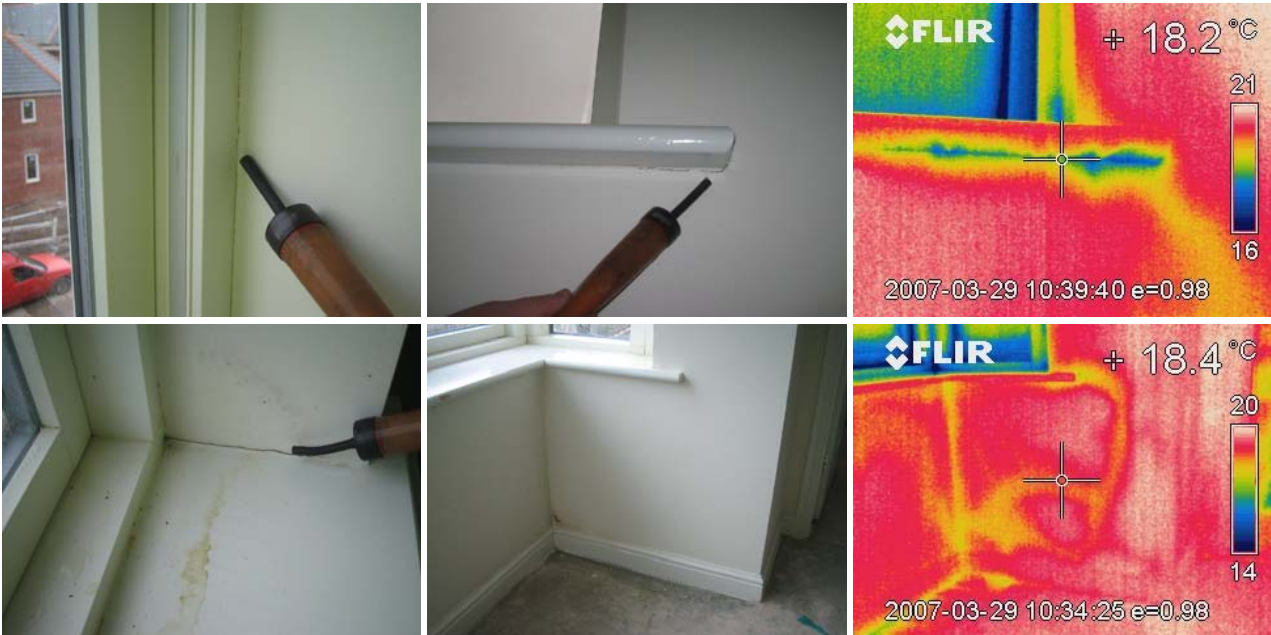
Figure 13.14 Air movement through gaps around the window frame and sills.

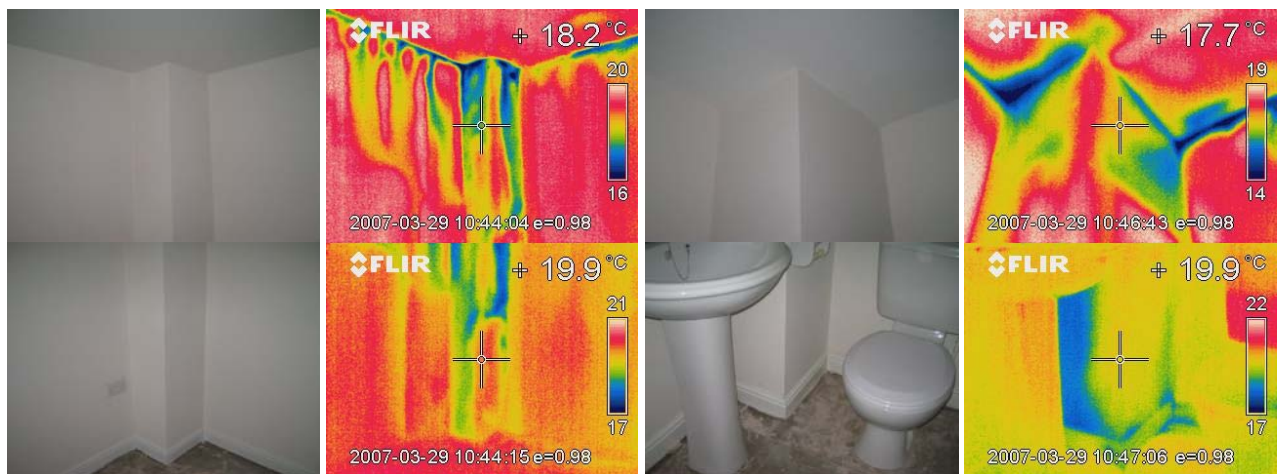
Figure 13.17 Air leakage into 2<sup>nd</sup> floor service voids in both bedroom and bathroom.

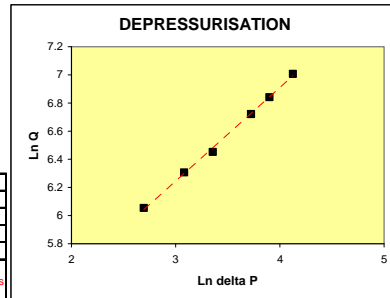
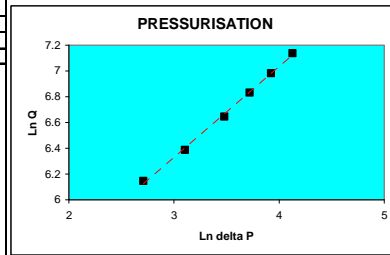
RESULTS:	Mean Flow AT 50Pa =	1011.16 m3/h
	ACH50 =	2.77 ach
	Air Permeability at 50 Pa =	3.20 m3/h/m2
	Equivalent Leakage Area =	0.038 m2 at 10 Pa

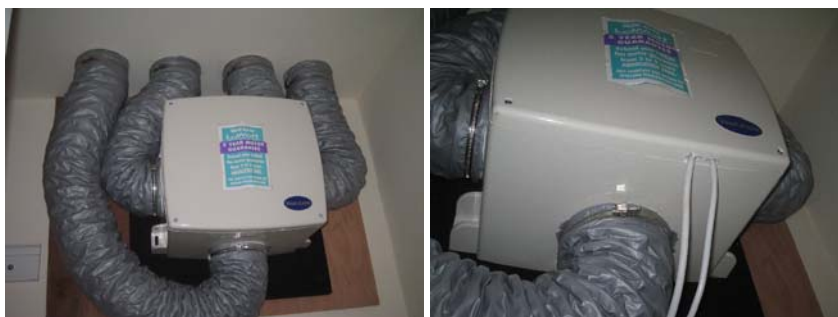
Figure 14.2 The MEV unit as when the initial pressurisation test was performed and with the additional wiring added by the time of the re-test.
