## **List of Appendices**

## Appendix 1: Pressurisation Test of Bryant Plot 116

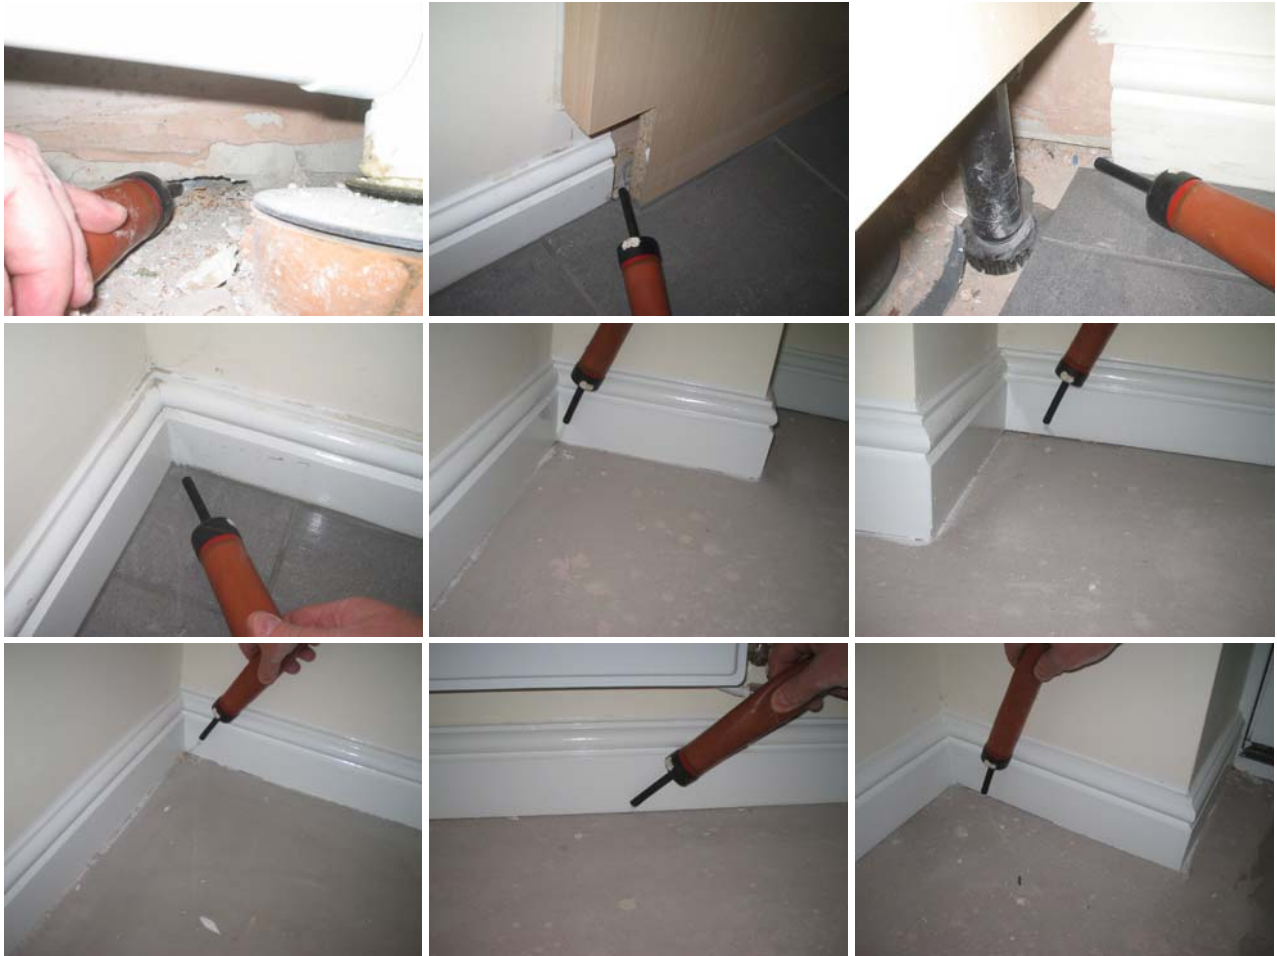
Figure 14.3 Air leakage at wall/floor junctions on the ground floor, in hidden areas behind units in the utility room and kitchen, under the skirting in the kitchen, dining room and hall on internal and external walls.

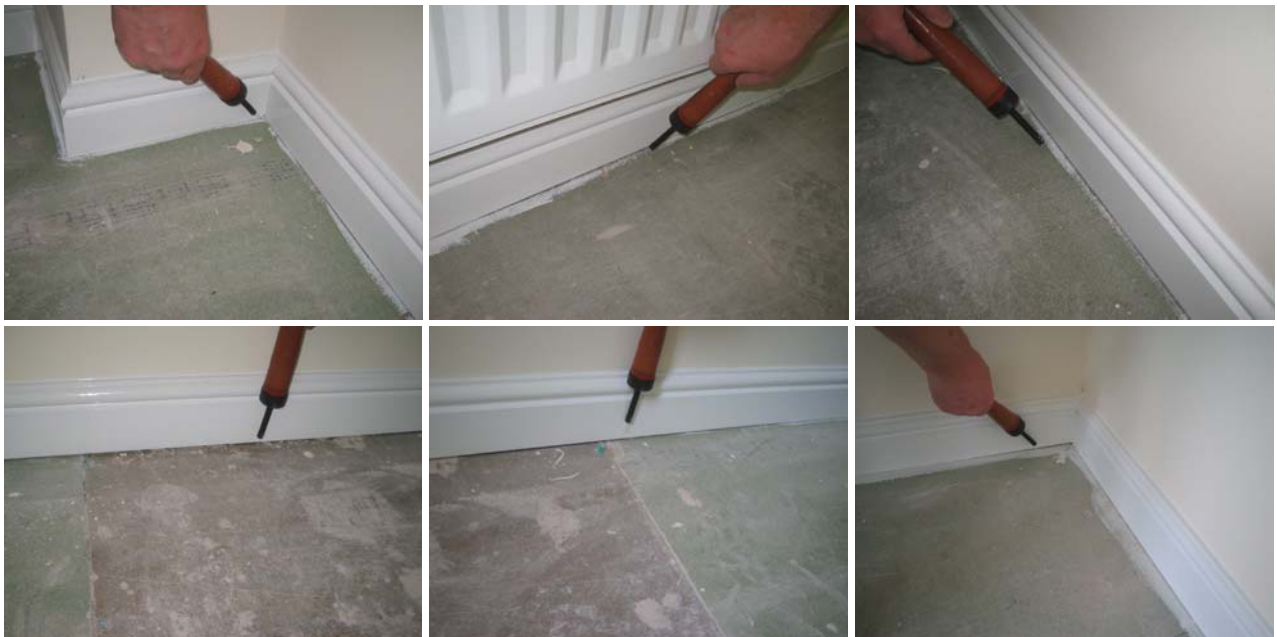
Figure 14.4 Air leakage at the unsealed wall/floor junctions on the 1<sup>st</sup> floor; detected along all external and separating walls.

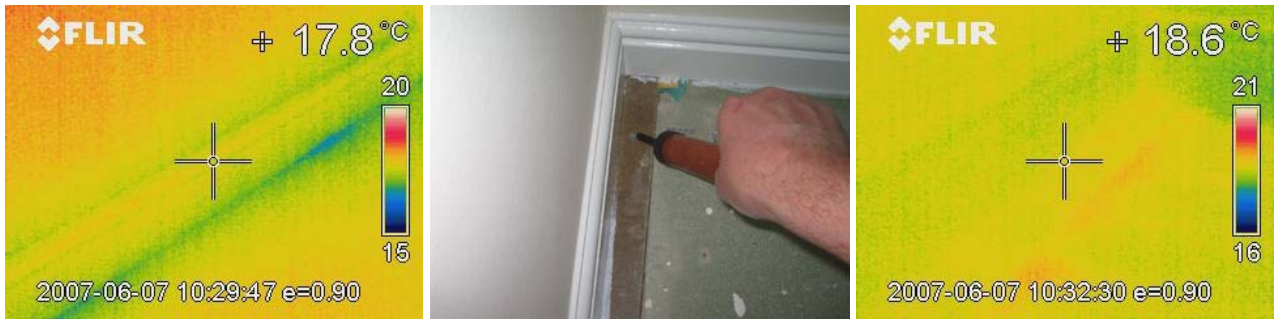
Figure 14.5 Under depressurisation, cooler air entering at the 1<sup>st</sup> floor on external walls, whereas on internal walls there was no temperature difference with warmer air emerging from gaps between flooring panels.

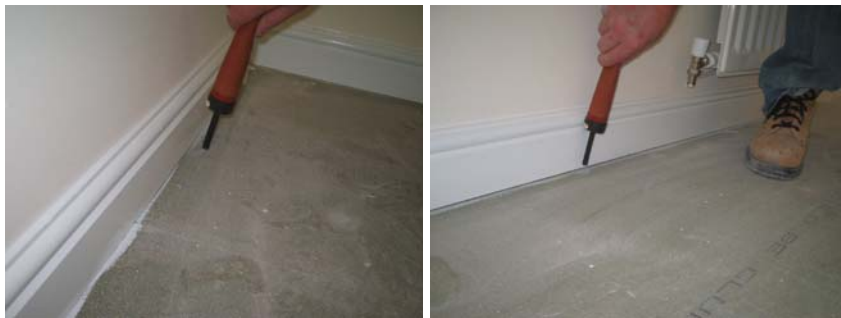
Figure 14.6 Infiltration detected at wall/floor junctions in the 2<sup>nd</sup> floor front and rear bedrooms on the party and external walls.

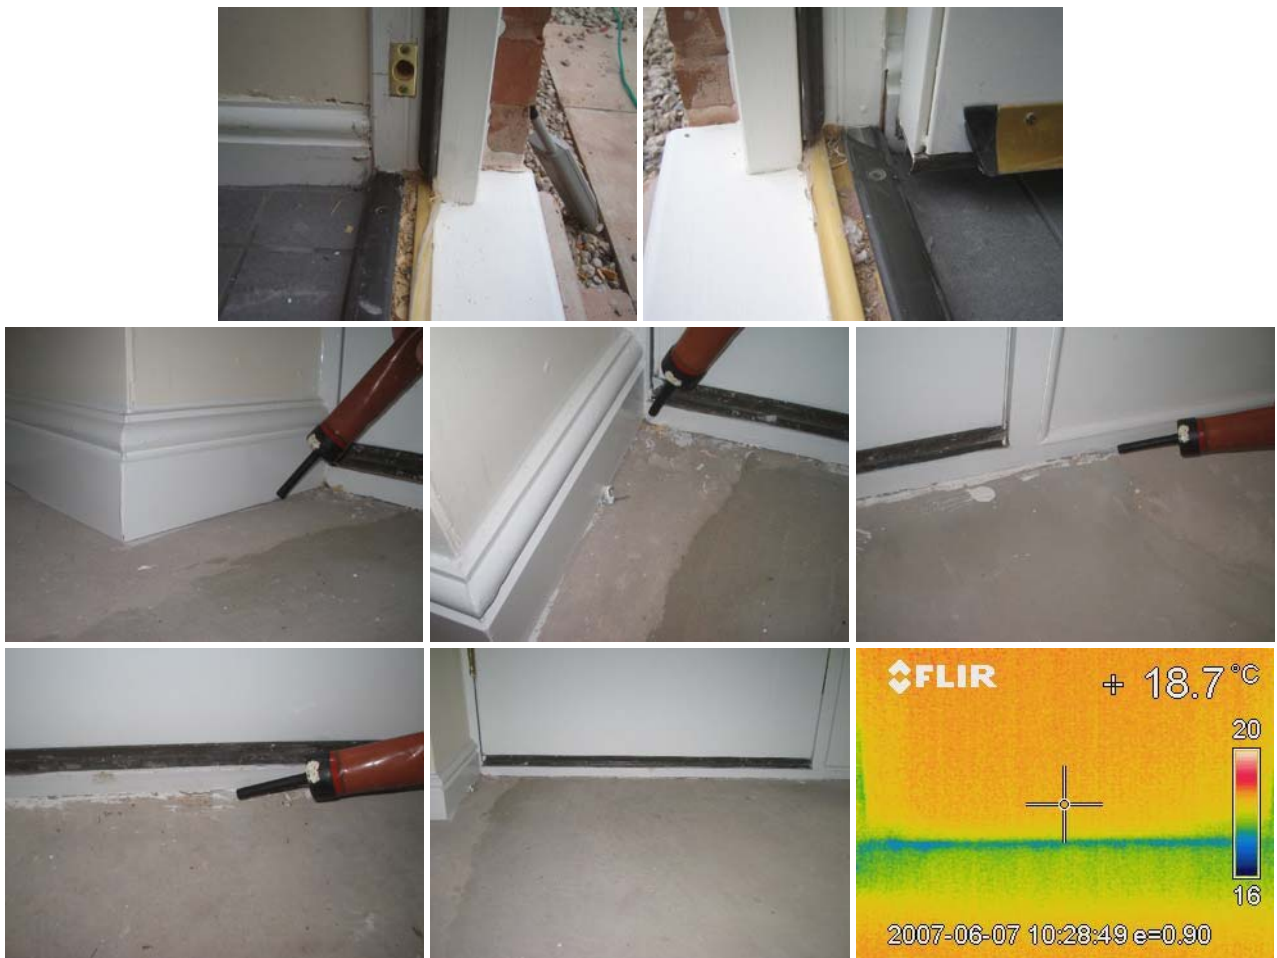
Figure 14.7 The back door threshold, and air leakage detected at the front door threshold.

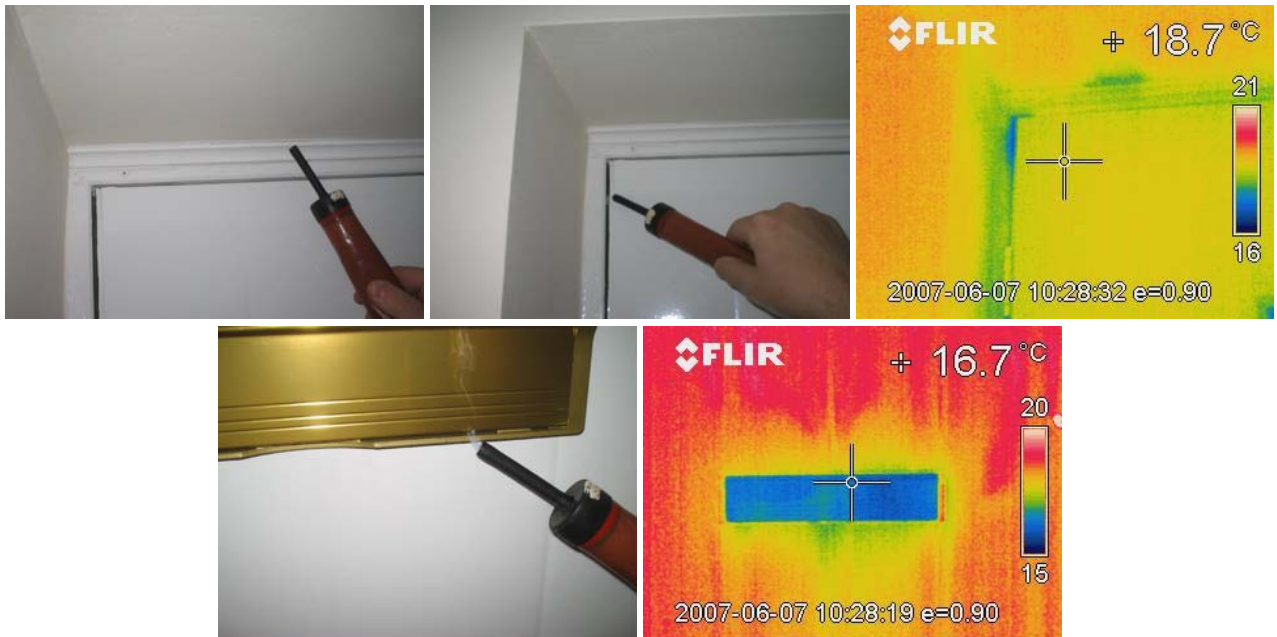
Figure 14.8 Air leakage at the head of the front door, around the door casement on the hinge side and around the letterbox.

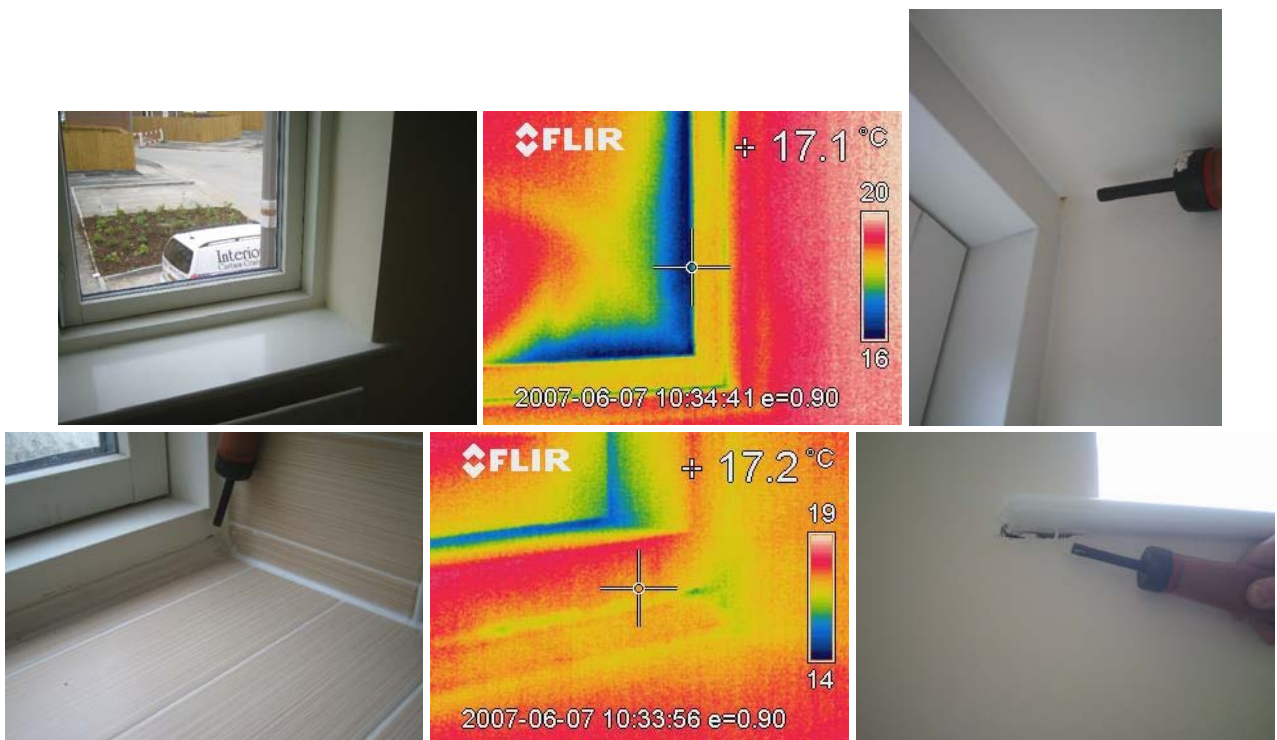
Figure 14.9 The replacement lounge window showing infiltration under depressurisation; and air leakage again detected around the kitchen window frame, the sill in the 1<sup>st</sup> floor bathroom and beneath window sills on the 1<sup>st</sup> and 2<sup>nd</sup> floor even though additional decorating work had been carried out.

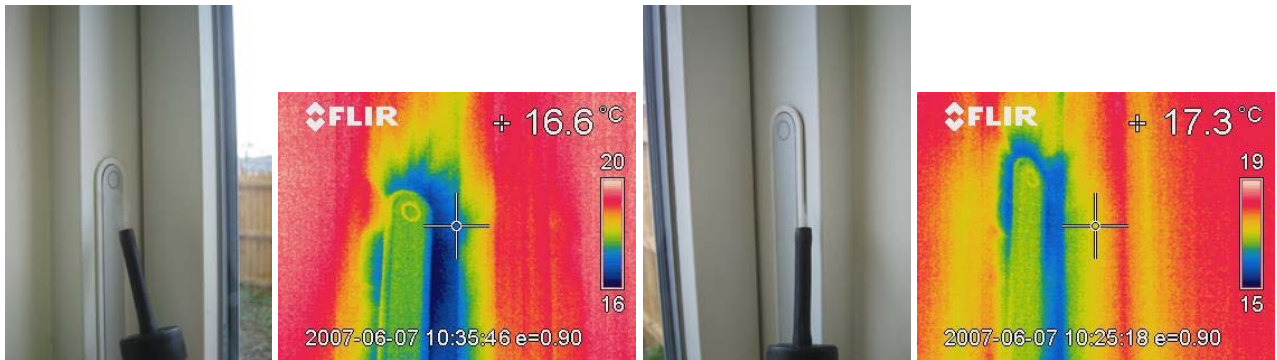
Figure 14.10 Air leakage at the trickle vents in the kitchen window.

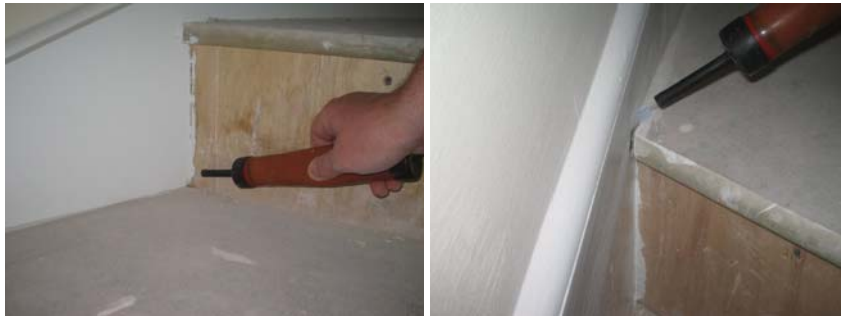
Figure 14.11 Air movement through gaps in the both staircases.

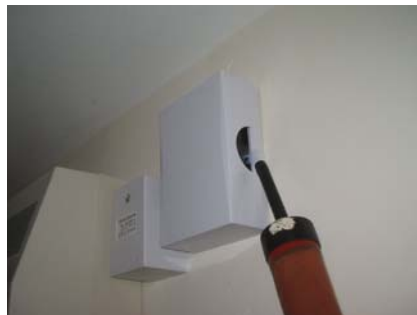
Figure 14.12 Movement of air through electrical penetrations on the ground and 1<sup>st</sup> floor electrical penetrations was the same as that observed in the initial test.

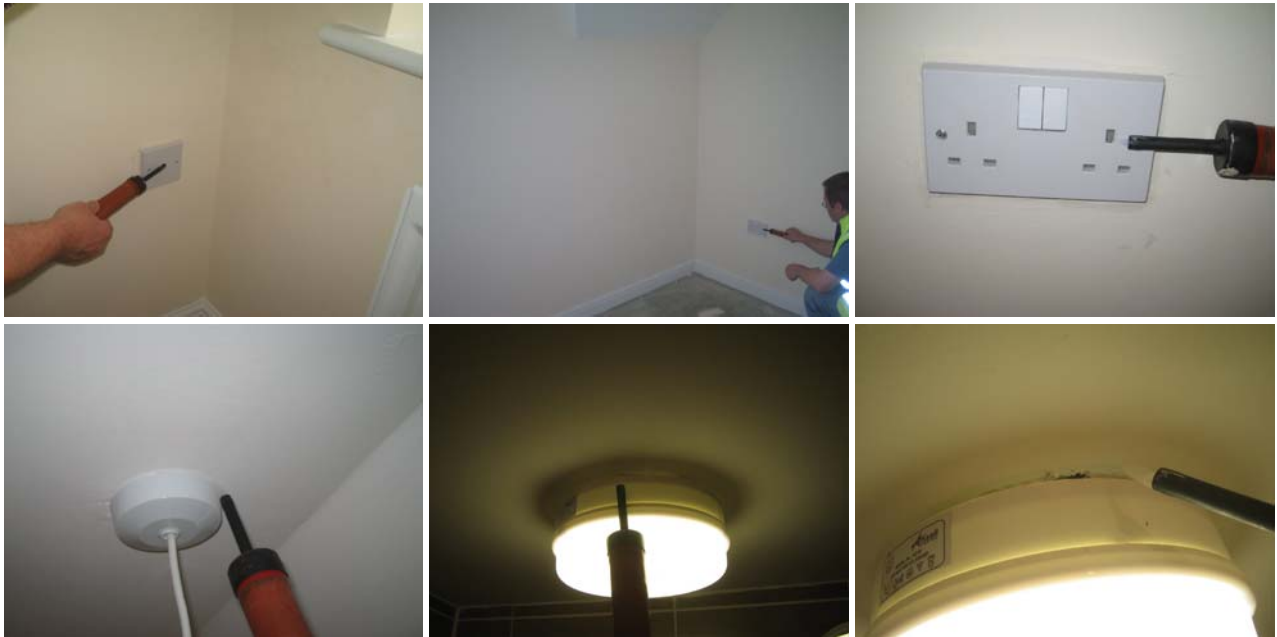
Figure 14.13 Indirect air leakage into walls and direct leakage into the loft space around electrical penetrations on the 2<sup>nd</sup> floor,

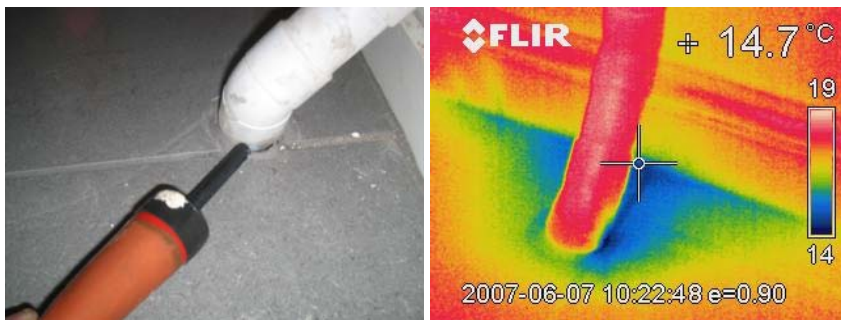
Figure 14.14 Air leakage around the waste pipe for the basin in the ground floor WC.

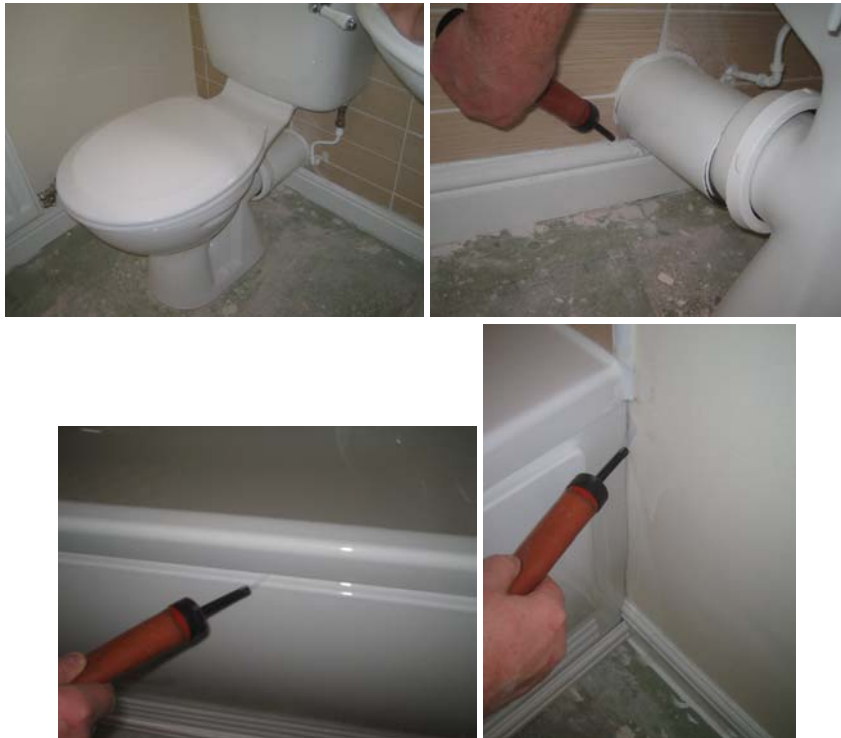
Figure 14.15 Where visible, plumbing penetrations into the service void along the wall in the 1<sup>st</sup> floor bathroom were sealed around effectively, in less visible areas the sealing was less successful.

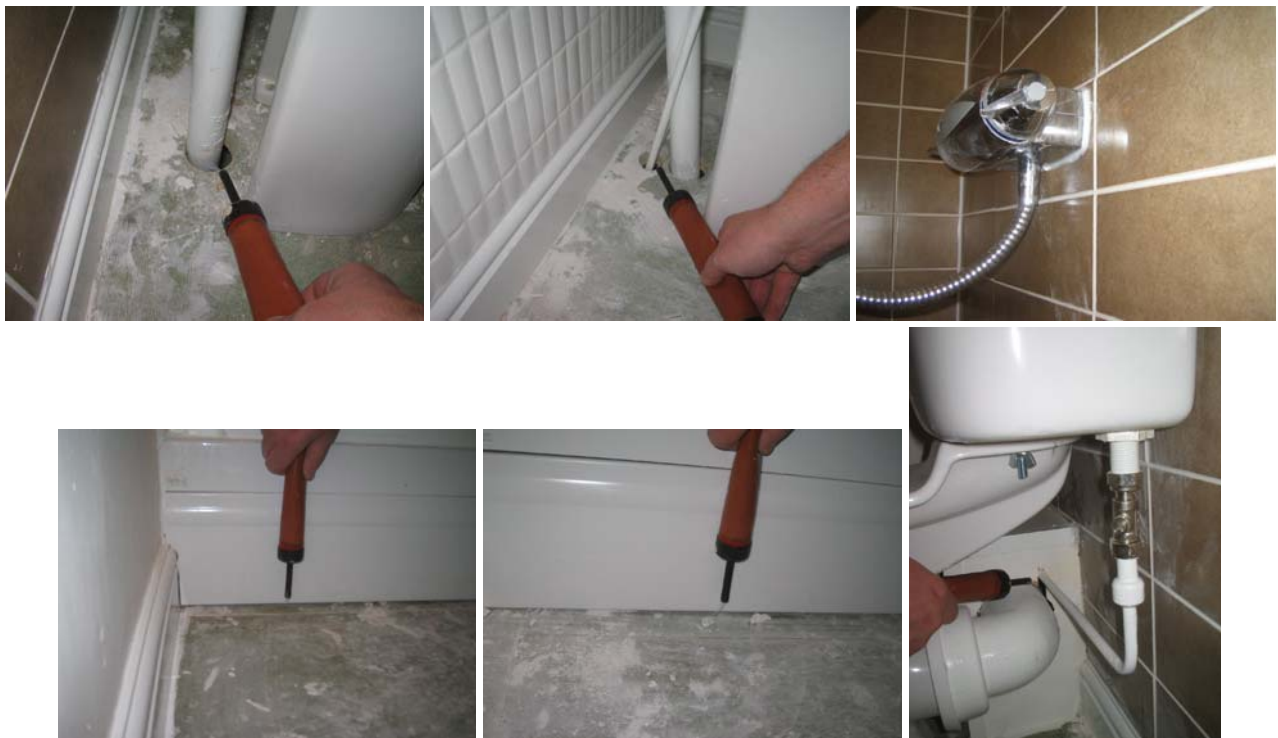
Figure 14.16 Unsealed plumbing penetrations into the 2<sup>nd</sup> floor in both front and rear en-suites; generally well sealed wall penetrations; air leakage around the shower trays in both bathrooms, and at the entrance to the boxing-in in the front en-suite.

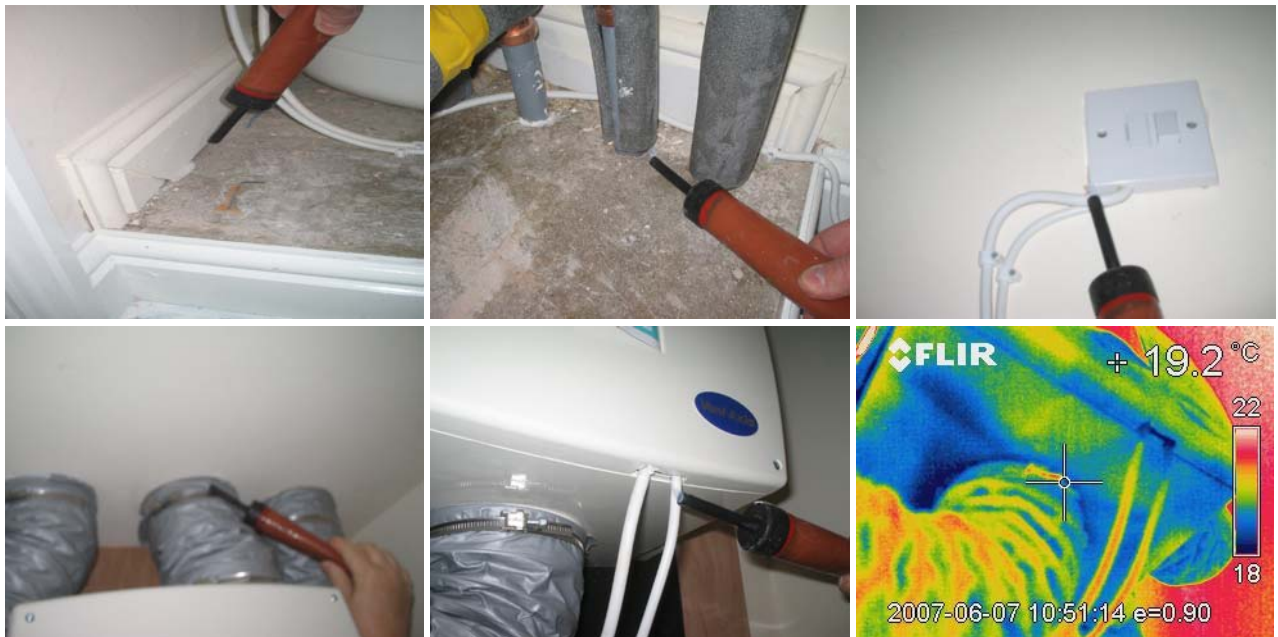
Figure 14.17 Air movement around junctions and penetrations in the 2<sup>nd</sup> floor cylinder cupboard.

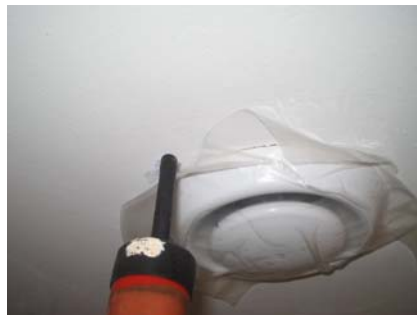
Figure 14.18 Air leakage around the vent for the MEV system in the kitchen.

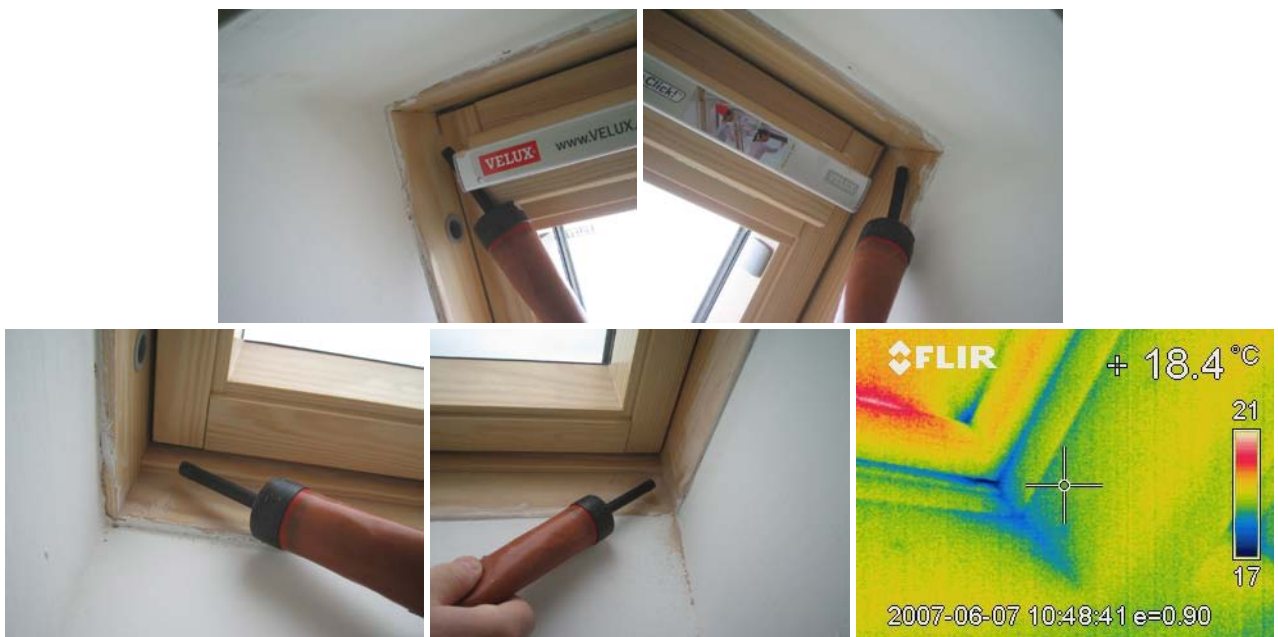
Figure 14.19 All 3 of the rooflights in the 2<sup>nd</sup> floor rear bedroom displayed some degree of air leakage.

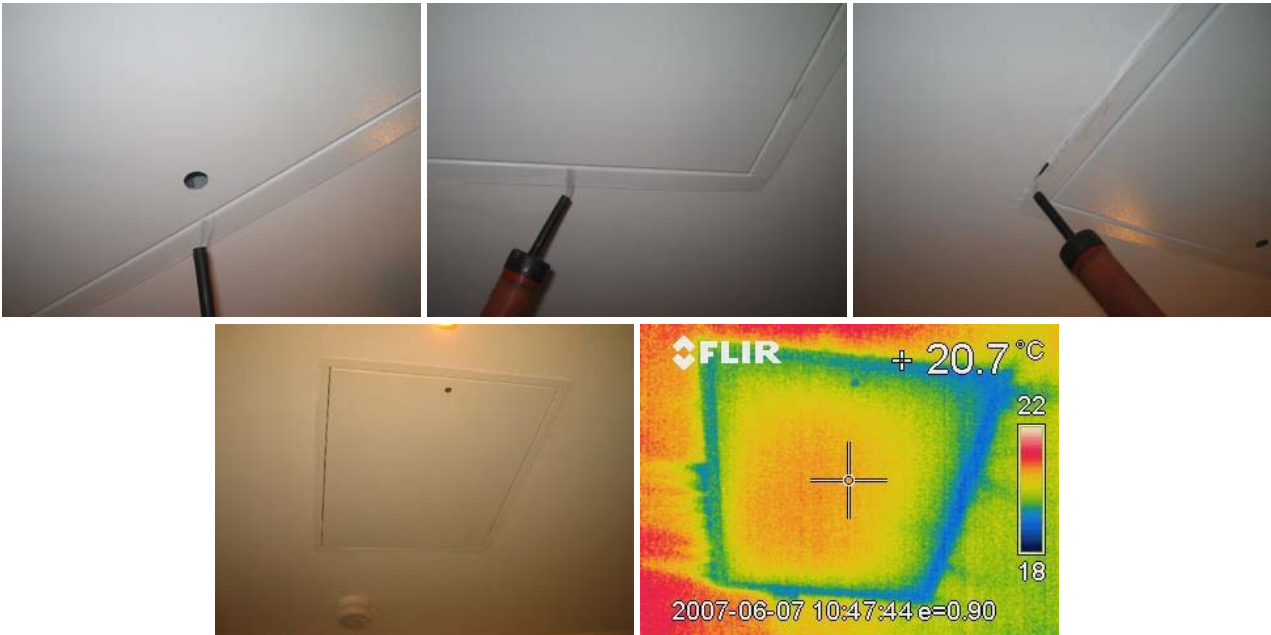
Figure 14.20 Infiltration at the loft hatch was again detected through the loft hatch keyhole, between the hatch and door, and around the frame itself.

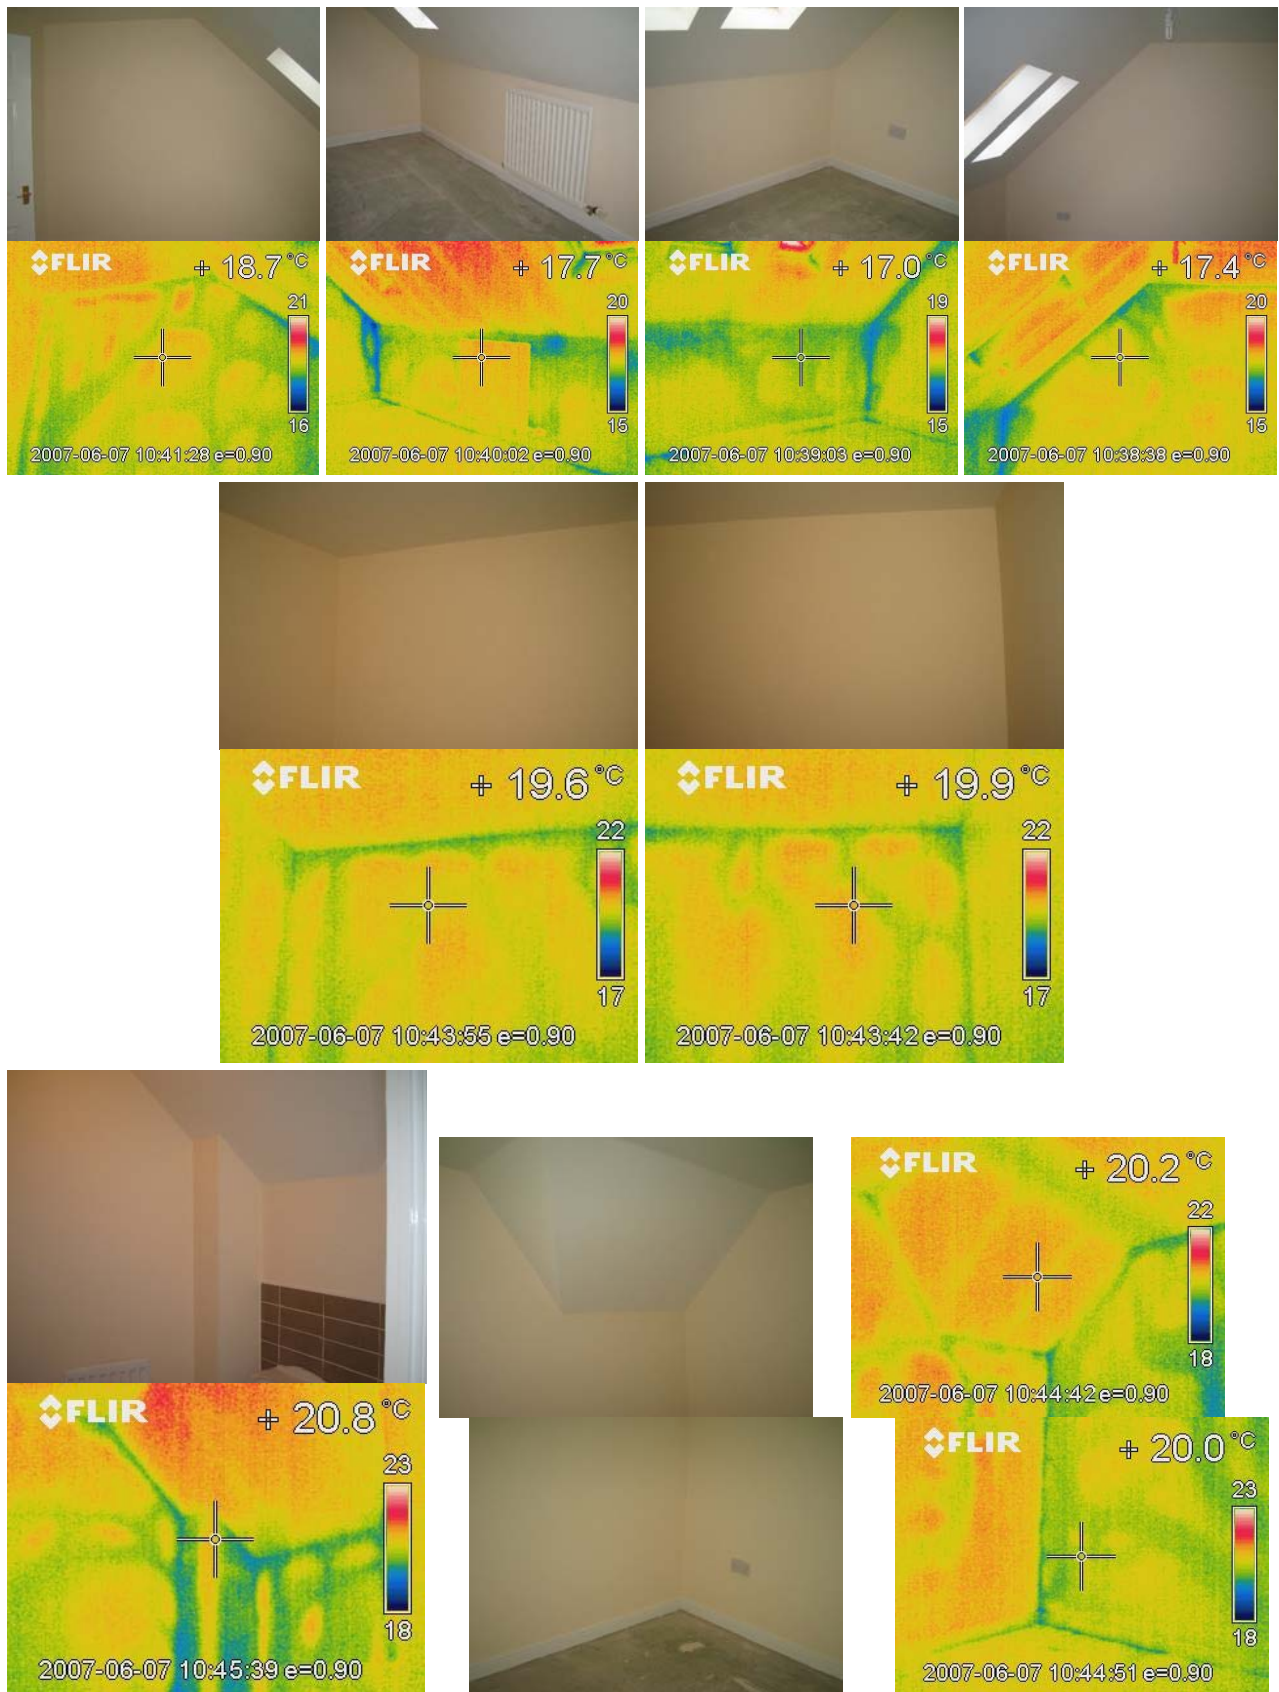
Figure 14.21 Thermal imaging of the dry-lining at the left boundary on the 2<sup>nd</sup> floor; along the section of sloping roof in the rear bedroom; at the party/internal wall junction on the landing; in the front en-suite bathroom, and around the junction of the front external wall with the party wall by the dormer window.

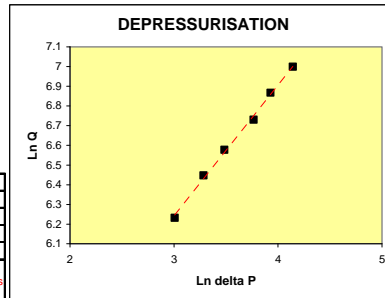
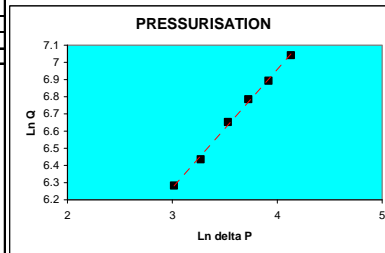
DEPRESSURISATION	RING (O=open or A,B,C,D,E)	MEASURED FAN PRESSURE (Pa)	MEASURED FLOW (m3/h)	FLOW RANGE OK FOR SELECTED RING?	Adjusted Pressure (Pa)	Ln delta P	Ln Q	Q50 Calculated Flow at 50Pa (m3/h)	Permeability Depress Only (m3/hr/m2)	ACH Depress Only (ach)
Approx 60 Pa	b	63	1113	OK	63	4.143135	6.999283	949.64	3.19	2.77
Approx 50 Pa	b	50.8	975	OK	50.8	3.927896	6.866907	r2	0.997	
Approx 40 Pa	b	43.2	850	OK	43.2	3.76584	6.729705	C	0.020	m3/s
Approx 30 Pa	b	32.6	730	OK	32.6	3.484312	6.577514	n	0.663	
Approx 20 Pa	b	26.7	641	OK	26.7	3.284664	6.447499	C (corrected)	0.020	m3/s
Approx 10 Pa	b	20.2	517	OK	20.2	3.005683	6.232512
