AIRTIGHTNESS OF BUILDINGS — TOWARDS HIGHER PERFORMANCE

Interim Report D5 — Site Assessments and Feedback Material

Dr David Johnston, Centre for the Built Environment, Leeds Metropolitan University

Reference Number: CI 61/6/16 (BD2429)

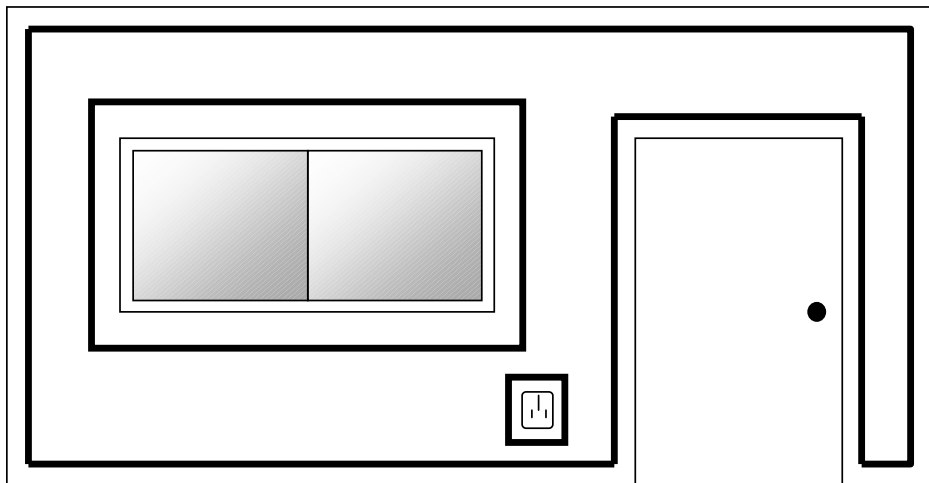
- 36 One of the main air leakage paths within UK dwellings is plasterboard dry-lining (see Stephen, 1998 and 2000). Problems arise with plasterboard dry-lining when air can freely move into the gap between the plasterboard and the masonry wall, especially where the plasterboard is fixed to the wall using adhesive dabs. The air gap between the plasterboard sheet and the masonry wall then acts as a plenum, effectively interconnecting all of the leakage paths within the dwelling. To limit air leakage through plasterboard dry-lining, the report on Robust Construction Details (see DEFRA, 2001) recommends that continuous ribbons of adhesive are used to seal the dry-lining at the perimeter of external walls, openings, and services on external walls. This is illustrated in Figure 8. In our opinion, the process of applying plaster ribbons in such a way as to seal all potential leakage sites is technically difficult to carry out. Observations from site confirm this (see Figures 9 to 11). Figures 10 and 11 also illustrate that the overall thermal performance of these dwellings will be degraded, as the discontinuous ribbons of adhesive will enable air to bypass the internal insulation.

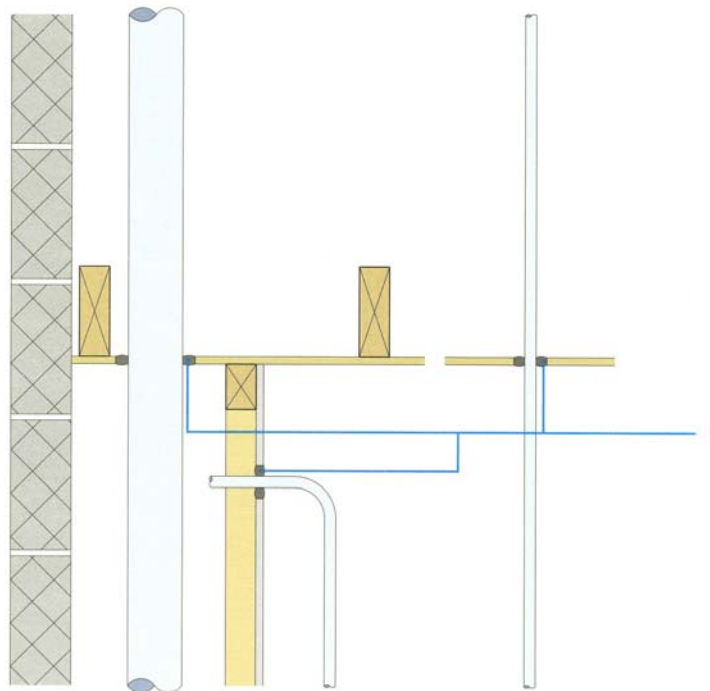
- 37 Service penetrations are known to be a significant route for air leakage (see Stephen 1998 and 2000). The report on Robust Construction Details (DEFRA, 2001) states that particular care on site should be paid to service penetrations and all service penetrations should be sealed with expanding foam or other suitable sealant, whether in the wall, ground floor, intermediate floor or ceiling (see Figure 12). Where large voids exist, mineral wool or some other backing material should be used to support the sealant. Observations from site illustrate that little attempt has been made to seal the majority of service penetrations through walls, ground floors, intermediate floors and ceilings, and where attempts at sealing have been made, the penetrations are generally inadequately sealed and inappropriate sealants have been used to seal gaps around the service penetrations. These points are illustrated in Figures 13 to 17.

- 38 In some cases, problems with service penetrations arose due to incorrect sequencing of work. For example, gas pipework which should have been placed in position at an early stage in the build sequence was omitted (due to missing details on drawings) and then had to be added at a later stage, requiring additional penetrations through the fabric that might otherwise have been unnecessary. In many cases, larger holes are made than are strictly necessary for the pipework, in order to allow for positioning (see Figure 13). These large holes are then much more difficult to seal. Another problem is that service penetrations that are subsequently hidden behind boxing or panels (for example the bath panel, shower tray, shower pod, in an under sink unit, in airing cupboard or in an under stairs cupboard) are often left unsealed, whilst visible penetrations in the same dwelling have been sealed. This suggests a lack of understanding of the importance of these areas, with the selection criteria being used when deciding to seal or not being one of cosmetic appearance rather than airtightness.
